# Power System Operating Incident Report – Trip of Millmerran Power Station Generating Units 1 and 2 on 23 December 2013

PREPARED BY: AEMO Systems Capability

DATE: 26 March 2014

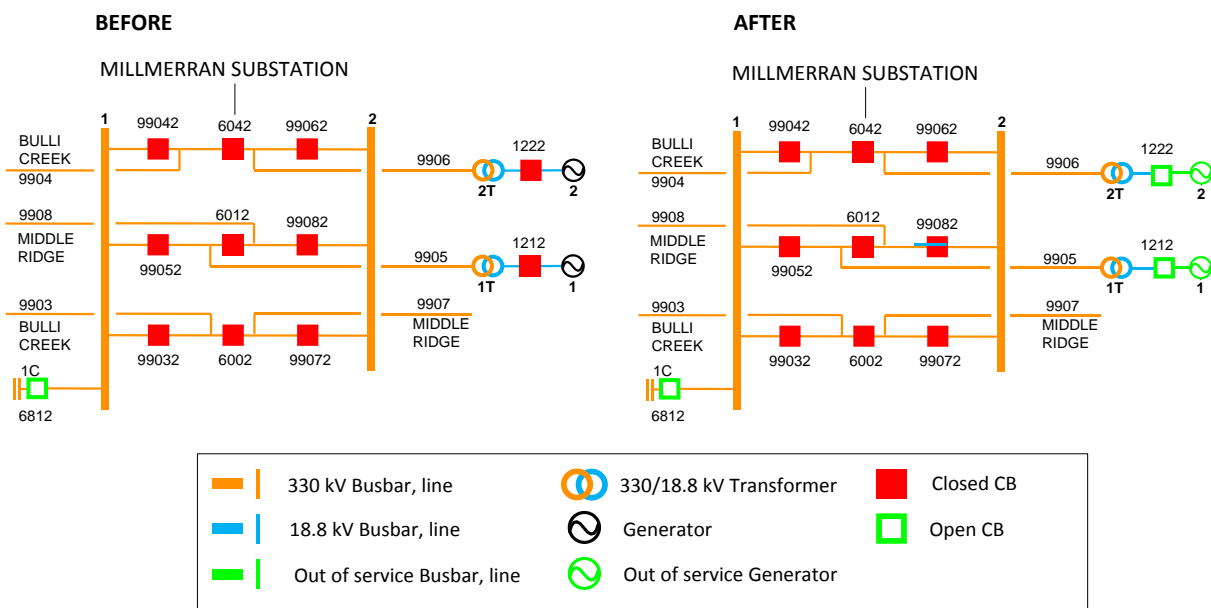
**Figure 1 - Status of the power system before and after the incident**

The status of the power system before and after the incident is shown in Figure 1. For clarity only equipment relevant to this incident has been included in the diagrams. The diagram shows the transmission system at Millmerran Substation unaffected by the generator unit trips.
