# POWER SYSTEM OPERATING INCIDENT REPORT - TRIP OF 76 AND 77 330KV TRANSMISSION LINES AND WALLERAWANG UNIT 8 ON 25 JANUARY 2013

PREPARED BY: System Performance & Commercial

DATE: 1 July 2013

FINAL

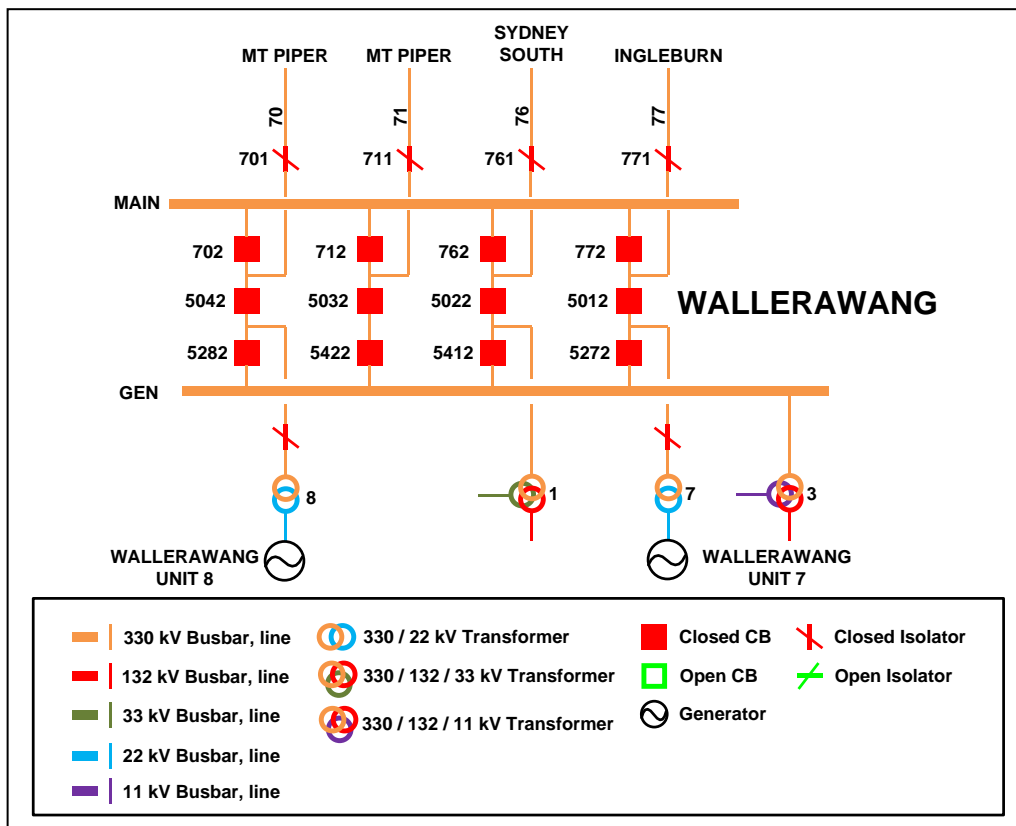
Figure 1 - Status of the power system prior to the incident

Prior to the incident, the 76 and 77 Transmission Lines were both in service and Wallerawang Power Station Unit 7 and Unit 8 were both in service.

The status of the power system prior to the incident is shown in Figure 1. For clarity only equipment relevant to this incident has been included in the diagram.

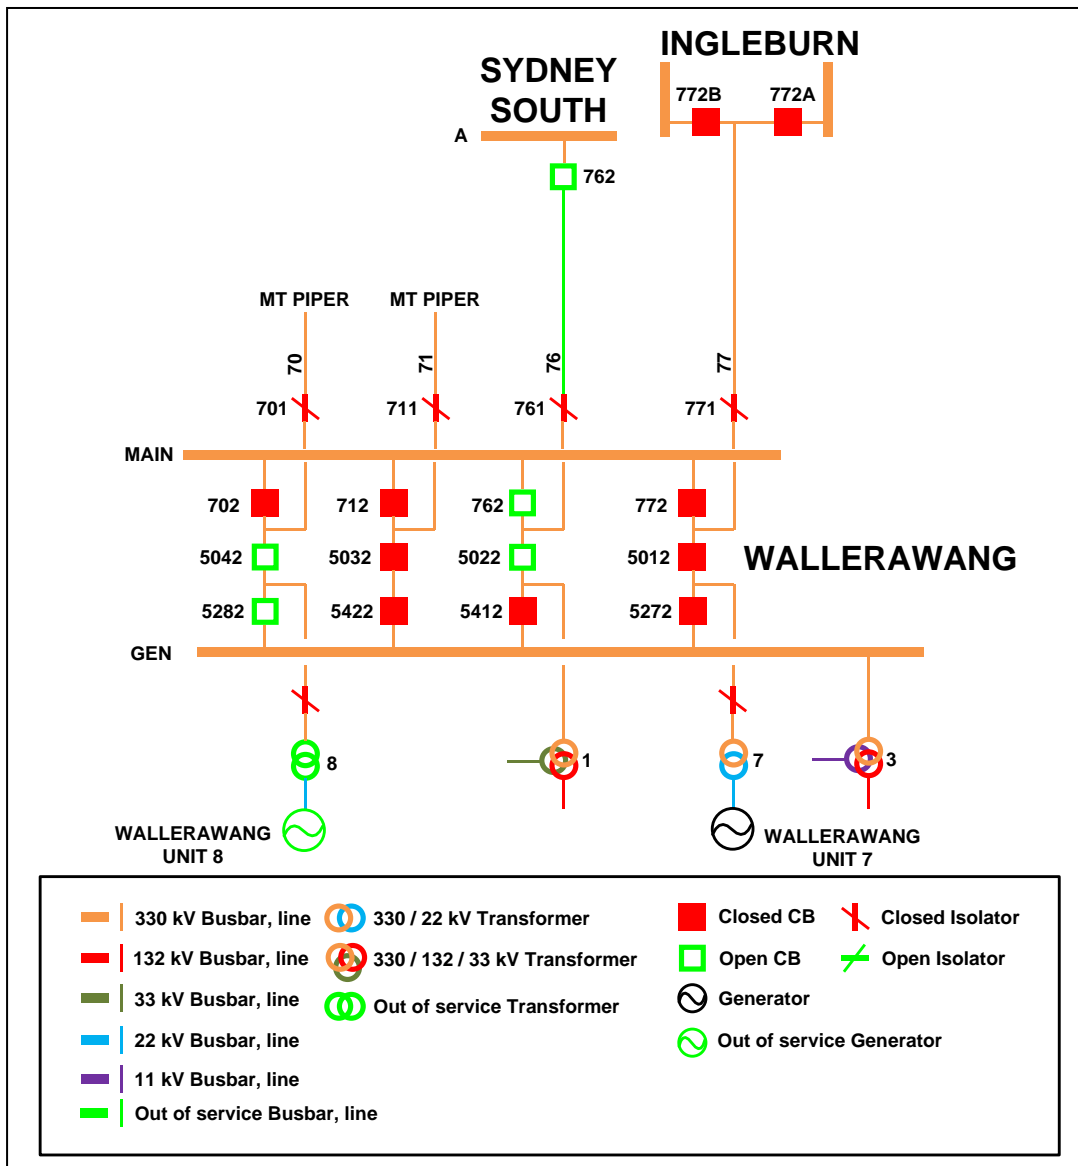
Figure 2 - Status of the power system immediately after initial event

At 1328, the 76 Transmission Line tripped on a single (red) phase to earth fault.

Immediately following the trip of the 76 Transmission Line, the Wallerawang Unit 8 Generator tripped due to the operation of a restricted earth fault protection system. The operation of this protection system was not an expected result of the transmission event.

The status of the power system immediately after this event is shown in Figure 2.

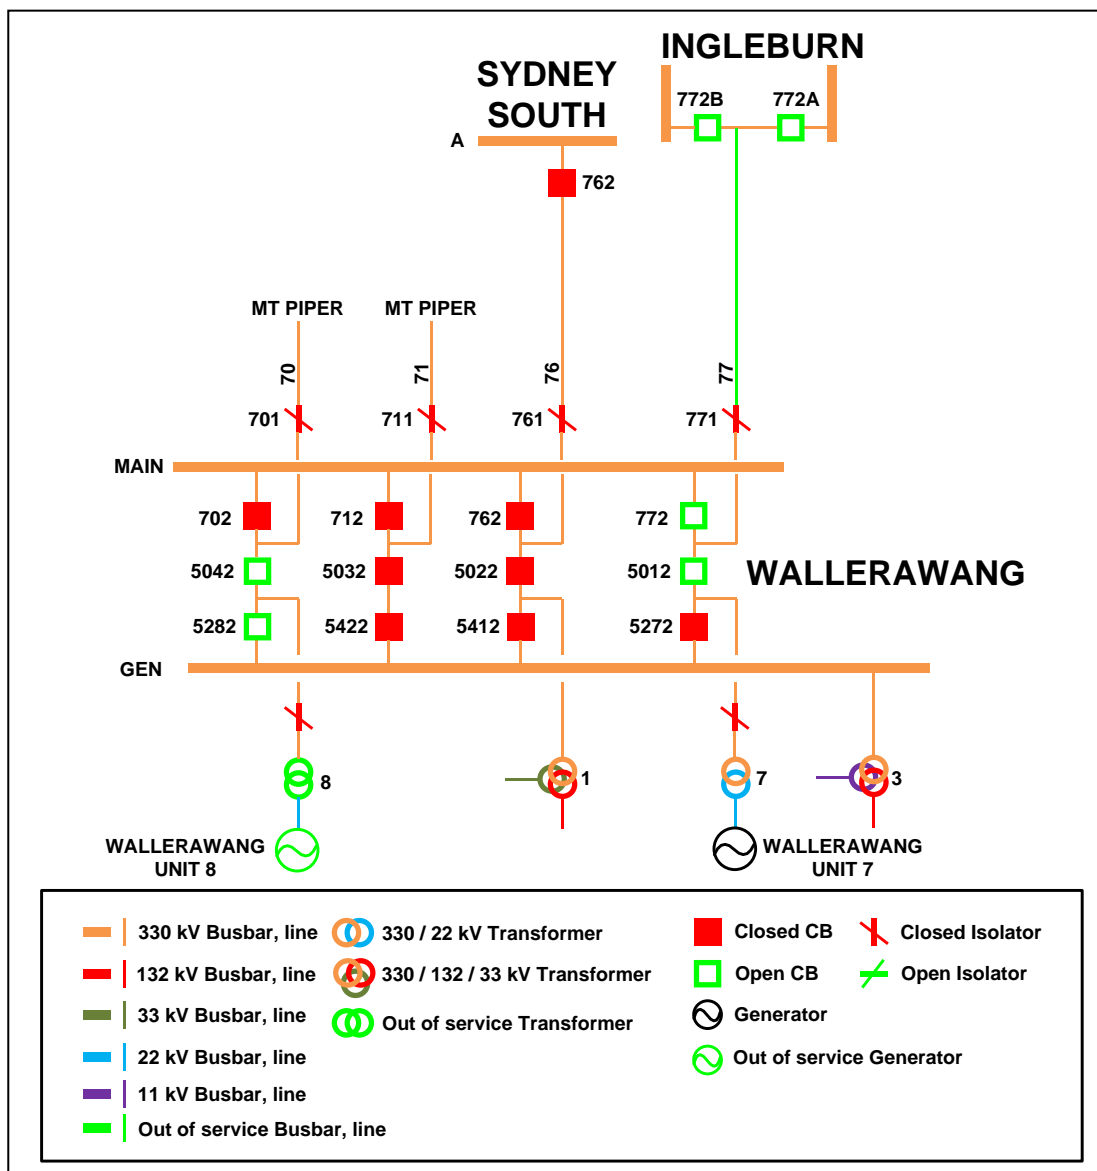
Figure 3 - Status of the power system immediately after secondary event

At 1328, the 77 Transmission Line tripped on a single (blue) phase to earth fault, approximately 15 seconds after the reclosure of 76 Transmission Line.

The status of the power system immediately after this event is shown in Figure 3.
