# POWER SYSTEM OPERATING INCIDENT REPORT - TRIP OF TARONG NO.2 275 KV BUS ON 29 APRIL 2013

PREPARED BY:        Systems Capability

DATE:                17 June 2013

At 2125 hrs on 29 April 2013, the No.2 275 kV busbar at H18 Tarong Substation in Queensland tripped due to operation of the busbar protection system. This occurred during restoration of the planned outage of the No.1 275/132 kV transformer at H18 Tarong Substation. There was no loss of generation or load as a result of this incident.

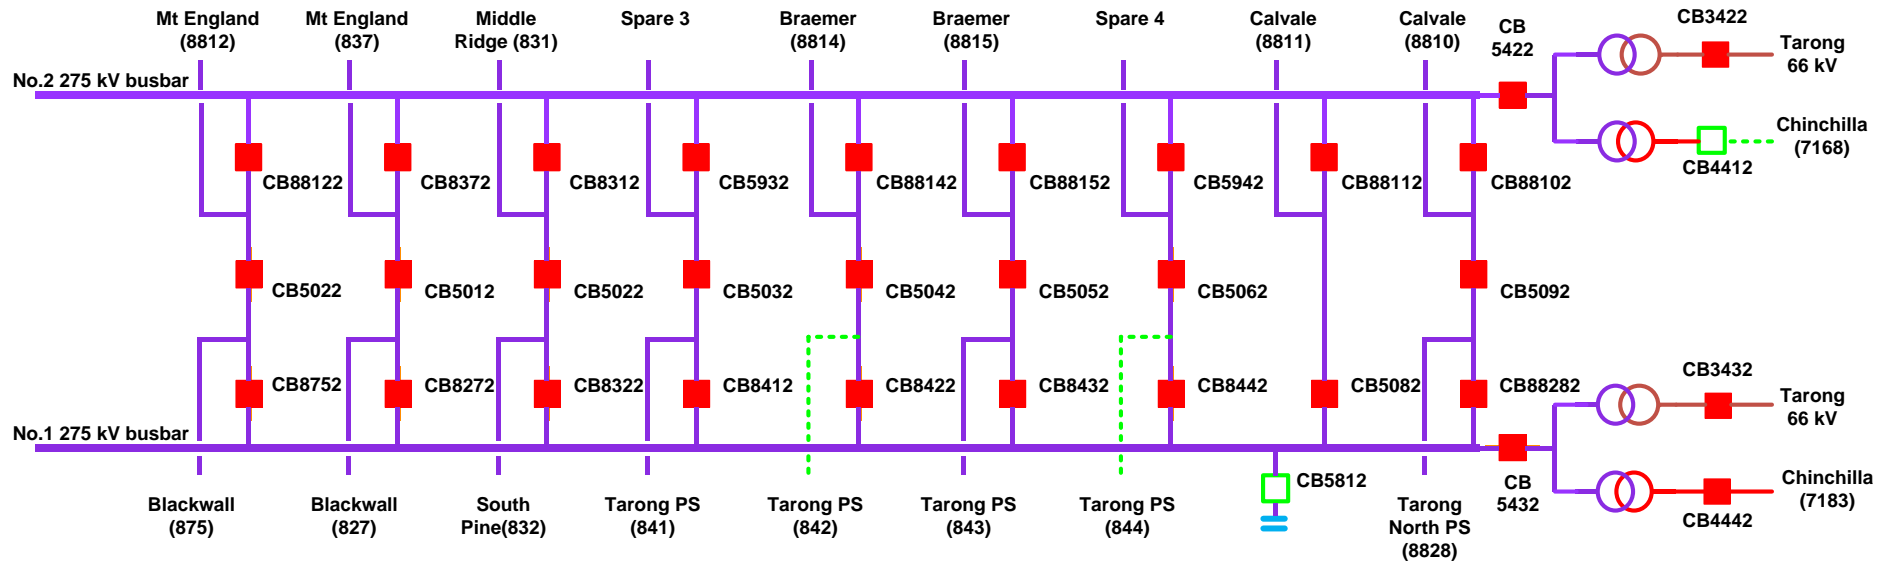
Figure 1 - Status of the power system prior to the incident

At the time of the incident, planned switching was underway to return to service the No.1 275/132 kV transformer at H18 Tarong Substation.

The status of the power system just prior to the incident is shown in Figure 1. For clarity only equipment relevant to this incident has been included in the diagram.

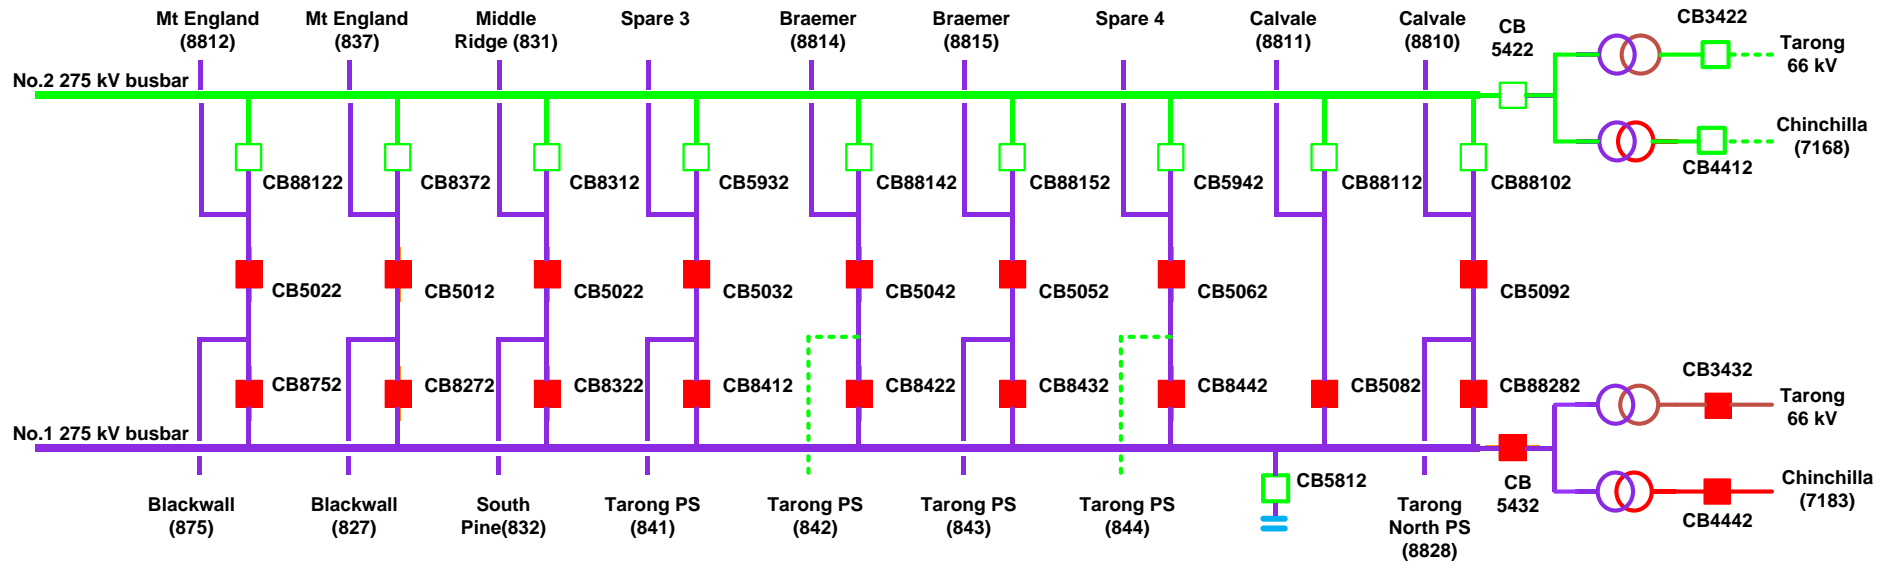
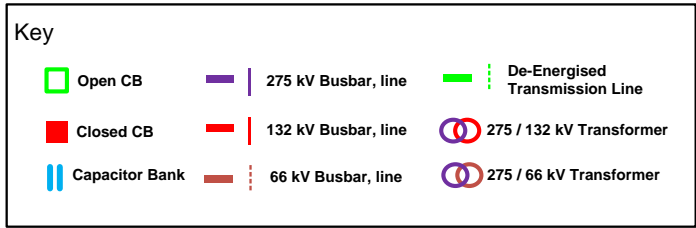
Figure 2 - Status of the power system immediately after the incident

The Powerlink investigation found that the secondary circuits of the current transformers associated with the 275 kV circuit breaker 5422 at H18 Tarong Substation were not returned to service prior to restoring the No.1 275/132 kV transformer to service. This triggered the operation of the busbar protection system and tripped the No.2 275 kV busbar. The secondary circuits of the current transformers associated with the 275 kV circuit breaker 5422 were isolated as part of the planned work.

The status of the power system immediately after the incident is shown in Figure 2.

Following the incident Powerlink staff carried out an investigation. The investigation found that the secondary circuits of the current transformers associated with the 275 kV circuit breaker 5422 at H18 Tarong Substation had not been returned to service prior to restoring the No.1 275/132 kV transformer to service. The secondary circuits were then returned to service.

Powerlink reviewed and changed the process in managing the isolation of current transformer secondaries for similar type of work, to ensure that the secondaries are returned to service as part of the planned work.
