POWER SYSTEM OPERATING INCIDENT REPORT – MULTIPLE GENERATING UNITS TRIP AT GLADSTONE POWER STATION ON 27 JANUARY 2013

PREPARED BY: Systems Performance and Commercial

DATE: 25 March 2013

FINAL

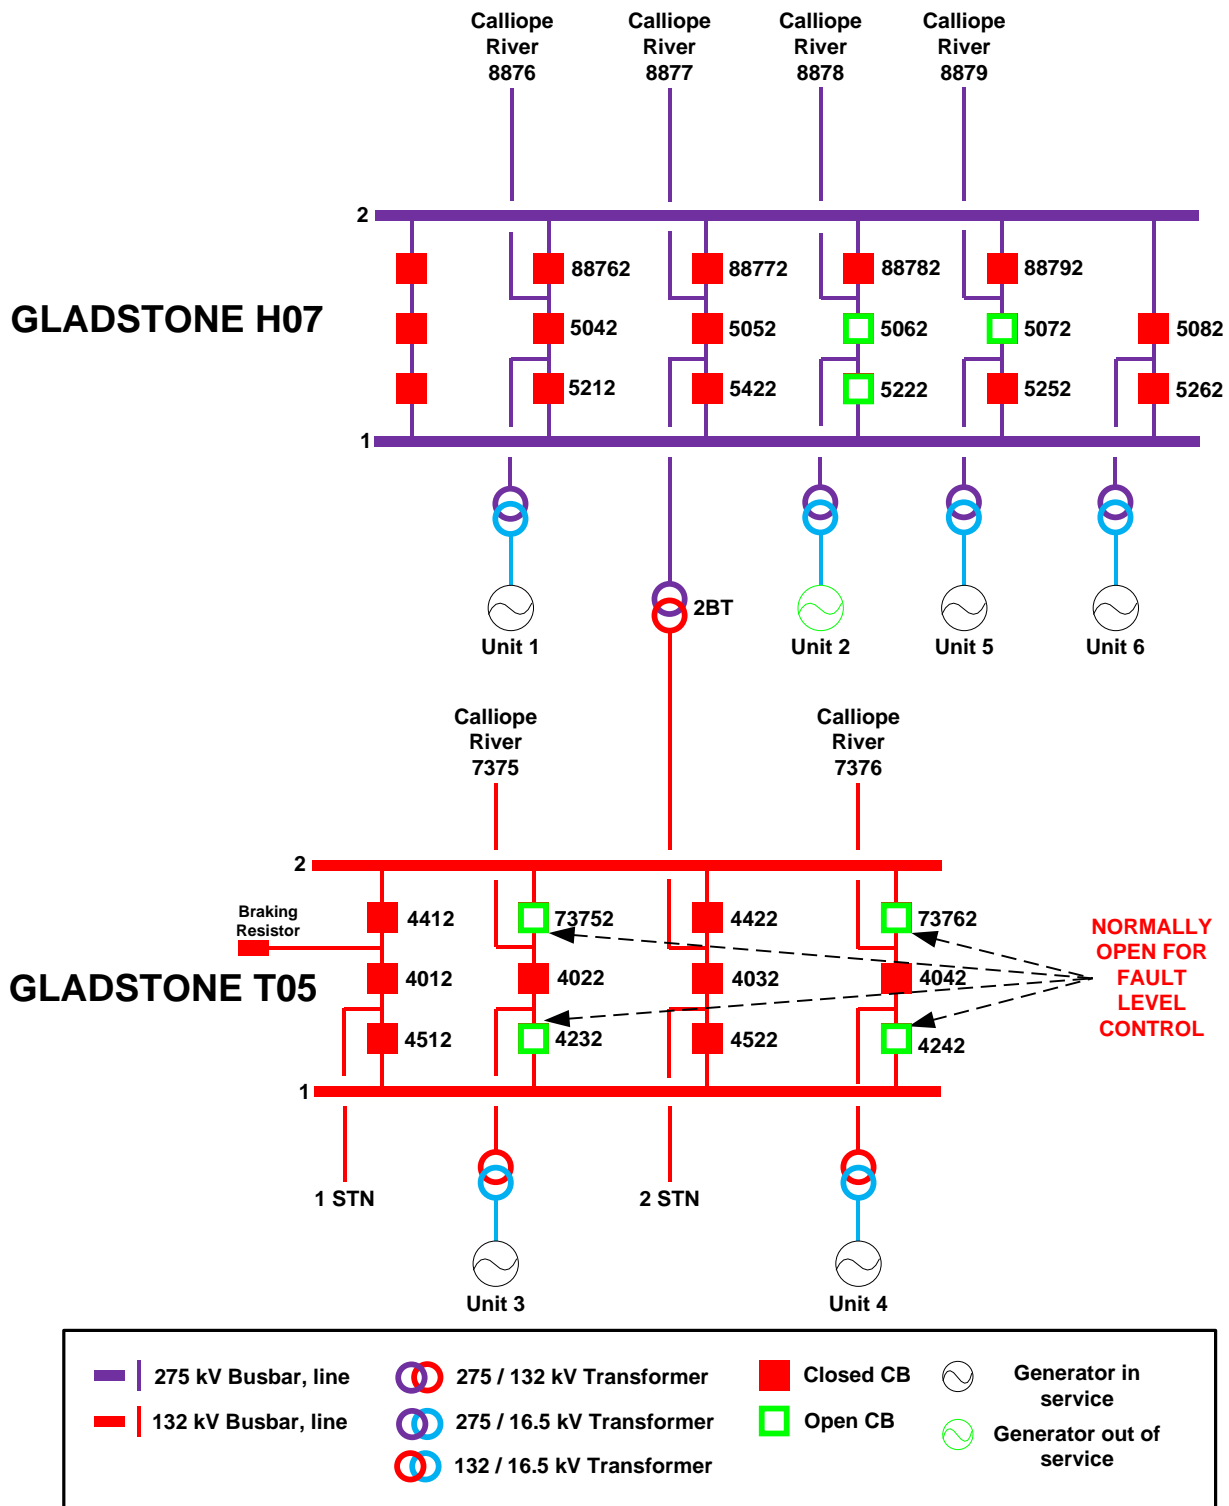
Figure 1 - Status of the power system prior to the incident

The status of the power system prior to the incident is shown in Figure 1.

Gladstone Power Station Unit 2 had tripped at 1057 hrs on 27 January 2013 and was in the process of returning to service. Accordingly the 275 kV circuit breakers 5062 and 5222 were open prior to the event.

Gladstone Power Station Unit 5 was synchronised at 1606 hrs on 27 January 2013 and was in the process of stabilisation when the event occurred. Powerlink has informed AEMO that it is a normal practice at Gladstone Power Station to synchronise the units using only one CB initially and wait until the unit is stable to close the remaining CB. Accordingly the 275 kV CB 5072 was open prior to the event.

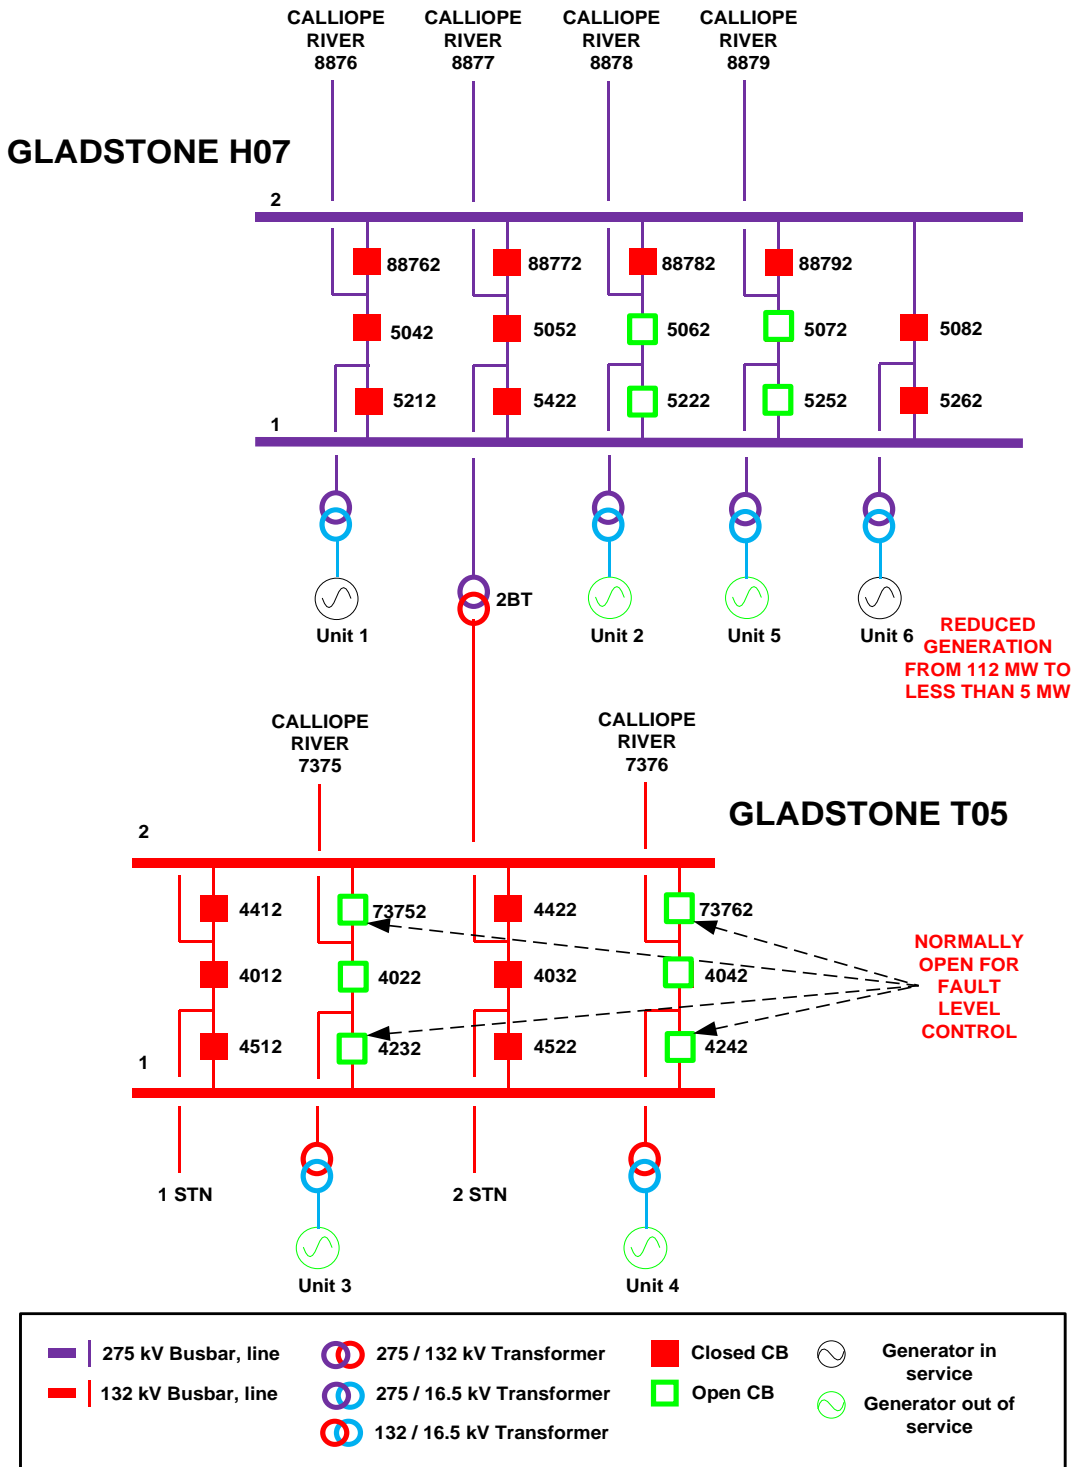
Figure 2 - Status of the power system immediately after the incident

NRG Gladstone Operating Services has indicated that due to the wet conditions and saturation of the coal supplies to the power station, all in-service units at Gladstone Power Station were experiencing difficulties milling the coal, requiring auxiliary firing to maintain flame stability.

A reduced level of auxiliary fuel affected boiler firing stability on units 3, 4 and 5 causing them to trip and causing unit 6 to reduce output. Unit 1 was not affected by this event.

The status of the power system immediately after the incident is shown in Figure 2.
