Power System Operating Incident Report – Trip of B1 330 kV Busbar at Newcastle on 1 May 2014

PREPARED BY: AEMO System Capability

DATE: 23 June 2014

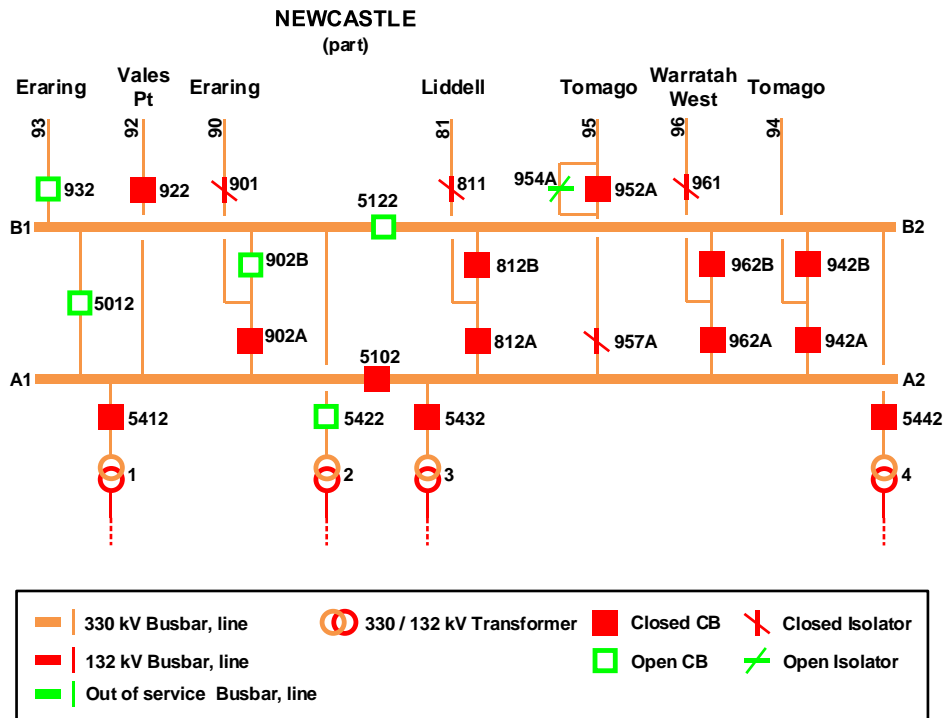
On Thursday 1 May 2014 at 1529 hrs the B1 330 kV Busbar at Newcastle (Busbar B1) tripped when a circuit breaker (CB) 5422 was closed to energise a new 330 / 132 kV No. 2 transformer (No. 2 Transformer). As a result of the busbar trip the Newcastle – Eraring 93 330 kV Transmission Line (Line 93) was offloaded. There was no loss of load or generation and the power system remained secure. See Appendix A for chronological log of the incident.

The status of the power system after the incident is shown below. The diagram shows Busbar B1 de-energised and Line 93 off-loaded. Circuit Breaker 5422 was open prior to the incident as part of the planned outage to replace No. 2 Transformer.

TransGrid investigated this incident and determined that the trip was caused by design error that resulted in an incorrect wiring configuration.

When TransGrid closed CB5422, to energise No. 2 Transformer, the No.2 330/132 kV transformer No.1 protection relay (Protection Relay) incorrectly operated and tripped Busbar B1. The busbar tripped as a result of the incorrect wiring and was not expected on energisation of No. 2 Transformer.

TransGrid identified the cause of the trip, corrected the wiring and returned Busbar B1 to service on the same day.
