# Power System Operating Incident Report – Trip of Calvale No.2 275kV busbar and Calvale-Halys 8810 and 8811 transmission lines on 30 March 2014

PREPARED BY: Systems Capability

DATE: 6 June 2014

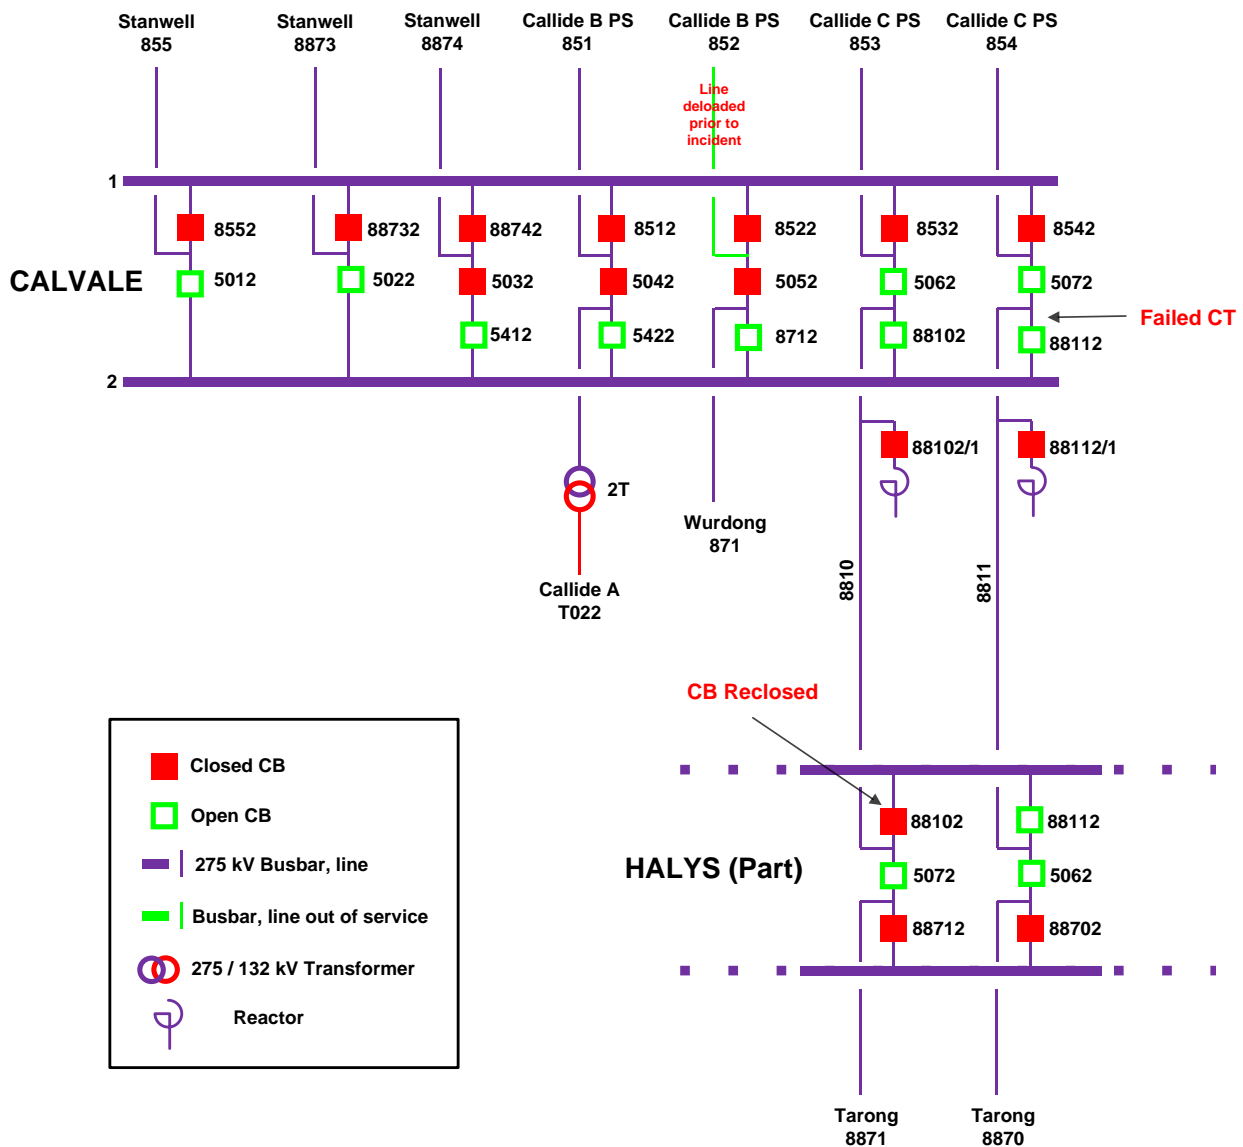
**Figure 1 - Status of the power system immediately after the incident**

Figure 1 shows the status of the power system at Calvale substation after the incident. The diagram shows the circuit breakers (CBs) that opened as a result of the incident.
