Power System Operating Incident Report – Trip of Rowville-Yallourn No.8 220 kV Transmission Line and Multiple Wind Farms on 5 January 2014

PREPARED BY: AEMO Systems Capability

DATE: 4 April 2014

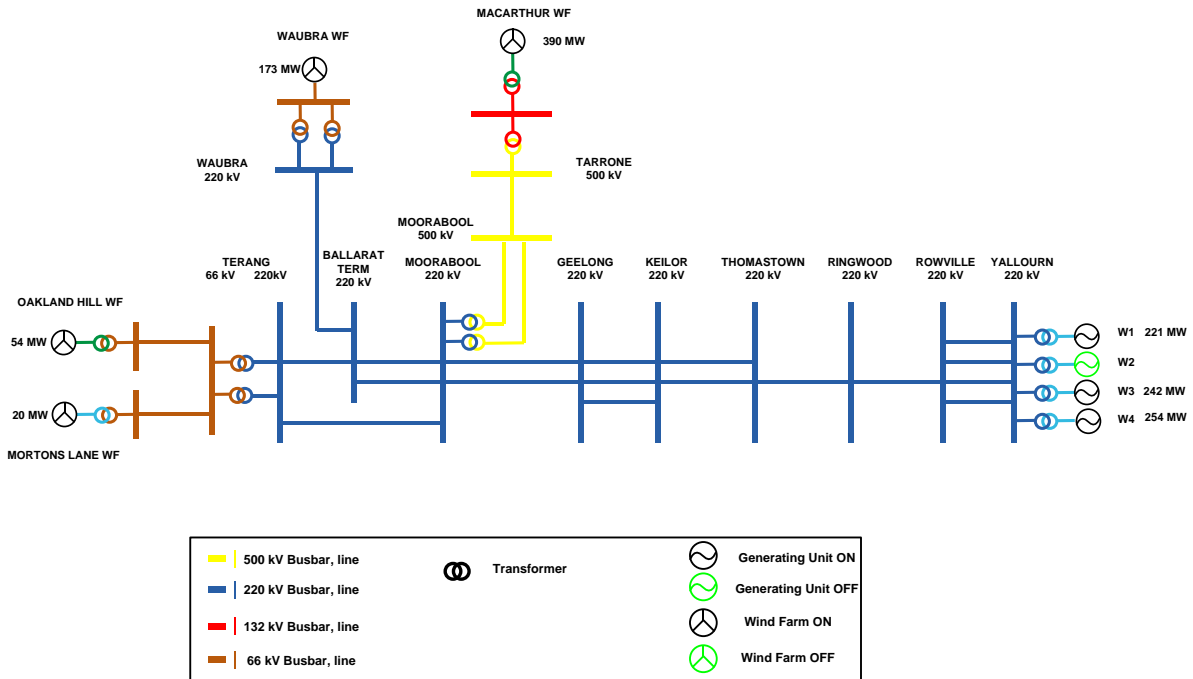
Figure 1 - Before the incident

The status of the power system before and after the incident is shown in Figures 1 and 2. For clarity only equipment relevant to this incident has been included in the diagrams. The diagrams show the network and the generating units affected by the events.

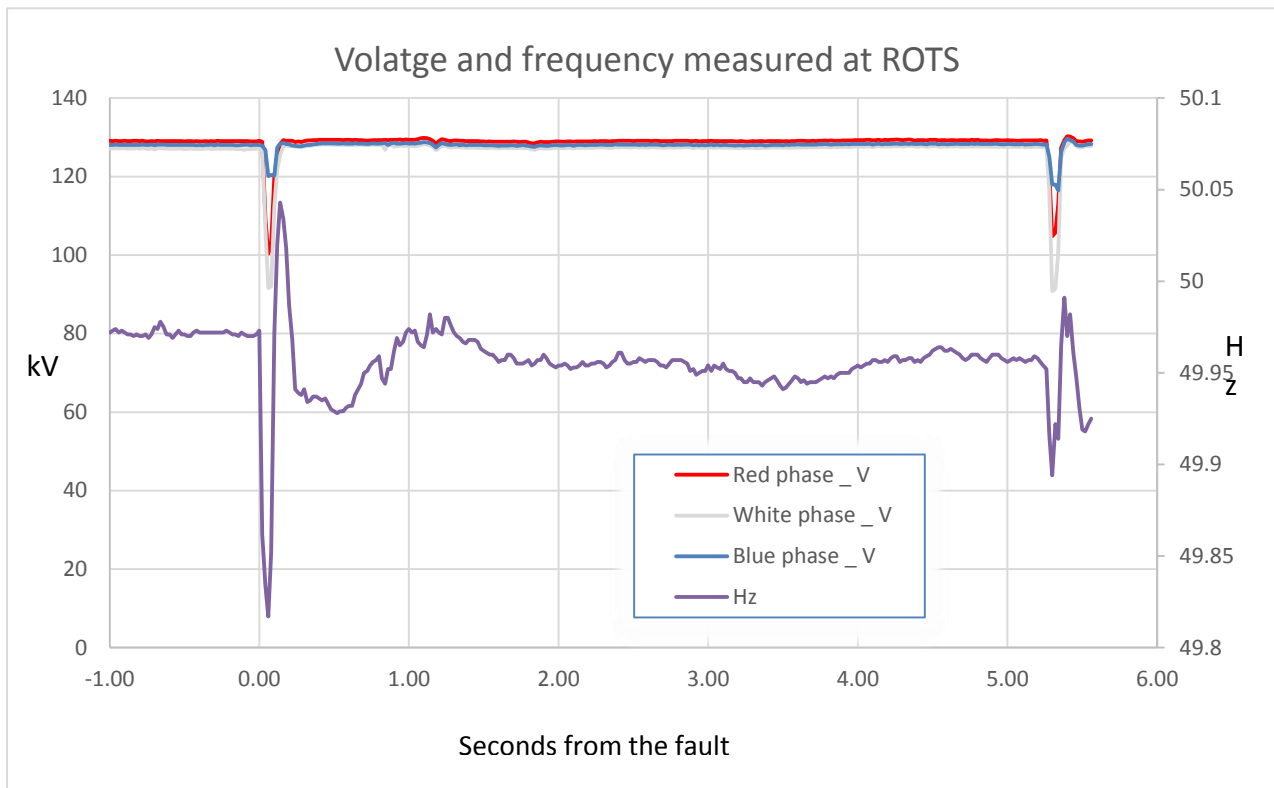
Figure A1 – Frequency and Voltage at Rowville Terminal Station (initial trip/reclose/trip)

SP AusNet identified that the initial fault was a White phase to earth fault⁸ on the Rowville – Yallourn No.8 220 kV line. This was detected by X and Y protection at both line ends. The trip was followed by a single ended auto reclose operation at Rowville Terminal Station, which reclosed onto the same white phase to earth fault and tripped.

¹⁸ Figure A1 (in Appendix 1) shows the phase voltages at Rowville Terminal Station (ROTS) on exit to Hazelwood Power Station (HWPS) during the initial event.
