Power System Operating Incident Report – Trip of Upper Tumut 5A1 and 5B 330 kV Busbars on 11 December 2013

PREPARED BY: Systems Capability

DATE: 6 March 2014

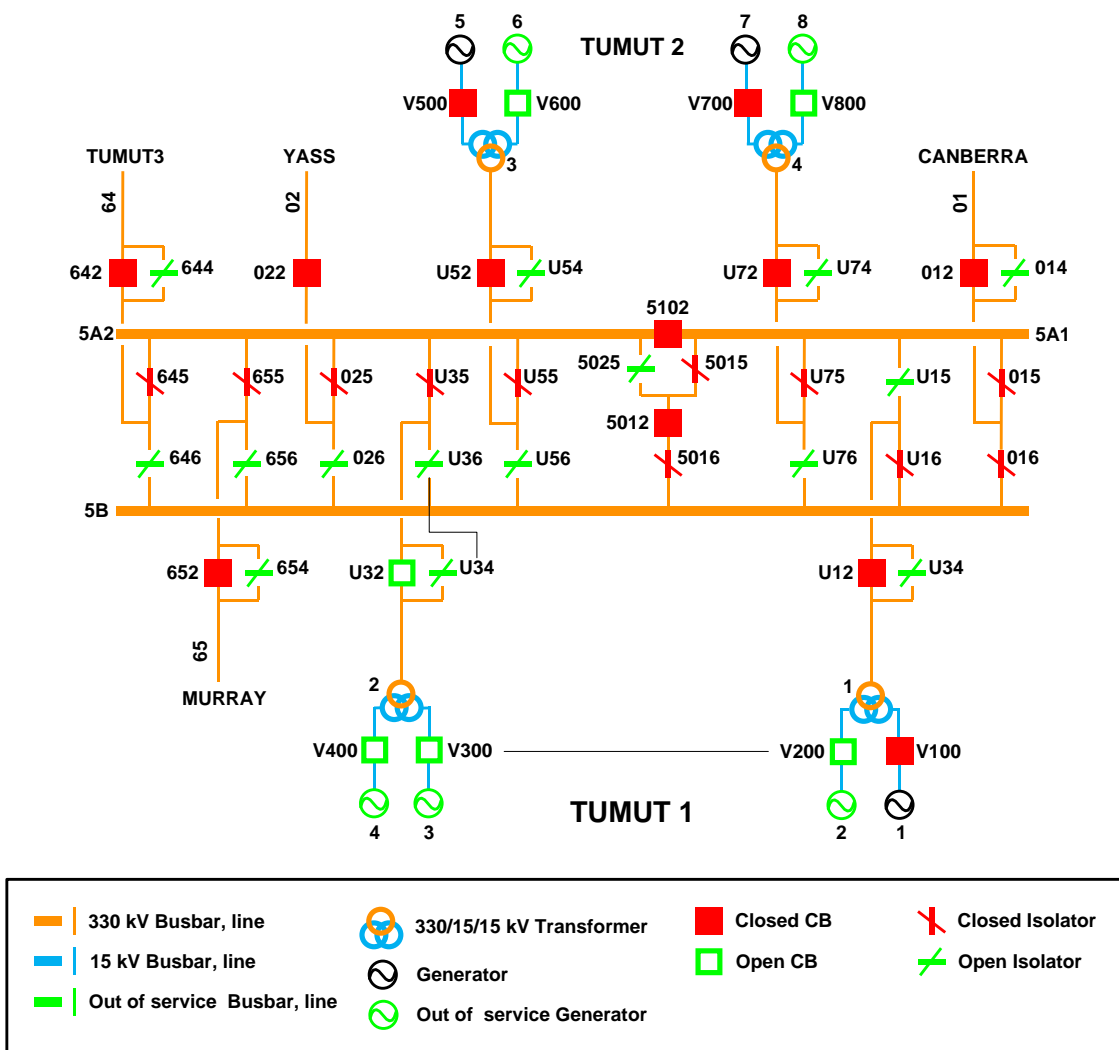
Figure 1 - Status of the power system prior to the incident

At the time of the incident, the Canberra line was paralleled between busbars 5A1 and 5B. The busbars tripped as 330 kV Isolator 015 was opened to transfer the Canberra line to the 5B busbar.

The busbars tripped because the busbar protection secondary circuits (CTs) were incorrectly configured. When 5A1 busbar is connected to busbar 5B, the bus coupler CT (5012) needs to be connected to the CT summation for busbars 5A1 and 5B. A manual selector switch connects the bus-coupler CT to either 5A1 busbar or to 5A2 busbar. For this incident the selector switch had been incorrectly set to the 5A2 busbar.

The status of the power system at Upper Tumut switching station before and after the incident is shown in Figures 1 and 2 respectively. Figure 1 shows the Canberra line was paralleled between 5A1 and 5B busbars. Figure 2 shows 5A1 and 5B busbars de-energised via open circuit breakers and generating unit circuit breakers V100 and V700 open.

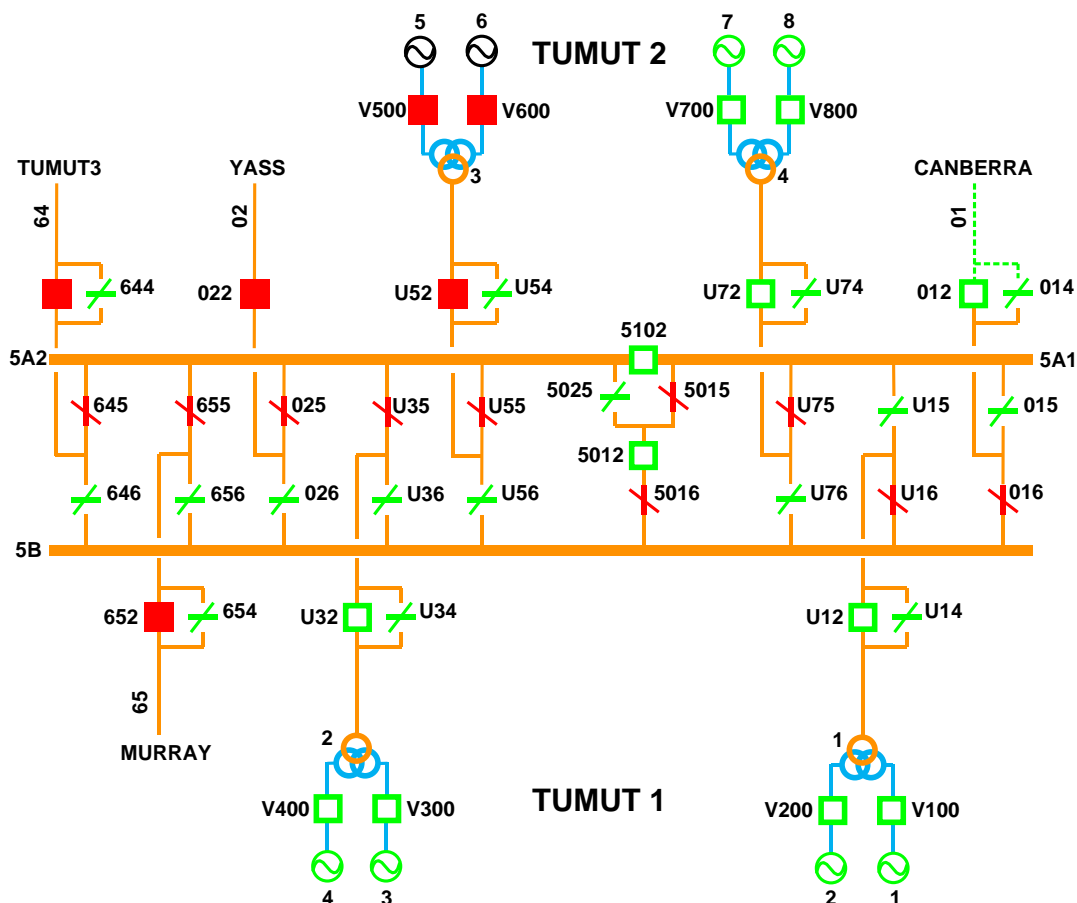
Figure 2 - Status of the power system immediately after the incident

The secondary current for both the 5A2 busbar and the combined 5A1 and 5B busbar protection circuits was thereby not balanced. The 5A1 and 5B busbar protection was more sensitive to the unbalance so the 5A1 and 5B protection operated first⁴. Following the trip of 5A1 and 5B busbars, the current flow through the bus coupler ceased so 5A2 busbar protection did not subsequently operate.

The operation of 5A1 and 5B busbar protection, in turn, opened 330 kV circuit breakers 5012, 5102, U72, O12 and U12 at Upper Tumut switching station. As a consequence Upper Tumut generating units 1 and 7 were disconnected, and the Canberra line was off-loaded.
