TRIP OF SOUTH EAST SUBSTATION No 1 AND No 2 275 KV SVCs ON 23 APRIL 2016

AN AEMO POWER SYSTEM OPERATING INCIDENT REPORT
FOR THE NATIONAL ELECTRICITY MARKET

Published: July 2016

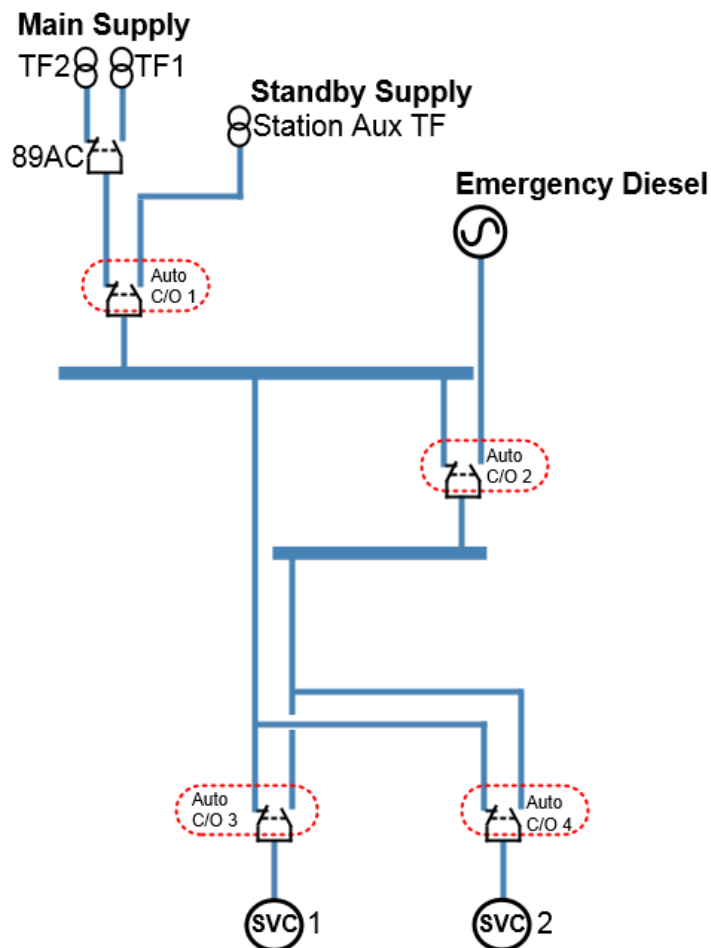
Figure 1 South East Substation 415V Supply

The 415V supply to each SVC is provided via a number of changeover switches as shown in Figure 1. A main supply is derived from either TF1 or TF2 auxiliary transformers, via switch 89AC. If this main supply fails an auto changeover, C/O 1, operates to switch the 415V source to the site Station Transformer supply. If normal and standby supplies fail a standby generator is started automatically and this will maintain essential 415V supplies to site, via changeover C/O 2.

Each SVC has a main and standby 415V supply and an automatic changeover switch. If the main 415V supply fails the SVCs should automatically switch to their standby supply via C/O 3 and C/O 4.

During operation of 89AC switch through the OFF position, the site 415V supply did not transfer to the standby supply or to the diesel supply and 415V supplies to SVC 1 were momentarily interrupted for greater than seven seconds. This led to a Cooling System Failure and tripping of SVC 1. SVC 2 did not trip due to slight discrepancies in the supply fail timers.

After the 132kV west bus and TF2 were restored to service, the switching operator attempted to restore switch 89AC to the TF2 position. However switch 89AC failed and remained stuck in the OFF position. Again the 415V supply did not transfer to the standby supply or the diesel supply, resulting in a loss of 415V supply and the trip of both SVCs.

Further testing on the 415V supply was undertaken. SVC 2 was taken out of service to prevent both SVCs unexpectedly tripping during testing. During testing on SVC 1, changeover switch C/O 3 failed to operate resulting in a loss of 415V supply to SVC 1. The faulty changeover switch (C/O3) was repaired/replaced. Changeover switch C/O4 was proved to be working correctly. Both SVCs were returned to service on completion of testing.

A final test was required to test the changeover to the diesel supply. SVC1 was taken out of service prior to this test. Both main and standby supplies were isolated but while the diesel successfully started the diesel supply changeover switch (C/O2) failed to operate resulting in the loss of 415V supplies to both SVCs.

A faulty changeover switch (C/O1) was replaced on 26 April.
