TRIP OF MULTIPLE TRANSMISSION ELEMENTS IN THE SOUTHERN NSW AREA, 11 FEBRUARY 2017

REVIEWABLE OPERATING INCIDENT REPORT UNDER THE
NATIONAL ELECTRICITY RULES

Published: **15 September
2017**

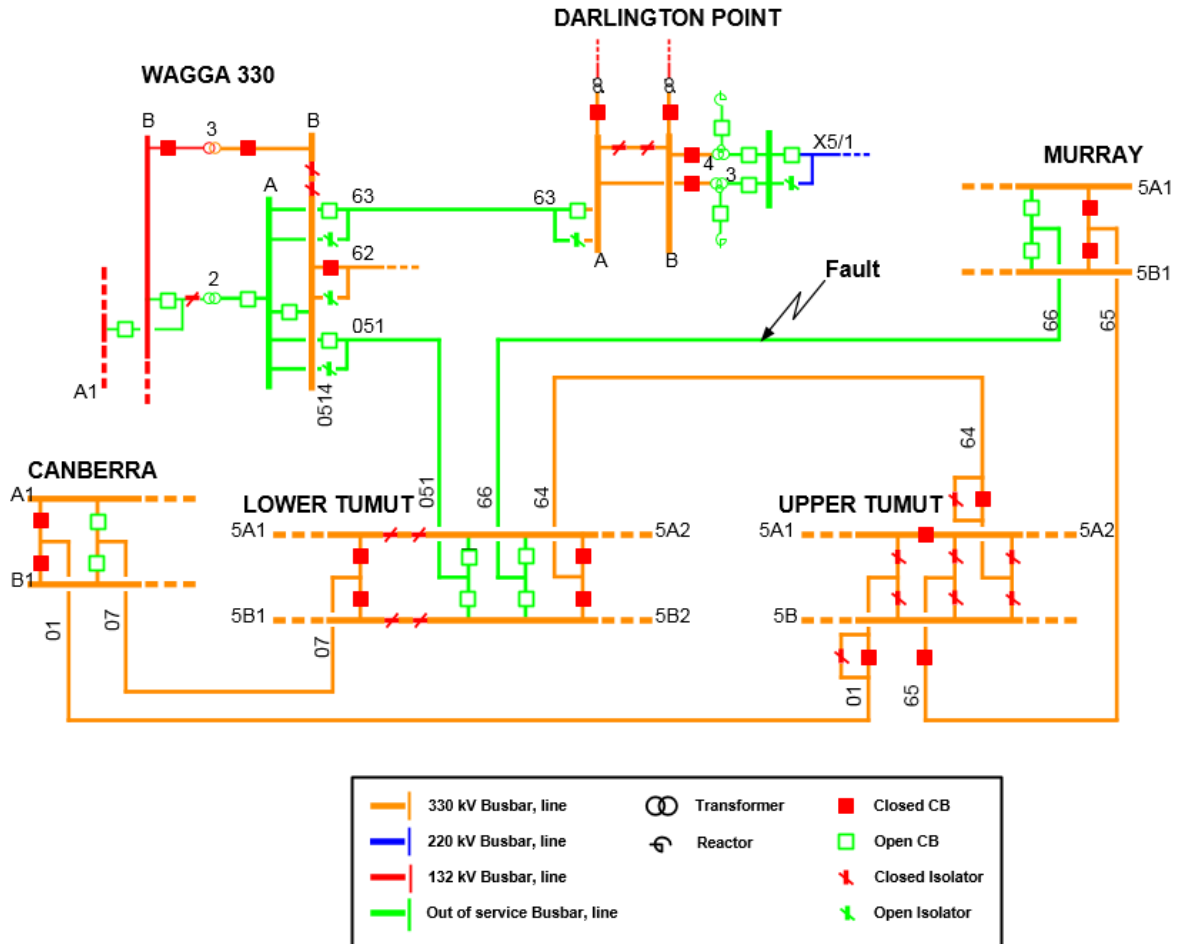
APPENDIX A. – POWER SYSTEM DIAGRAM

The power system immediately after the incident (prior to the trip of 64 line)
