# Trip of Tamworth No. 3 330 kV Busbar on 20 February 2018

**November 2018**

Reviewable operating incident report under the  
National Electricity Rules

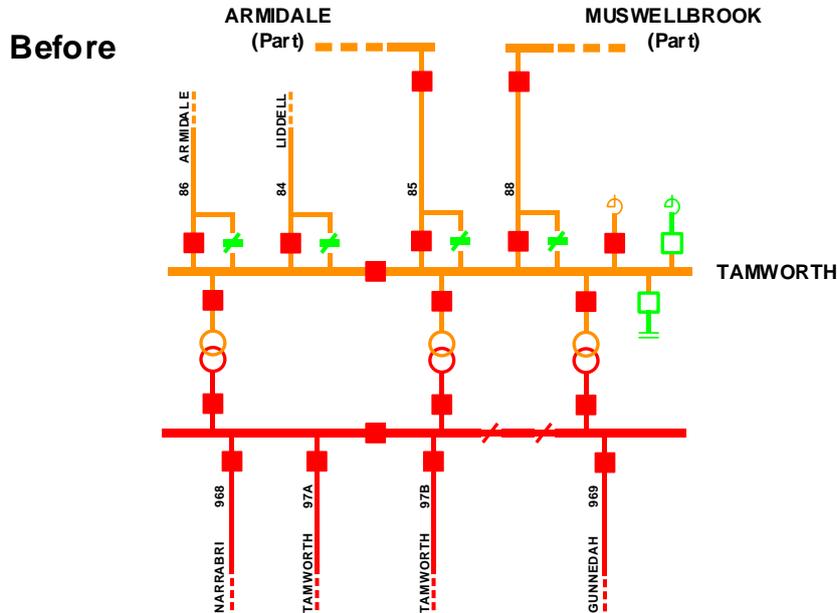
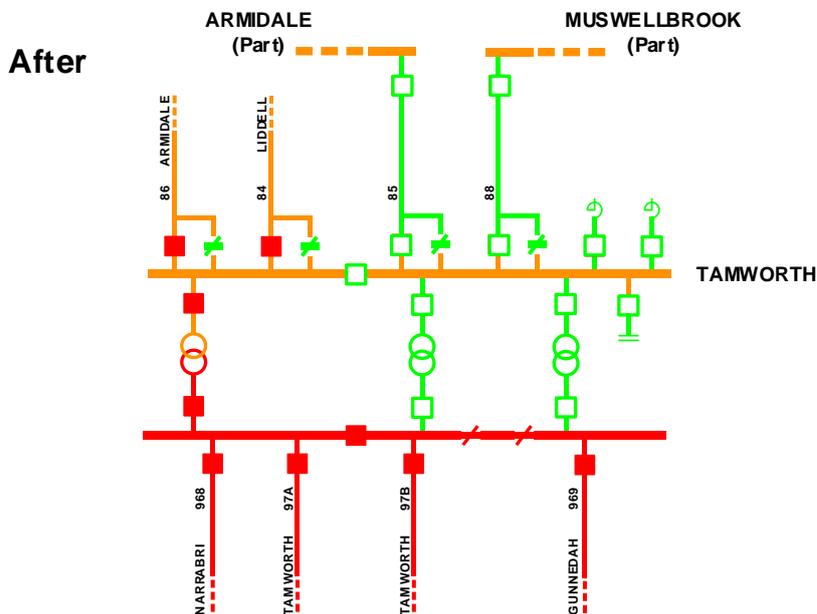
# A1. Power system diagram

Refer to Appendix A1 for a diagram of Tamworth both before and immediately after this incident.

The following diagrams show the power system at Tamworth before and immediately after the incident.
