Trip of South Pine 275 kV No. 1 Busbar and 275/110 kV No. 5 Transformer on 26 November 2019

July 2020

Reviewable Operating Incident Report under the
National Electricity Rules

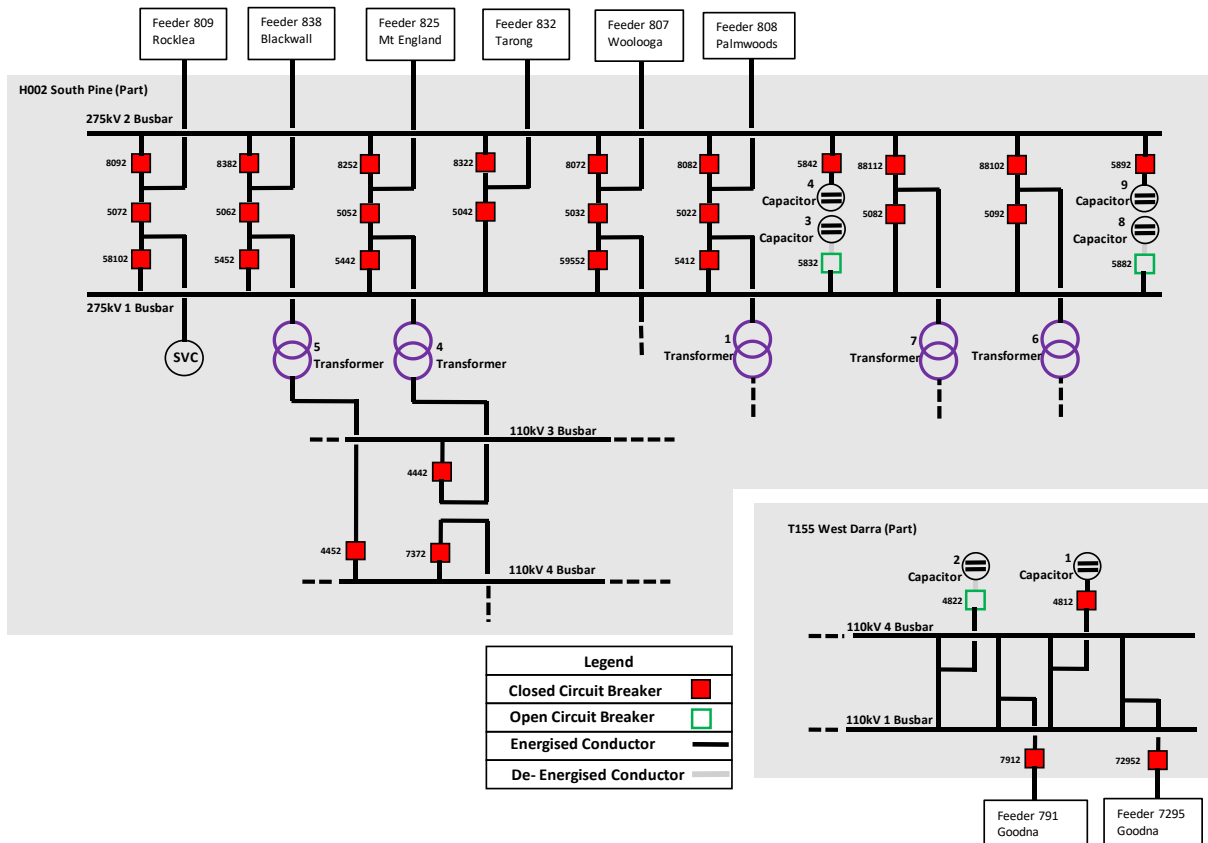
Figure 1 Single line diagram of the relevant power system plant showing plant status prior to incident

Figure 1 shows the switching configurations and statuses of the relevant power system plant at H002 South Pine Substation (Part) and T155 West Darra Substation (Part). For clarity, only plant and equipment that operated or provides connectivity between the affected items are shown.

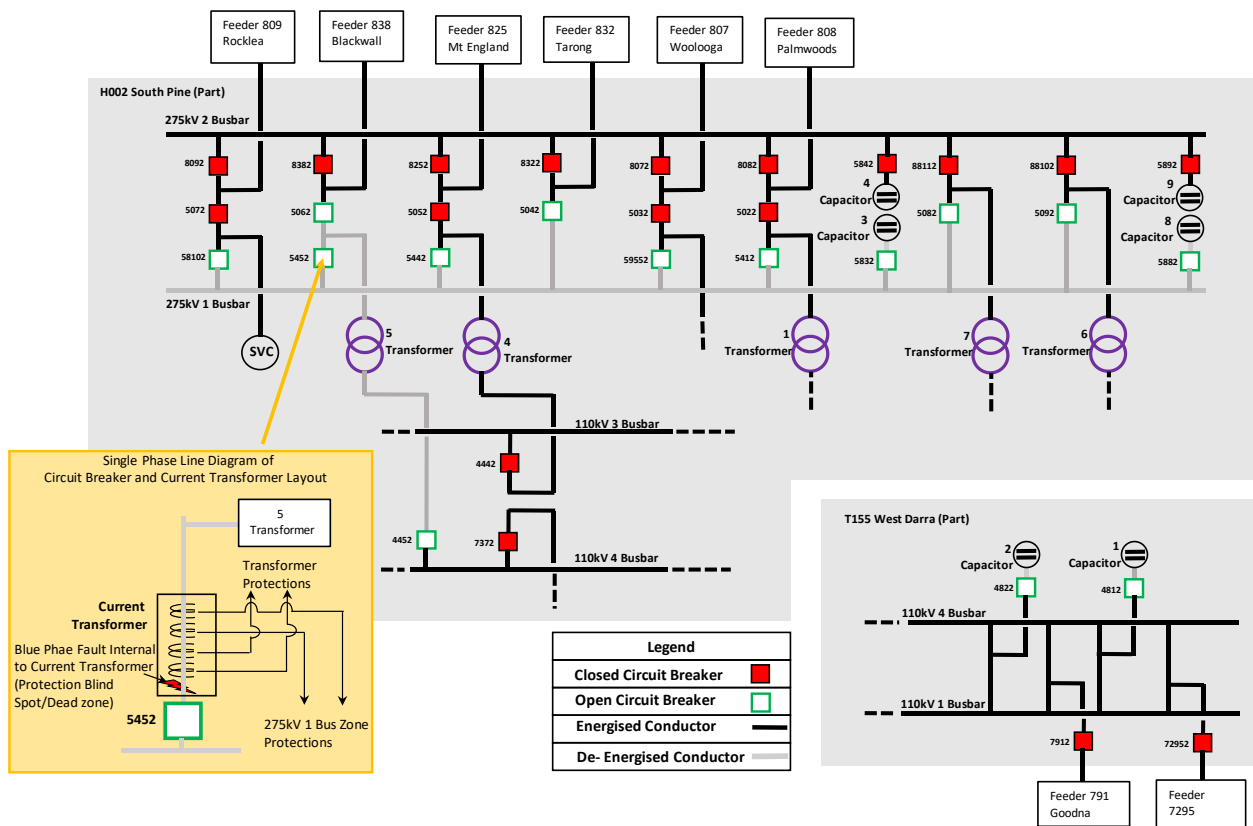
Figure 2 Single line diagram of relevant power system plant including status after event

At 12:14 hours on 26 November 2019, a high voltage fault occurred internal to a 275 kV current transformer associated with CB 5452 at South Pine Substation, as shown in Figure 2.

As a result of the incident, the following primary elements, as shown in Figure 2, were tripped following protection operations:

- H002 South Pine 275 kV No. 1 Busbar (No. 1 Busbar).
- H002 South Pine 275/110 kV No. 5 Transformer (No. 5 Transformer).
- T155 West Darra 110 kV No. 1 Capacitor Bank (No. 1 Capacitor).

The incident involved a high voltage fault internal to a 275 kV current transformer associated with CB 5452 at South Pine Substation. The location of the fault was in the “blind spot/dead-zone” of the overlapping No. 5 transformer and No. 1 Busbar protection zones of CB 5452, as shown in Figure 2.

The term “blind spot/dead-zone” is a fault location where the primary protection, in this case the 275 kV No. 1 Busbar protection, detects the fault, but does not isolate the fault, instead relying on the backup CBF protection to isolate the fault.

b) At 12:14:25.717 hrs – as fault current was still flowing through the faulted CT to the “blind-spot/dead-zone” location, the CB 5452 CBF backup protection operated correctly 142 ms following the operation of the 275 kV No. 1 Busbar protection and initiated the trip of 275 kV CB 5062 and No. 5 Transformer 110 kV CB 4452 to isolate the fault.

The No. 1 Busbar was returned to service at 1701 hrs on 26 November 2019⁵ and the No. 1 Capacitor and No. 5 Transformer were returned to service at 1340 hrs and 1734 hrs respectively on 27 November 2019. Refer to Appendix 1 for a full sequence of events.

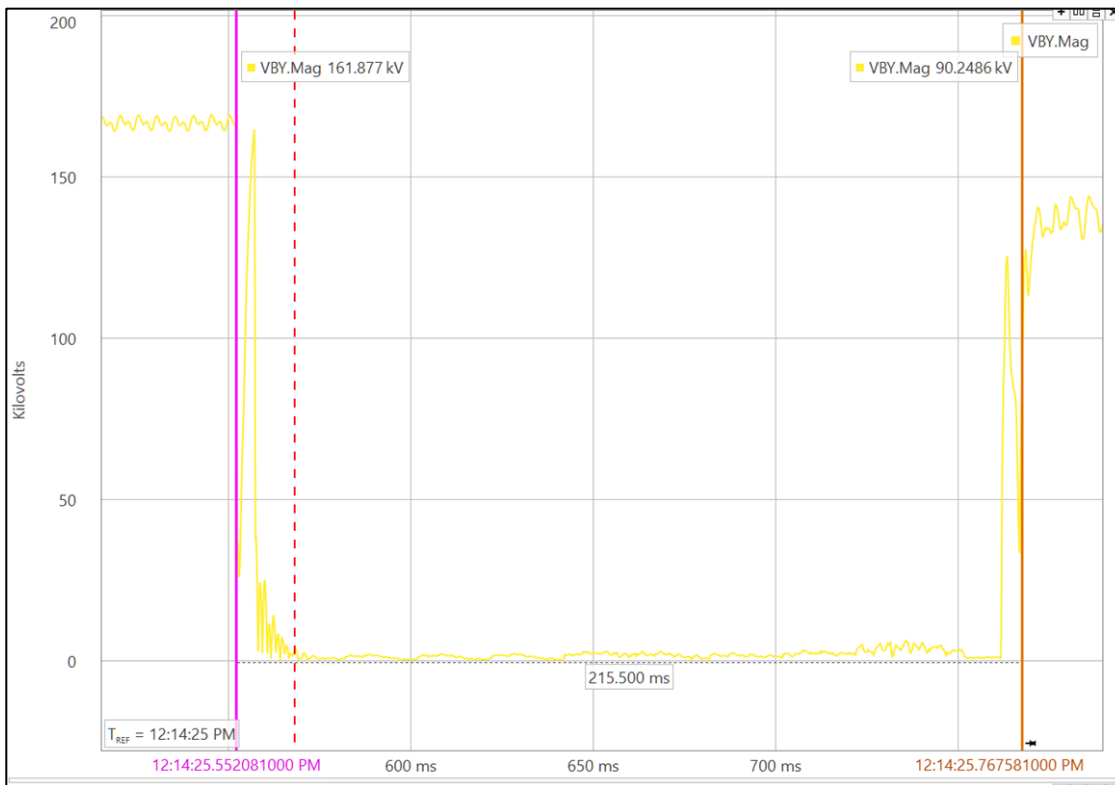
Figure 3 Disturbance recording of the South Pine 275 kV B phase voltage

Resulting from the fault, a disturbance recording (see Figure 3) was taken of the South Pine 275 kV B phase voltage magnitude, as measured from a voltage transformer on an unimpacted element at South Pine Substation. This recording clearly shows that the total fault clearance time was 215.5 ms.

All protection systems at South Pine Substation operated correctly as designed and the high voltage fault was isolated from the power system in 215.5 ms from fault inception, as shown in Figure 3. This time is compliant with the 250 ms CBF total fault clearance time specified in the NER⁶.

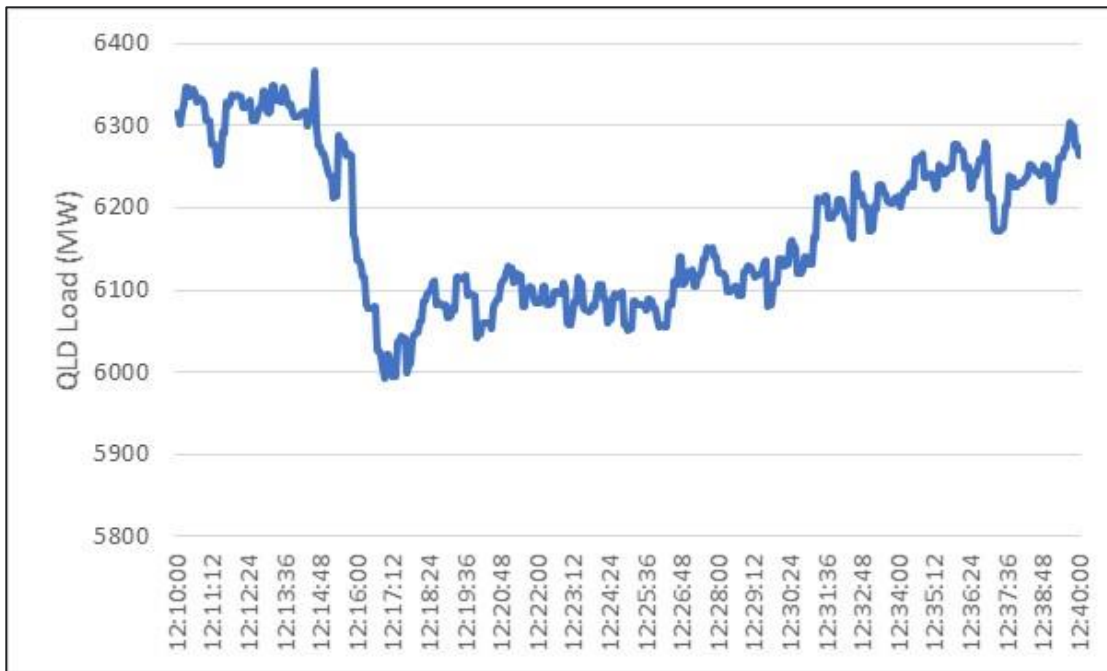
Figure 4 Queensland Load in response to fault

As a result of the voltage disturbance caused by this incident, there was an approximate 300 MW temporary reduction in customer load⁸ as shown in Figure 4. The load returned to pre-fault levels within approximately 20 minutes.

Further analysis of the Queensland load in response to the voltage disturbance shows the change comprises two major components:

- A reduction in load of approximately 490-620 MW, and
- A reduction in distributed PV generation in the South East Queensland area in the range of 180-310 MW, resulting in a net reduction in load of approximately 310 MW.

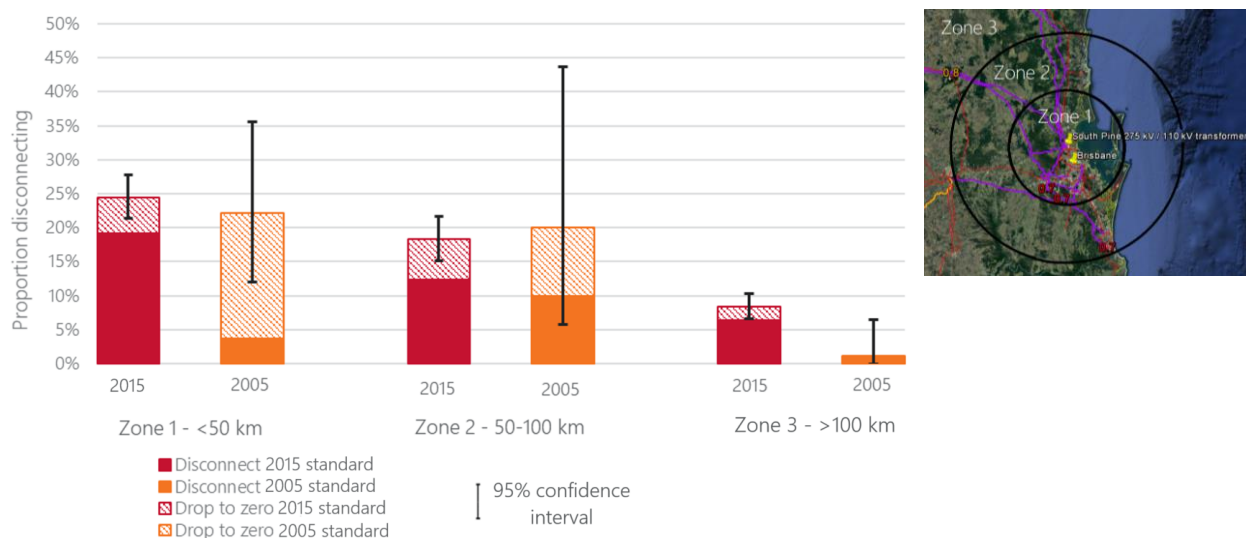
Figure 5 Distributed PV disconnections by distance from fault location in Queensland

Figure 5 shows that distributed PV disconnections were highest close to the fault location and reduced at more distant locations.

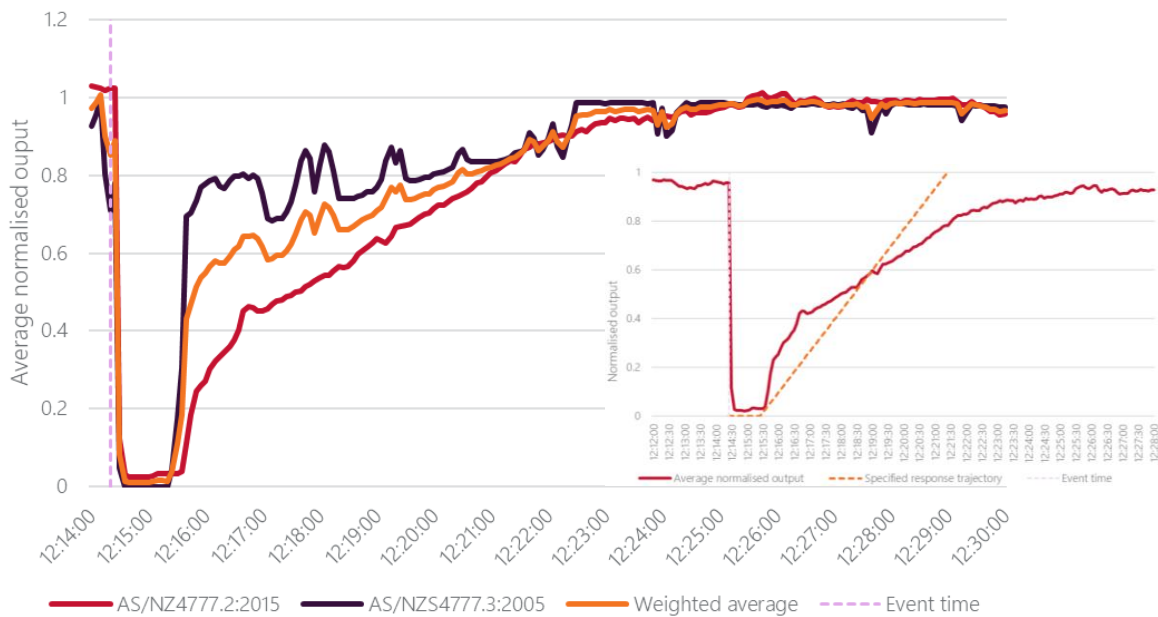
Figure 6 Average normalised reconnection profile for in Queensland (inset with 2015 inverter response)

For inverters on the 2015 standard, Solar Analytics provided anonymised data at a five second resolution for 135 distributed PV systems that were observed to disconnect. The average normalised¹⁹ generation from each of these systems is shown in Figure 6. The following observations can be made:

- The aggregate profile remains close to zero for one full minute. This is consistent with the 2015 standard, which specifies that the inverter should not reconnect until voltage and frequency are within the required ranges for at least one minute. All but one inverter demonstrated this behaviour.
- Following the first minute, the aggregate generation profile increases gradually, reaching close to pre-event power over around 10 minutes.
- The aggregate rate of increase is faster in the first two minutes.

Analysis of the reconnection behaviour indicates that 30-40% of systems do not appear to be observing the six-minute ramp rate limitation specified in the 2015 standard, ramping up in two minutes or less²⁰. This provides evidence that up to 40% of distributed PV inverters are not behaving consistently with defined standards and is consistent with previous findings exploring compliance with over-frequency droop response²¹. AEMO is engaging with stakeholders across the industry to develop a program of work to improve monitoring and enforcement of standards compliance.

Figure 6 shows the average normalised output for systems under the 2005 and 2015 standards that disconnected after the event, with an average normalised output weighted by the proportion of systems in Queensland installed under each standard²².
