# Multiple contingency event at Broken Hill on 17 May 2019

**November 2019**

Reviewable Operating Incident Report under the  
National Electricity Rules

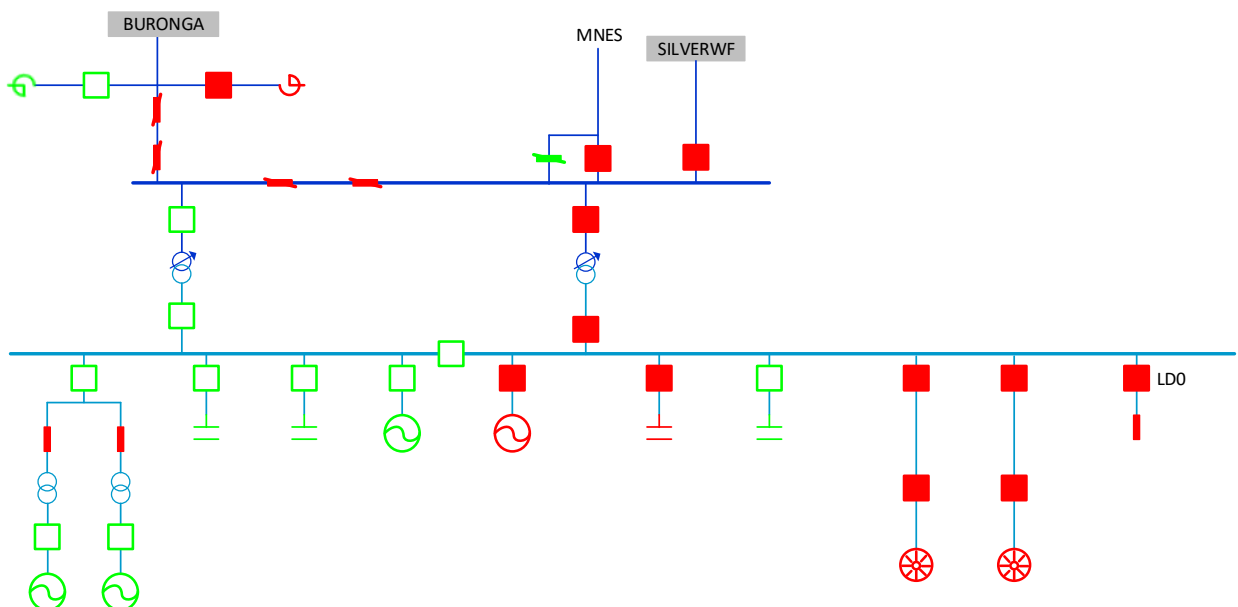
Broken Hill (during incident – Stage 1)

The trip of the No. 1 22 kV bus section resulted from a bird strike on a 22 kV disconnecter adjacent to the 22 kV 1-2 Bus Section Circuit Breaker (CB) 2112. This resulted in the trip of the No. 1 Transformer and all CBs connected to the No. 1 22 kV bus section. This was a correct outcome for a fault in this location. Appendix A1 shows diagrams of Broken Hill before and immediately after the trip of the No. 1 Transformer.

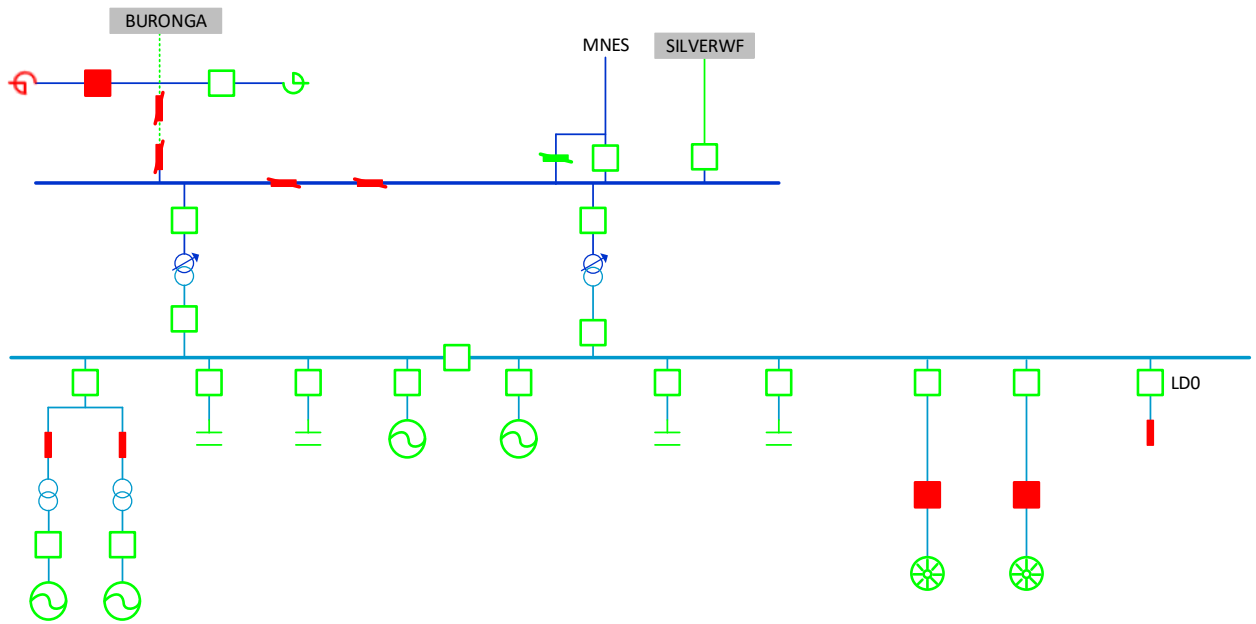
## Broken Hill (during incident – Stage 2)

At 12:08:10 hrs on 17 May 2019, the No. 2 Transformer and the X4 and X6 lines tripped, along with the remaining 22 kV CBs on the No. 2 22 kV bus section, resulting in a loss of supply to Broken Hill and the Broken Hill mines. Generation from the Broken Hill Solar Farm and the Silverton Wind Farm was also disconnected. This was not an expected operation, because there was no associated high voltage fault on the power system. The 220 kV busbar remained energised via the X2 line from Buronga. Refer to Appendix A1.3 for a diagram of Broken Hill immediately after the trip of the 220 kV busbar.

Investigations by TransGrid revealed the No. 1 Transformer No. 2 Protection relay instantaneous overcurrent output was intermittently high<sup>7</sup> due to a fault in the relay. This, coupled with the latched multitrip relay<sup>8</sup> for the No. 1 Transformer, resulted in the initiation of the No. 1 Transformer local back up protection, which in turn initiated the 220 kV busbar protection at Broken Hill tripping the No. 2 Transformer and the X4 and X6

lines. This trip signal, coupled with the X2 Auto-Reclose Scheme, then resulted in the multiple CB open/close cycling that occurred. It is likely the No. 2 Protection relay had been faulty for some time, but the fault only became evident after the trip of the No. 1 Transformer. TransGrid has advised the faulty protection relay has been replaced. TransGrid has reviewed internally the population of the failed relay. There is no indication of a type fault. This type of relay is 40 years with approximately 60 still in service in the TransGrid network. There has been no observed increase in failure rates for these relays, and it is presumed to be an individual failure of a relay in a comparatively harsh physical and electrical environment.

In response to this incident, TransGrid disabled the X2 Auto-Reclose Scheme, pending design changes to prevent multiple open/close operations as seen during this incident. TransGrid has advised that changes to prevent the scheme operating for a 220 kV busbar protection operation have been completed, and the X2 Auto-Reclose Scheme was returned to service on 8 July 2019.
