# Power system in South Australia not in a secure operating state on 5 May 2019

**January 2020**

Reviewable Operating Incident Report under the  
National Electricity Rules

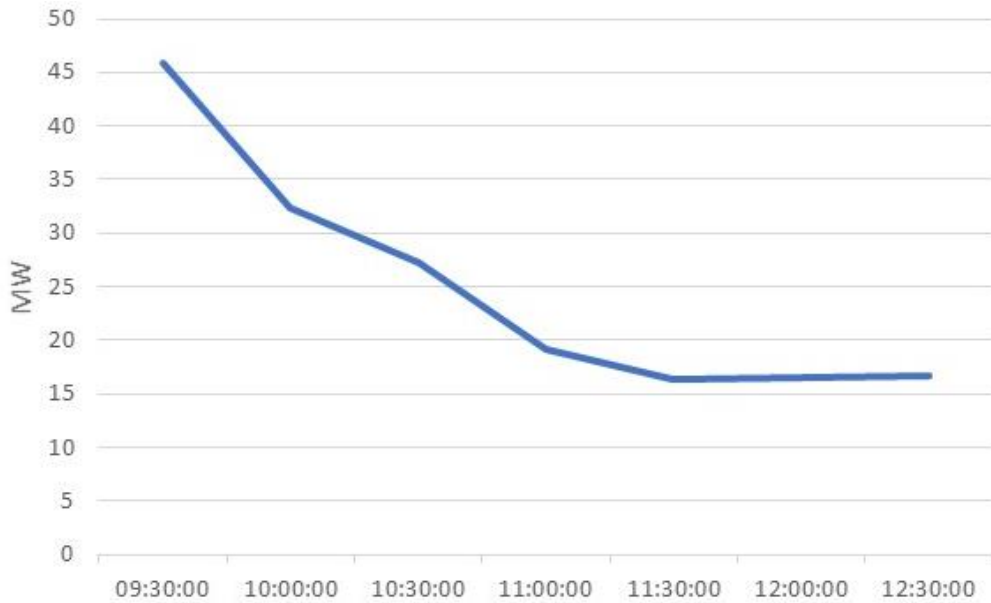
**Figure 1 Forecast output of Northern area wind generation**

In the period prior to this incident, the wind farms in the northern area of South Australia<sup>7</sup> were forecast to be generating at low outputs but would remain above zero, as shown in Figure 1.

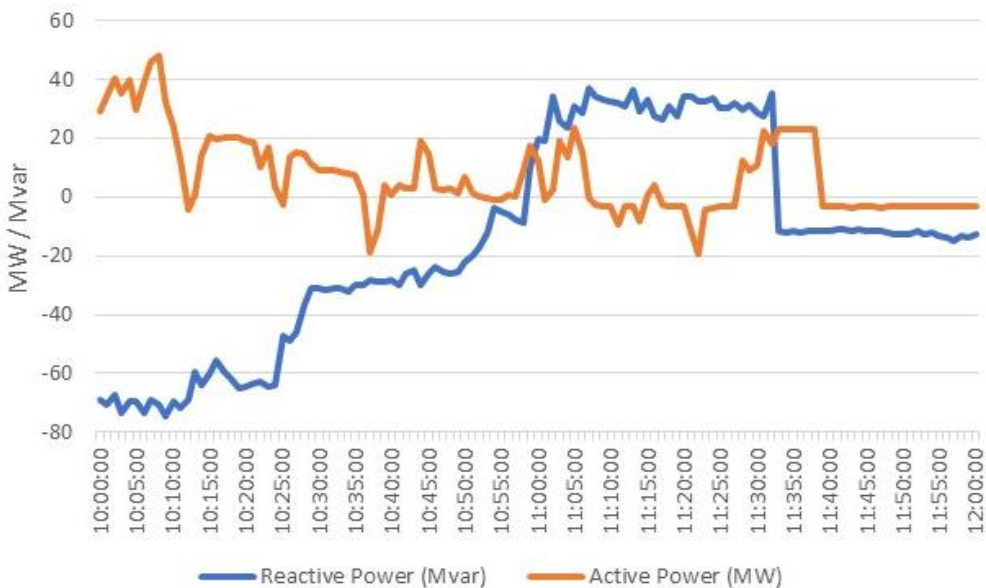
**Figure 2 Northern area wind farm generation – active and reactive power output**

From approximately 1015 hrs on 5 May 2019, the output of the Northern area wind farms reduced to zero or near zero. For the majority of wind farms, the reactive power capability is defined as  $\pm 0.395 \times P$ , where P is the active power output. As such, when P approaches zero, so does the reactive power capability. Therefore, as the generation from the wind farms reduced to zero, the ability of the wind farms to absorb reactive power to limit voltages in the area was reduced.

This problem was further exacerbated by capacitor banks that were in service at Willogoleche and Snowtown North wind farms, resulting in a net rise in reactive power output from the wind farms (shown in Figure 2) and an increase in voltages in the area. As an example, Figure 3 shows the voltage levels at Willalo substation.

AEMO did not initially consider switching out the in service filters (capacitors) at Willogoleche and Snowtown North, because these filters were in service in accordance with the wind farms’ normal voltage control strategy, and AEMO was unsure if they could be switched out of service. However, after seeking advice from ElectraNet, AEMO requested these filters be removed from service at 1123 hrs. AEMO was advised this would take 30 minutes and 60 minutes respectively to occur, because staff needed to be called to site. The Snowtown capacitor was switched out of service at 1223 hrs and the Willogoleche capacitor was switched out at 1454 hrs.

Further to this, AEMO recommends that TNSPs ensure the voltage control strategy documents developed in consultation with wind and solar farm operators contain clear statements as to when capacitor/filter banks may be switched in or out of service and when alternative control modes may be used outside of the normal voltage control strategy. To assist with this, AEMO is in the process of developing a template for voltage control strategy documents. This template will be made available to TNSPs in the near future.

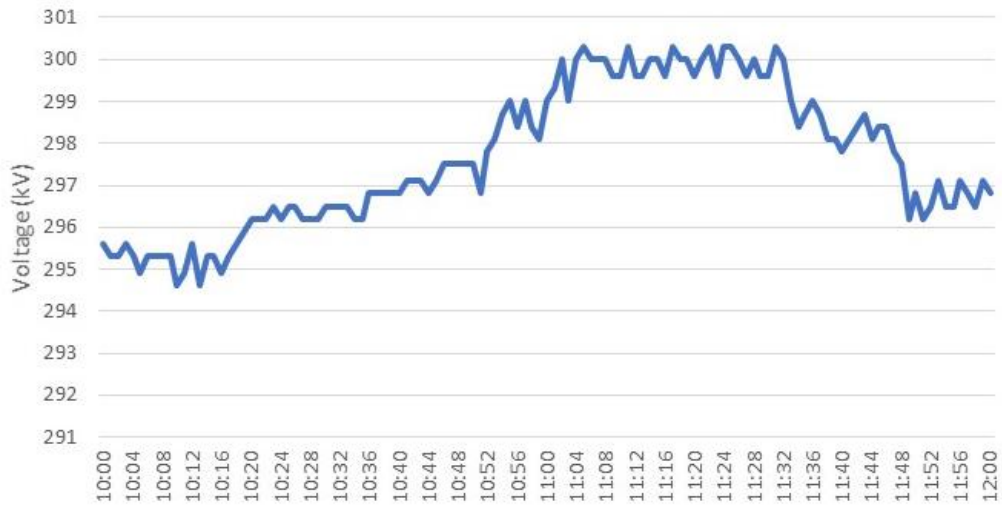
**Figure 3 Voltage level at Willalo 275 kV substation**

In response to the contingency violations occurring from 1031 hrs, AEMO explored ways to reduce voltage levels in the area, including:

At 1107 hrs, AEMO requested ElectraNet to open circuit breaker (CB) 8001 at Blyth West. With this CB open, the outage of the Blyth West – Munno Para 275 kV transmission line would also result in the loss of the Blyth West – Snowtown North and South 275 kV transmission line and reduce the post-contingent voltages at Blyth West substation to acceptable levels. CB 8001 at Blyth West was closed again at 1329 hrs, after studies showed no further post-contingent voltage violations.

Similarly, after seeking further advice on the operation of the Hornsdale Battery, at 1127 hrs AEMO requested the Hornsdale Battery be switched from power factor control mode to voltage control mode and the voltage setpoint be lowered to 293 kV to reduce the pre-contingent voltages in the area. This action resulted in the Hornsdale Battery absorbing up to 40 megavolt amperes reactive (Mvar), reducing both pre-contingent and post-contingent voltages at Willalo substation to acceptable levels, with all violations cleared by 1145 hrs.
