Simultaneous trip of both potlines at the Alcoa Portland aluminium smelter on 9 October 2019

February 2020

Reviewable Operating Incident Report under the National
Electricity Rules

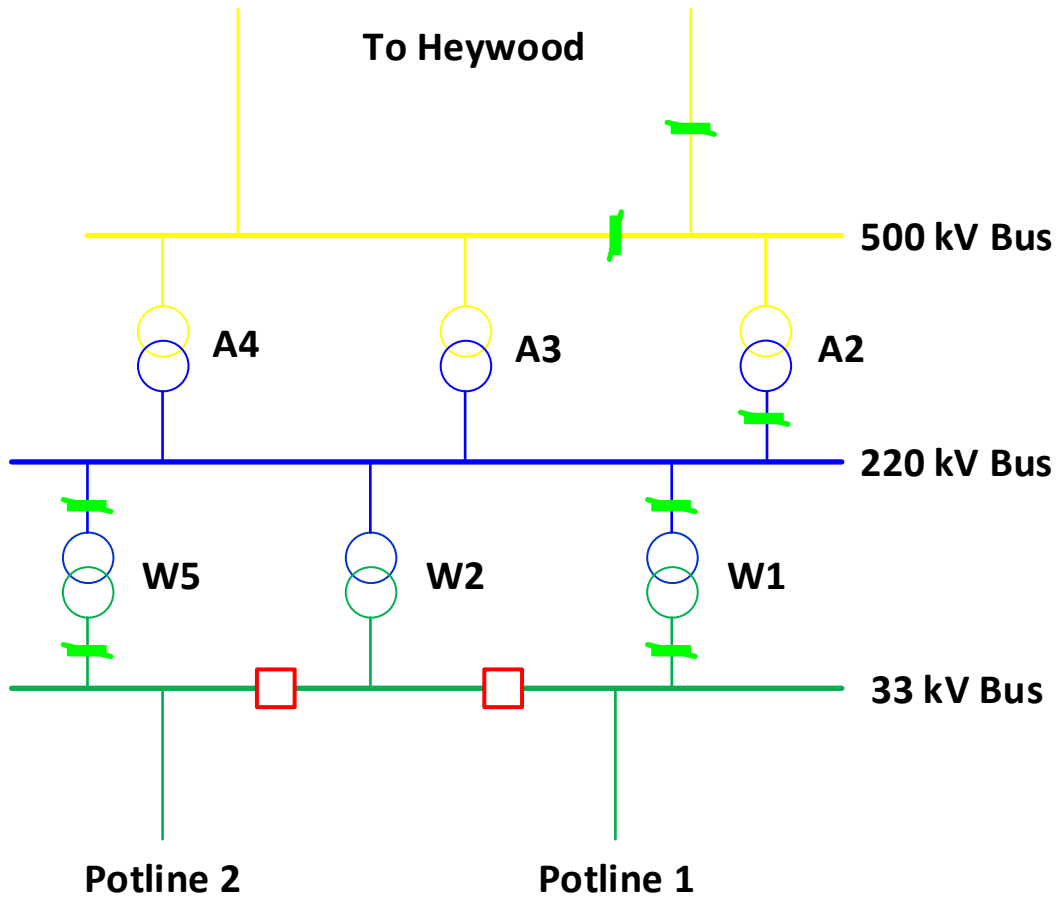
A1. System diagram

At 0634 hrs on 9 October 2019, the 500/220kV A2 Transformer at APD was de-energised as part of planned work. Coincident with the de-energising of the A2 Transformer, the 220/33kV W1 and W5 Transformers at APD tripped, resulting in the loss of all potline load at APD (approximately 468 MW). Refer to Appendix A1 for a diagram of APD immediately after the incident.

The W1 and W5 Transformers tripped due to the operation of the under-frequency (U/F) load shed relays at APD when the A2 Transformer was de-energised. This was not an expected outcome of the planned switching.

The U/F load shed relays source their frequency reference signal from capacitive voltage transformers (CVTs) located on the 220 kV side of the A2 and A3 Transformers. The frequency reference signal to the U/F relays is normally selected to the CVT on the A2 transformer. If the input from the CVTs is lost, the relay will interpret this as a low frequency event and the relay will operate.

When supply to the A2 Transformer is lost, there is an auto-changeover scheme in place to switch to the reference signal from the CVT on the A3 Transformer. In this instance, as this was planned switching, the U/F supply was switched manually from the A2 Transformer to the A3 Transformer prior to the high voltage switching. However, although the operator had correctly moved the changeover switch to the A3 Transformer position, the changeover relay failed to operate, meaning that the frequency reference signal to the U/F relays remained sourced from the A2 Transformer CVT. The operator was not aware of this, because there is no indication provided from the change-over relay. When the A2 Transformer and associated CVT was isolated, this resulted in the loss of the frequency reference signal to the U/F relays and subsequent operation of the U/F relays, tripping both potlines.

The diagram below is a simplified overview of the switchgear at APD immediately after the outage of the A2 Transformer.

On 11 October 2019, Alcoa replaced the auto-changeover relay with a new relay of the same type. After the auto-changeover scheme was retested and proven to be operating correctly, the U/F load shed scheme was returned to service.

Alcoa has updated its procedures for annual testing of the U/F load shed scheme to include testing of the auto-changeover scheme.

Alcoa also plans to further update the existing electro-mechanical auto-changeover relay with a new digital relay. This relay will also include external indication as to whether it is switched to the A2 or A3 Transformer. A timeframe for this work has not yet been identified.
