**Simultaneous trip of Tungatinah –  
Butlers Gorge – Derwent Bridge 110 kV  
Transmission Line and No. 1 and No. 2  
Transformers at Tarraleah Power  
Station on 13 July 2019**

**January 2020**

Reviewable Operating Incident Report under the National  
Electricity Rules

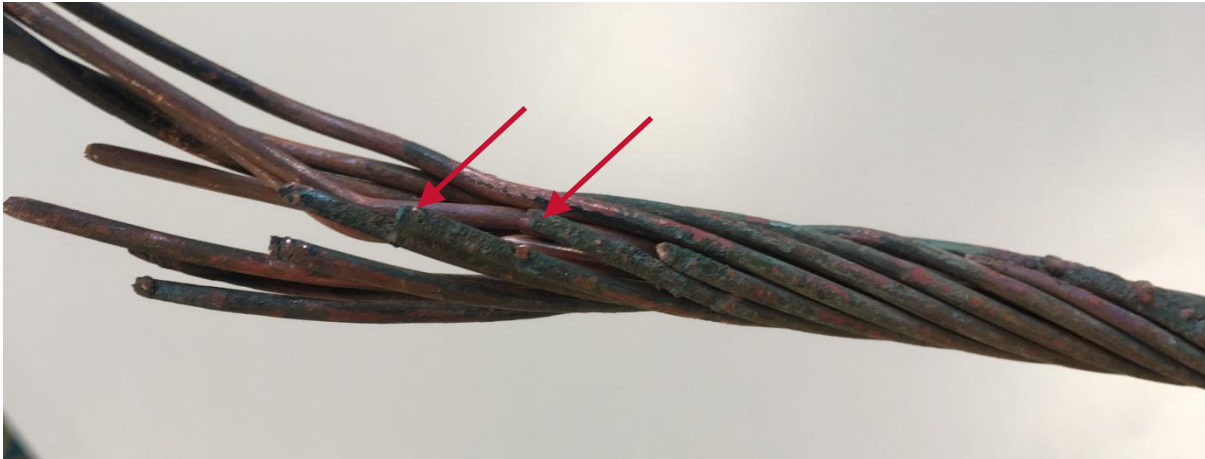
**Figure 1 Failed section of conductor**

Examination of the broken line conductor by TasNetworks found existing damage resulting from a flashover, likely caused by lightning. This flashover resulted in arc melt damage to some conductor strands and a number of broken conductor strands adjacent to an insulator clamp. Although this damage had been repaired by use of a mid-span splice, evidence showed the splice had not covered all the damaged section of the conductor, leaving a section of arc melt damage exposed at one end of the splice. Over time, localised stress and fatigue at the location of this damage resulted in the breakage of further strands of the conductor.

In the 24-hour period prior to the fault on 13 July 2019, heavy snowfall occurred in the central highlands area of Tasmania, with approximately 41 millimetres of rain/snow recorded at the Butlers Gorge weather station. As a result of the prior conductor damage and the heavy snow loading on the line, on 13 July 2019 the conductor failed completely.

Figure 1 shows a picture of the failed section of the conductor after the old mid-span splice had been removed, and shows evidence of strand failure prior to this incident.

The failed section of conductor was replaced, and the DB section of the line was returned to service at 1606 hrs on 14 July 2019.

Although the TU-BG-DB line is designed to withstand the level of snow loading often experienced in the area, and there have been no similar types of failure in the past, TasNetworks will continue to monitor conductor failure incidents on the TU-BG-DB line. If an increasing rate of failure is identified, then further investigations into the condition of the line conductors will be undertaken, including an inspection of any previous repairs.
