Gordon B 220 kV Busbar Trip on 9 September 2021

January 2022

Reviewable Operating Incident
Report under the National
Electricity Rules

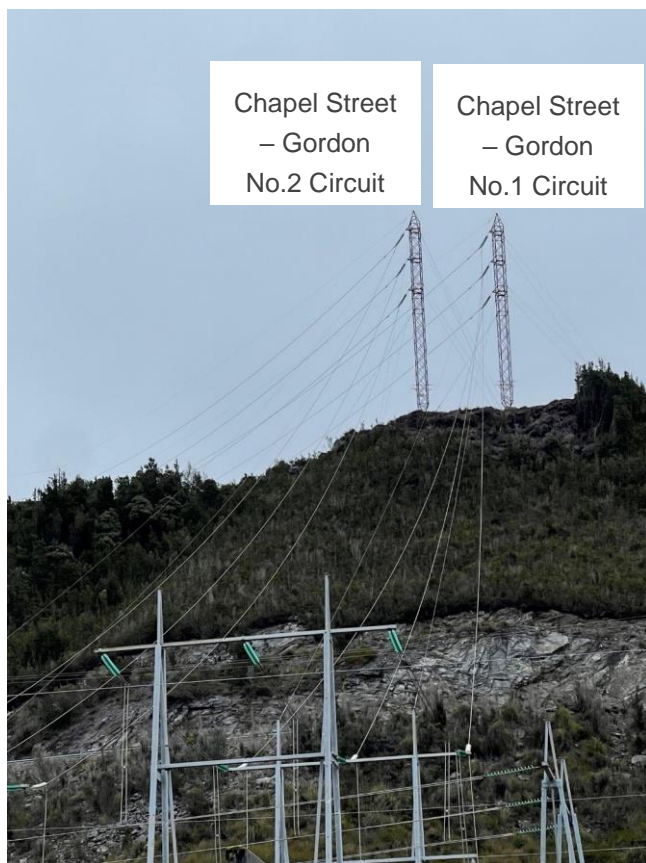
Figure 1 Chapel Street – Gordon 220 kV circuits (entry to Gordon 220 kV substation)

Incident cause	<p>Post-incident investigation by TasNetworks has concluded that:</p> <ul style="list-style-type: none"> A lightning strike hit the red phase of the Chapel Street – Gordon No. 2 220 kV circuit close to the Gordon substation. The lightning strike caused the Gordon B busbar “A” protection to mal-operate. This protection initiated a trip of the Gordon B 220 kV busbar.
Power system response (facilities and services)	<p>Prior to and during the incident, TasNetworks’ lightning detection software did not record a lightning strike near to Gordon substation⁴. However, lightning was observed by operational personnel in the vicinity of Gordon substation. Data from protection relays associated with the Chapel Street – Gordon No. 2 circuit has been analysed by the relay manufacturer and is consistent with a lightning strike on the red phase of this circuit (see Figure 1).</p> <p>TasNetworks has confirmed that the Gordon B busbar “A” protection mal-operated due to the lightning strike on the Chapel Street – Gordon No. 2 circuit. The Gordon B busbar protection was found to have operated too quickly for the out of zone fault, clearing the fault before the Chapel Street – Gordon No. 2 circuit could operate. The relay manufacturer has advised that a firmware update is available for the busbar protection relay which operated during this incident. The update allows the relay to perform a final repeat measurement prior to making a trip decision. Once applied, this firmware update will protect against busbar tripping for similar out of zone lightning strikes in the future.</p> <p>TasNetworks has confirmed that there was no indication of any flashover within the Gordon substation.</p>
