# Preliminary Incident Report - Trip of Torrens Island A and B West 275 kV busbars on 12 March 2021

**March 2021**

A preliminary operating incident report for the National Electricity Market –  
information as at 16/03/2021

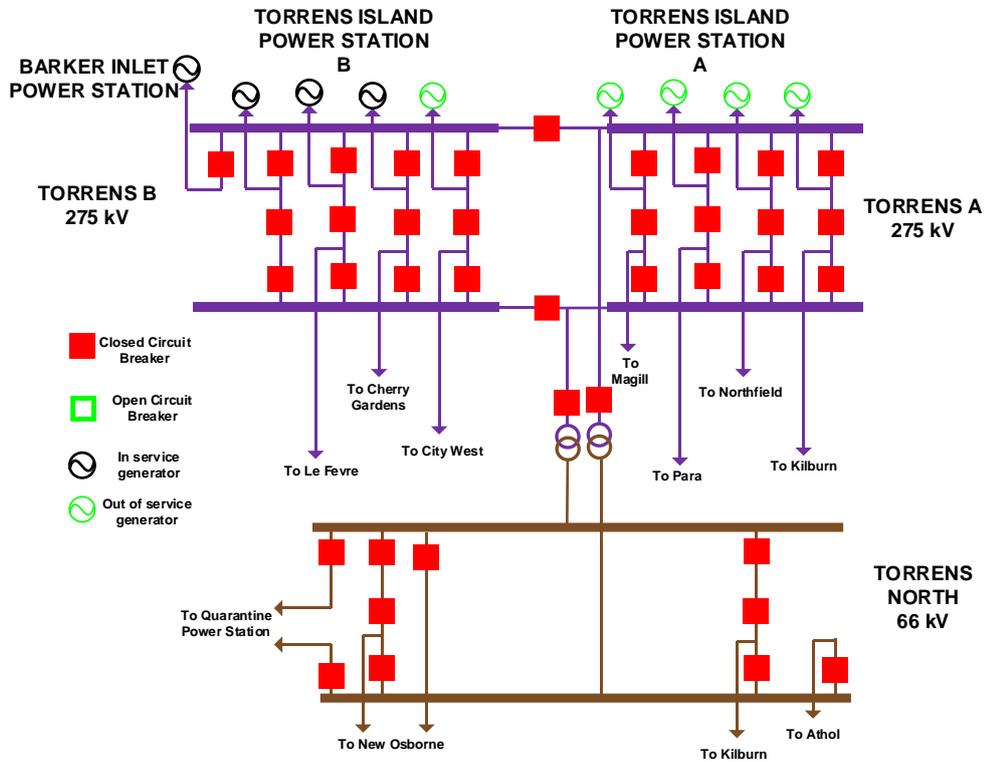
Figure 1: Pre fault system diagram

Immediately prior to the incident, all circuit breakers at Torrens Island A and B 275 kV substations were closed. In addition, units 2, 3 and 4 at Torrens Island B power station and Barker Inlet power station were operating. Unit 1 at Torrens Island B and all units at Torrens Island A were not generating prior to the incident.

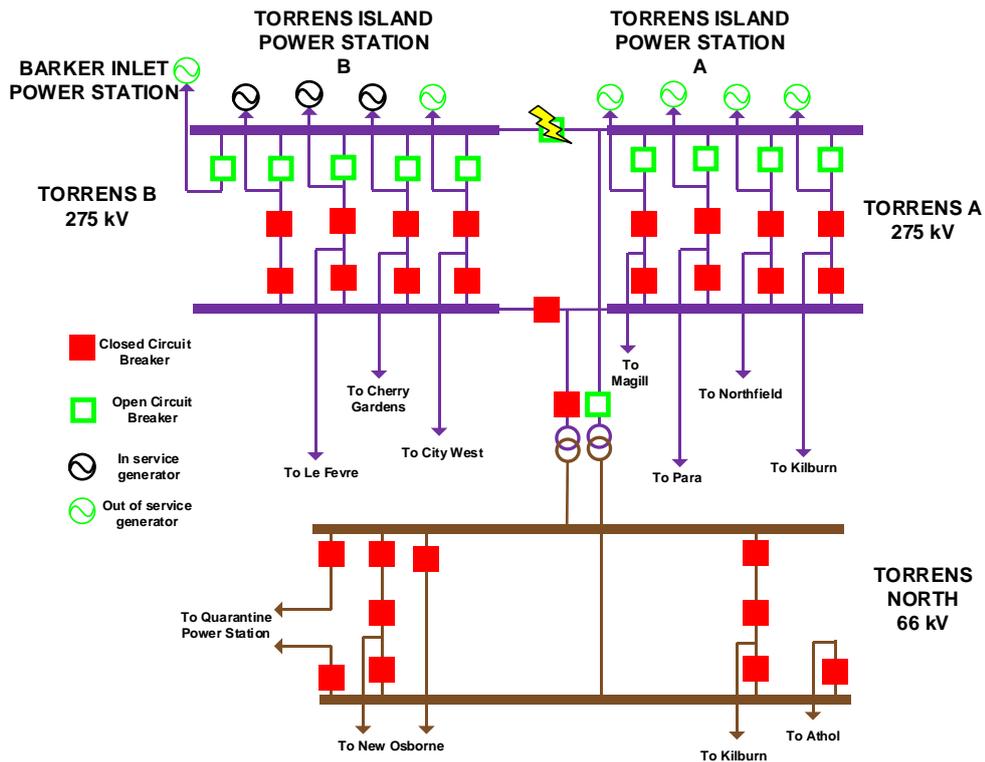
Figure 2: Post fault system diagram

At 1708 hrs on 12 March 2021 TORW\_A and TORW\_B 275 kV busbars simultaneously tripped. The event resulted in disconnection of Barker Inlet power station in the order of 111 MW and caused the TORW\_A to Torrens West 275/66 kV transformer to disconnect at the TORW\_A end. Preliminary investigations have determined the bus trip was caused by the failure of the Current Transformer (CT) associated with the Torrens Island substation West bus section circuit breaker.

Oil from the failed CT leaked into adjacent cable trenches at Torrens Island substation and caught fire. This oil fire impacted circuit breaker air supplies and operability for Torrens Island Power Station B (TIPS B) unit B3 and unit B4 and control and communications equipment at Torrens Island 275 kV substation.
