Incident review

This reviewable operating incident¹ report is prepared in accordance with clause 4.8.15(c) of the National Electricity Rules (NER). It has been prepared using information provided by ElectraNet² and from AEMO systems.

Table 1 Summary of event

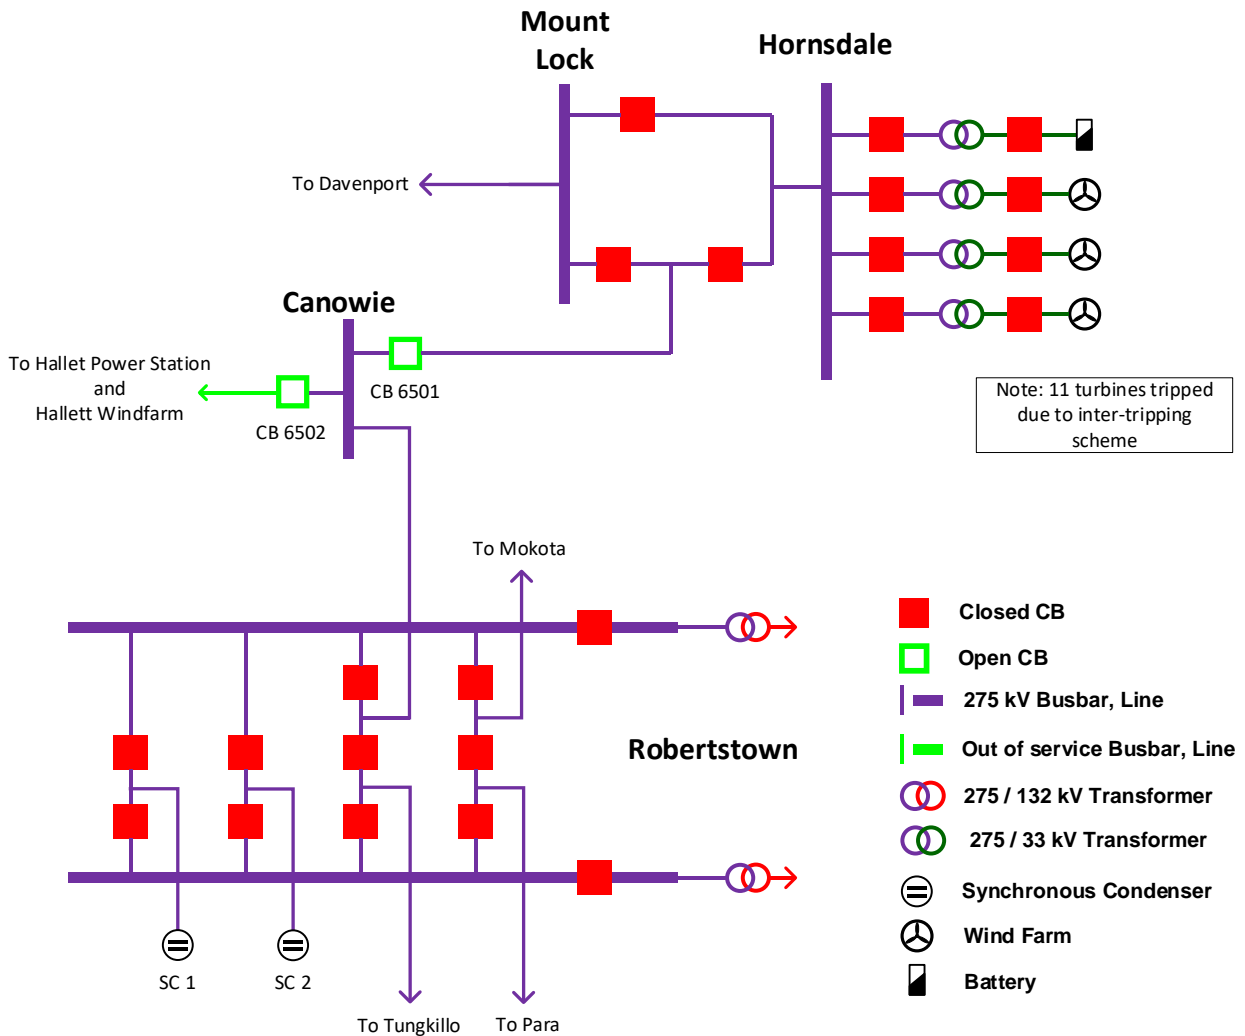
Figure 1 Incident diagram after protection signalling equipment mal operation

Incident key events	<ol style="list-style-type: none"> 1. At 1822 hrs on 12 September 2021, Canowie 275 kV substation's circuit breakers CB 6501 and CB 6502 tripped which resulted in the following: <ul style="list-style-type: none"> – Opening of the Canowie-Mount Lock 275 kV line at the Canowie end only and disconnection of Hallett substation, Hallett Wind Farm and Hallett Power Station (see Figure 1), and – Hornsdale Wind Farm 3 reduced output by 33 MW. 2. At 1826 hrs, CB 6501 at Canowie was manually closed and the Canowie – Mount Lock 275 kV line was returned to service. 3. At 2120 hrs, CB 6502 at Canowie was manually closed. 4. At 2150 hrs, Hallett substation and Hallett Wind Farm returned to service.
Incident cause	<p>Post incident investigation by ElectraNet has confirmed that:</p> <ul style="list-style-type: none"> • The Canowie 275 kV substation had unexpectedly received a Robertstown Set 2 Direct Intertrip Receive signal and Robertstown Islanded Permissive signal. Based on the Robertstown Set 2 Direct Intertrip Receive signal, the protection system at Canowie 275 kV substation operated and opened CB 6501 and CB 6502. This mal operation resulted in the line trips and generation disconnection/reduction described in the incident key events section of this report. • No circuit breakers or protection relays at Robertstown operated. <p>Further investigation of the Canowie – Robertstown protection signalling equipment showed that a transient error was introduced to the telecoms network time synchronisation system during maintenance work on 10 September 2021 at Robertstown substation. This was caused by a human error and caused synchronisation and buffer issues</p>

Details	
	in the Robertstown substation's protection signalling equipment. These signalling issues caused a trip of the Canowie 275 kV circuit breakers on 12 September 2021.
Power system response (facilities and services)	<p>In response to the trip of the Canowie – Mount Lock 275 kV line circuit breaker at the Canowie substation, the Hornsdale Wind Farm stage 3 inter-tripping scheme operated. This scheme tripped 11 wind turbines at Hornsdale Wind Farm stage 3, in line with its expected performance. This resulted in a reduction of 33 MW output from Hornsdale 3 Wind Farm.</p> <p>There were no other material impacts on the broader power system, load or generation.</p>
Rectification	On 13 October 2021, ElectraNet adjusted the settings on Robertstown substation protection signalling equipment and cleared the error. ElectraNet reviewed the maintenance procedures used on 10 September 2021 at Robertstown substation and determined that no changes were required to these procedures.

Power system security	The power system remained in a secure operating state throughout this incident and the Frequency Operating Standard ⁴ was met.
Reclassification	<p>AEMO assessed whether to reclassify this incident as a credible contingency event⁵.</p> <p>AEMO identified that the system impact of this incident was similar to having a fault on the Canowie-Robertstown 275 kV line, which is an existing credible contingency event, therefore AEMO correctly identified that reclassification was not required.</p>
Market information	<p>For this incident, AEMO issued the following market notices (all market notices for this incident were issued in accordance with NER requirements):</p> <ul style="list-style-type: none"> • AEMO issued Market Notice 90395 at 1939 hrs on 12 September 2021 to advise of a non-credible contingency event.
Conclusions	<p>AEMO has concluded that:</p> <ol style="list-style-type: none"> 1. The simultaneous trip of the Canowie 275 kV substation circuit breakers was caused by the maloperation of the Canowie – Robertstown protection signalling equipment. This mal operation was caused by a network synchronisation error introduced during maintenance work carried out two days prior to the incident. The trip of these circuit breakers caused the disconnection of Hallett substation, Hallett Wind Farm, Hallett Power Station, and operation of the Hornsdale Wind Farm 3 inter-tripping scheme. 2. AEMO correctly identified there was no requirement to reclassify this incident as a credible contingency. 3. The power system remained in a secure operating state throughout this incident and the Frequency Operating Standard was met. 4. ElectraNet adjusted the settings on the Robertstown substation's protection signalling equipment and cleared the error.
