# Trip of Multiple Cherry Gardens Lines on 24 January 2021

**June 2021**

Reviewable Operating Incident Report under the  
National Electricity Rules

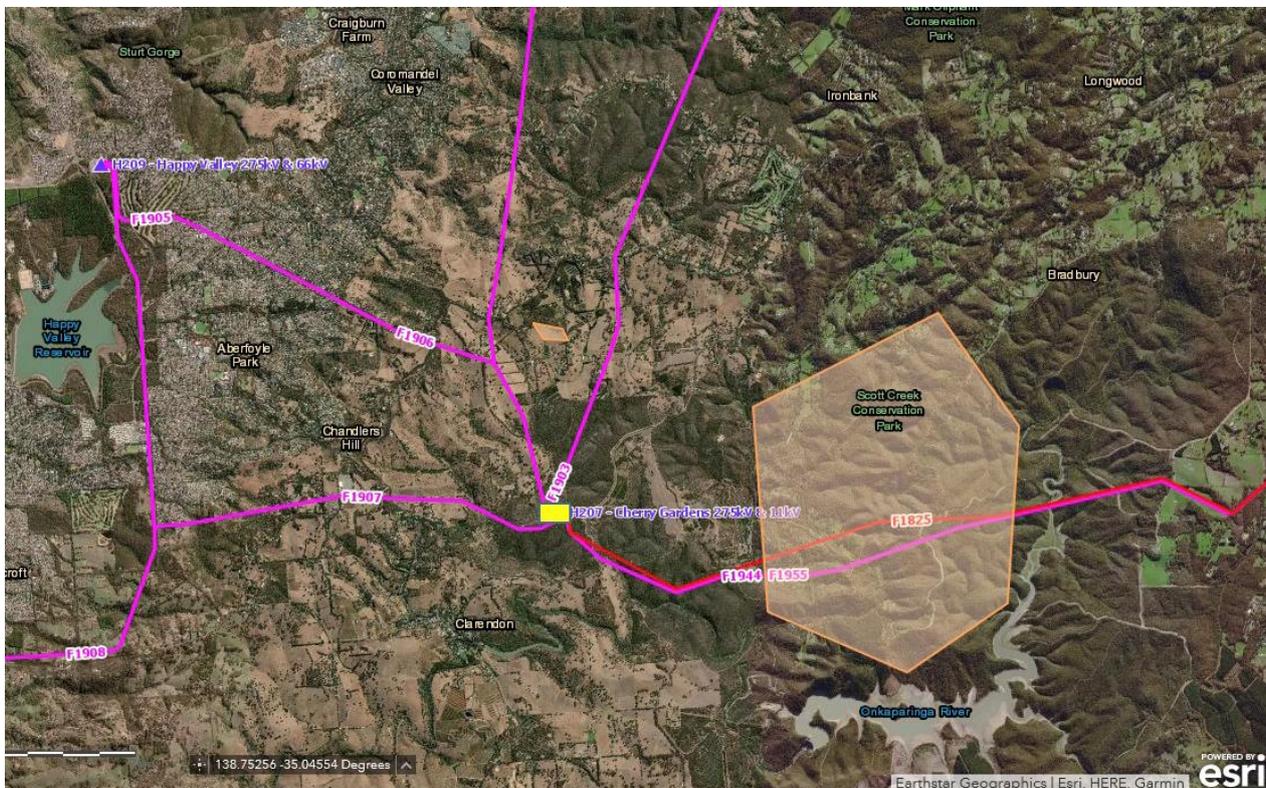
**Figure 1 Bushfire location in relation to the transmission network**

At 1643 hrs, ElectraNet was advised by the Country Fire Service (CFS) that seven separate spot fires had been reported. Moments later, one of these newly reported fires burned under the CHG – MTB 132 kV, CHG – MTBS 275 kV, and CHG – TBE 275 kV lines, causing multiple line faults. Due to the speed of the changes in fire location and status, no new notifications were received from INDJI prior to the event.

The locations of all the above faults were determined to be within the area impacted by the bushfire. All lines were kept de-energised until a patrol could be arranged as directed by the CFS. This was completed on Tuesday, 26 January 2021 and confirmed that none of the lines were significantly damaged. All lines were successfully re-energised by 0945 hrs on 26 January 2021.

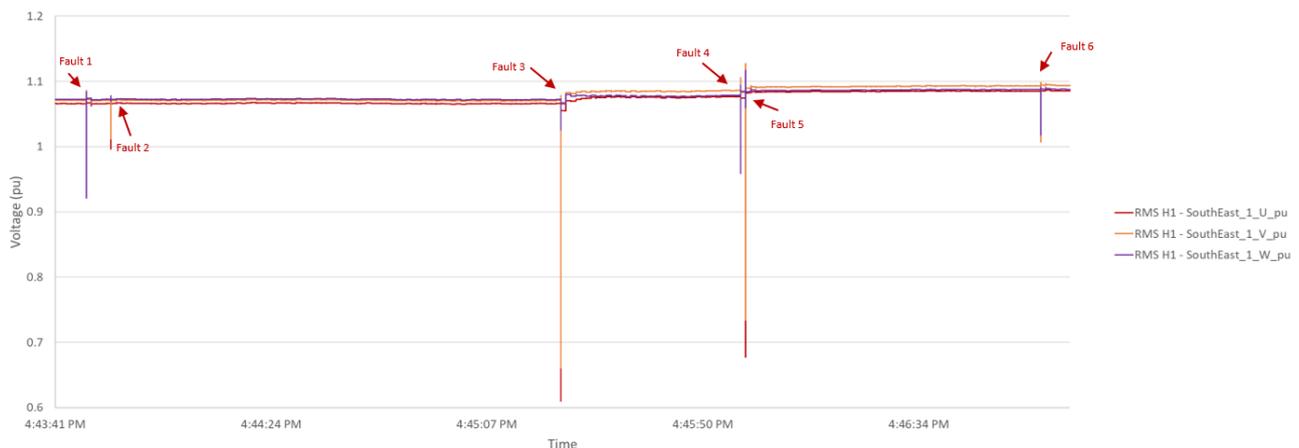
**Figure 2 Taillem Bend 275 kV line fault recorder data**

High speed monitoring at Taillem Bend recorded the voltage disturbances associated with the six faults caused by the bushfire, as shown in Figure 2.

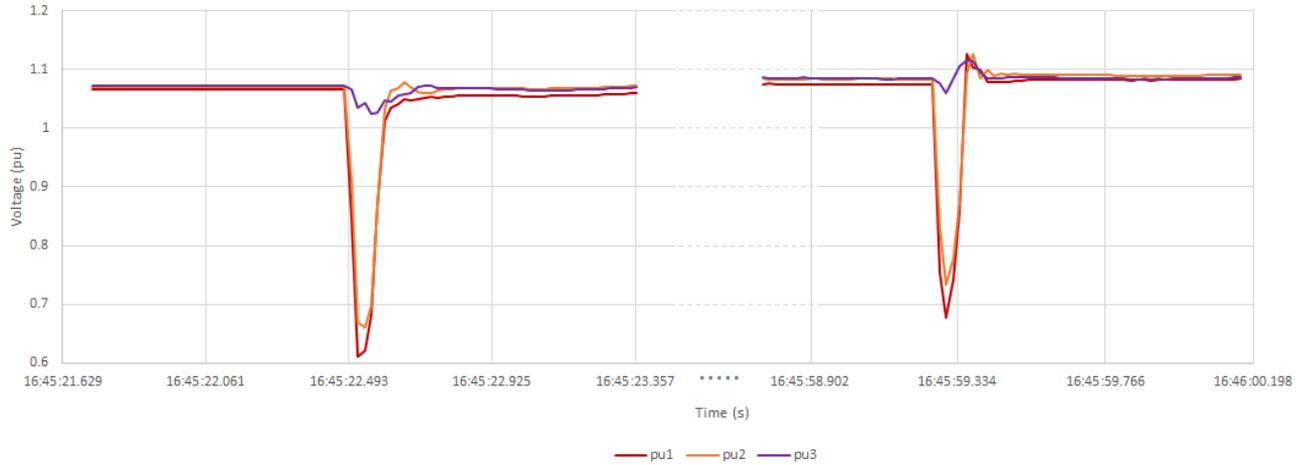
**Figure 3 Taillem Bend 275 kV line fault recording data of 275 kV for faults 3 and 5**

Figure 3 shows a voltage minimum of just above 0.6 pu on a single phase (and a minimum of 0.77 pu positive sequence) following the third fault<sup>9</sup>. Voltage disturbances of this depth on previous occasions have been observed to result in more than 10% of distributed photovoltaics (PV) disconnecting, and significant load disconnection, as discussed further in Appendix A3.

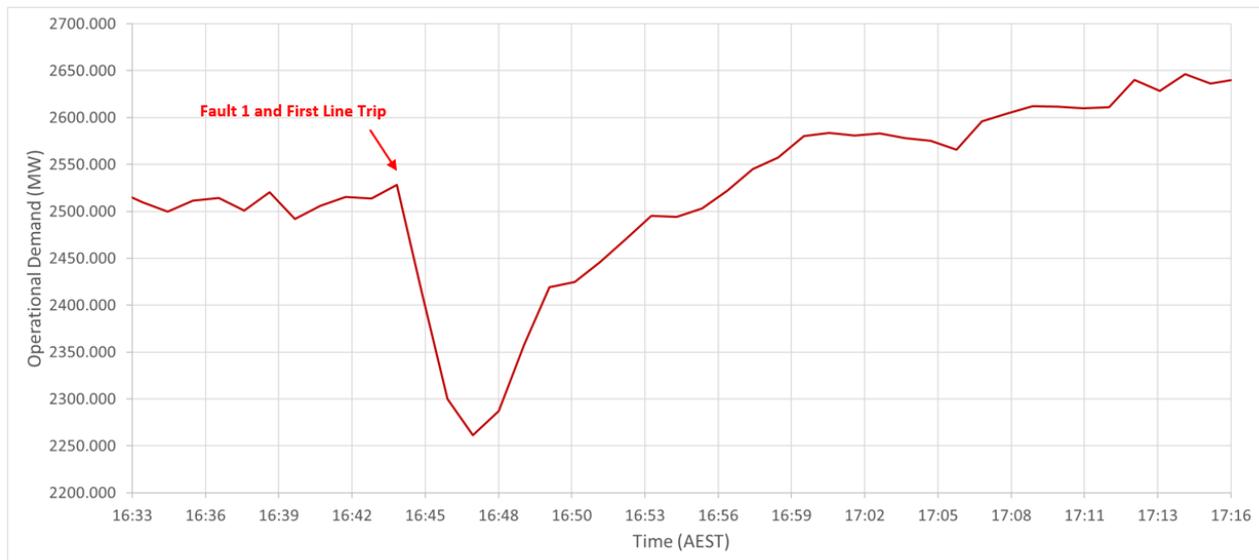
**Figure 4 South Australia regional load at the time of event**

Prior to the event, total operational demand in South Australia was estimated at 2,510 MW. As a result of the voltage disturbance caused by this incident, there was an approximate 250 MW temporary net reduction in load, as shown in Figure 4. The load returned to pre-fault levels within approximately 15 minutes.

Distributed PV was estimated to be generating a total of 576 MW in South Australia immediately prior to the disturbance. It is estimated that approximately 100 MW of distributed PV disconnected in response to the voltage disturbance, as discussed further in Appendix A3. Since distributed PV disconnection offsets load disconnection, it is estimated that a total of approximately 350 MW of underlying load disconnected in response to this event.

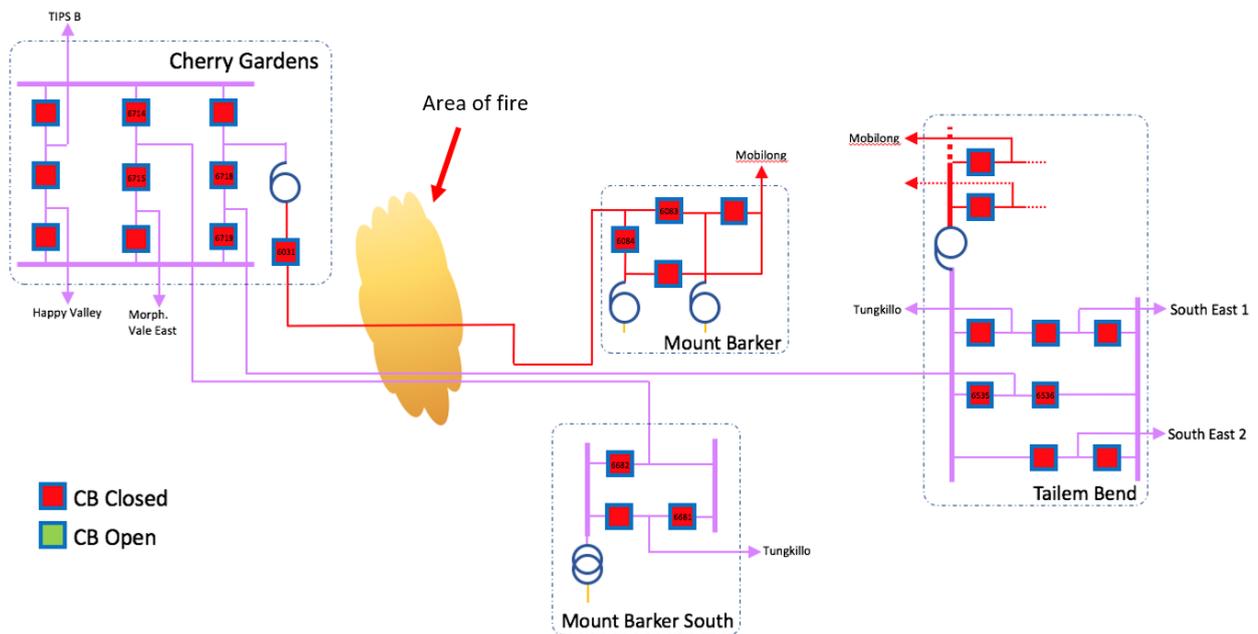
**Figure 5 Initial network configuration prior to the event**

Figure 5 in Appendix A2 shows the configuration at Cherry Gardens substation immediately prior to the event.

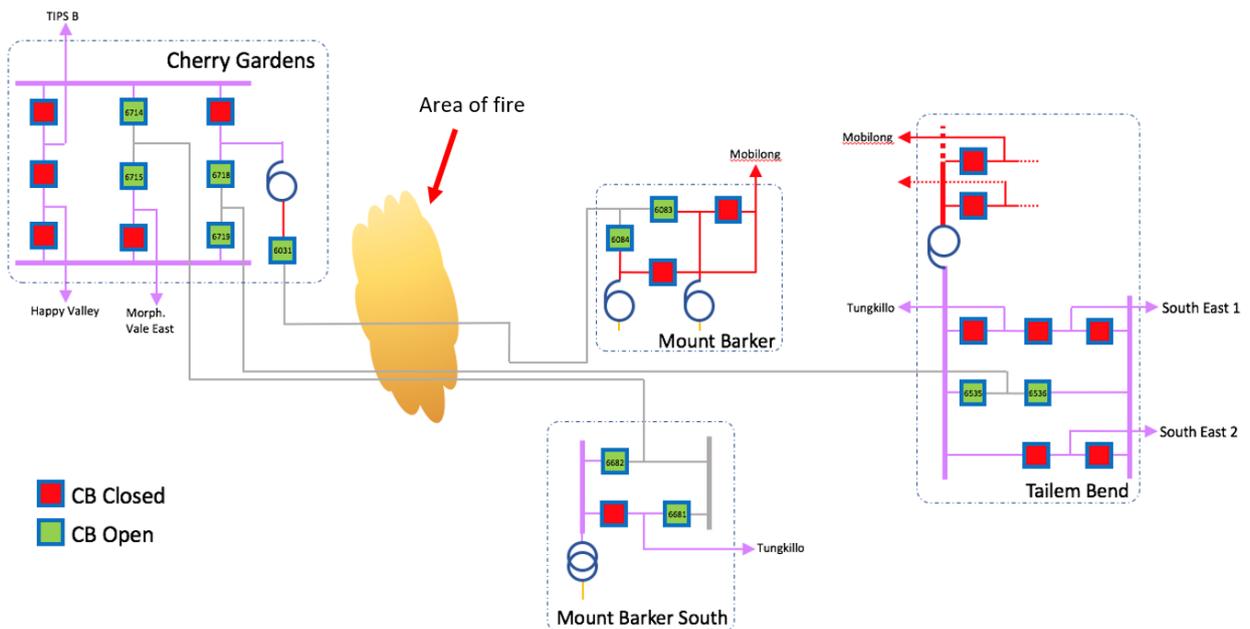
**Figure 6 Final network configuration after the event**

Figure 6 in Appendix A2 shows the final system configuration following the six faults caused by the bushfire. Table 1 in Appendix A1 summarises the sequence of events.

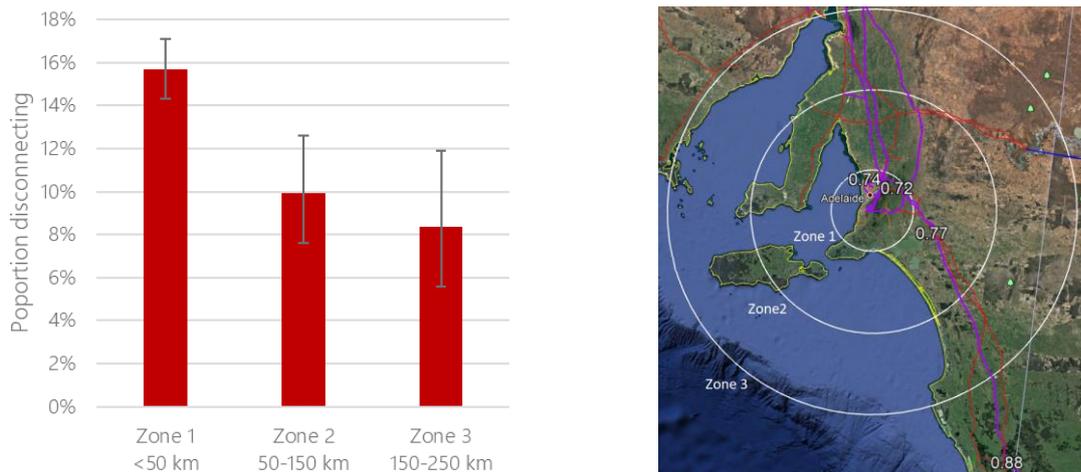
**Figure 7 Distributed PV disconnections by proximity to the fault (systems under the 2015 standard, excluding SA VDRT inverters)**

Figure 7 shows that distributed PV disconnections were highest close to the fault locations and reduced at more distant locations, as expected based on the high-speed voltage measurements recorded at each location.

Map illustrates minimum positive sequence per unit voltages recorded in the transmission network.

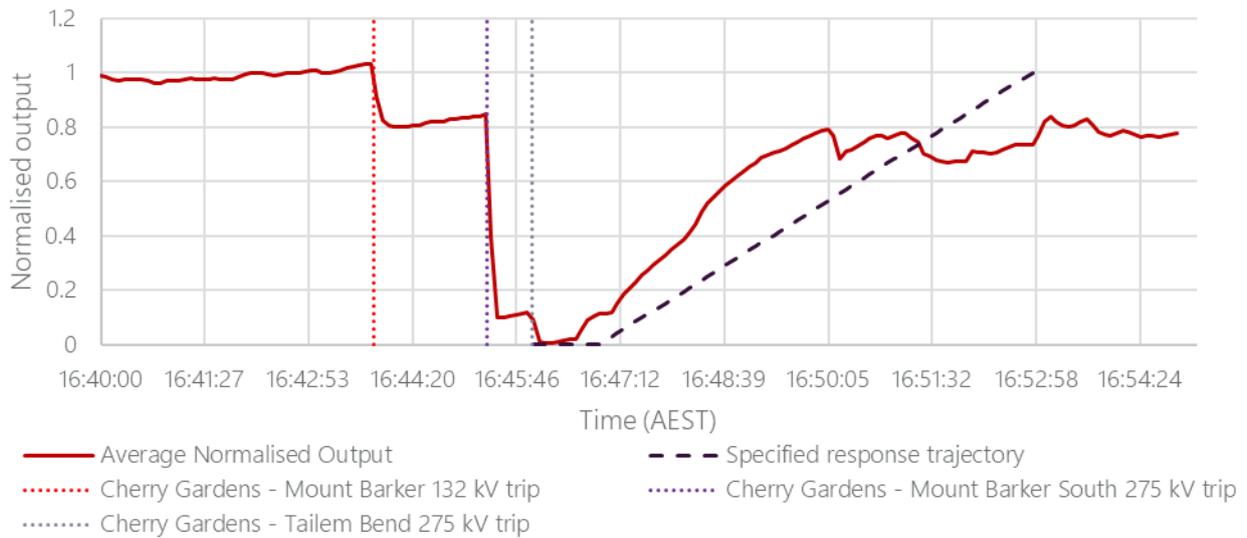
**Figure 8 Normalised aggregate generation profile for distributed PV systems under the 2015 standard that disconnected**

For inverters installed under the 2015 standard in the Solar Analytics sample of five-second resolution data, 252 systems (out of 1,351 samples) were observed to disconnect during the event window associated with the disturbances. The aggregate normalised<sup>25</sup> generation profile from these systems is shown in Figure 8. Systems disconnected in several tranches, following each of the faults, with the maximum number of systems disconnected following the third fault. The aggregate profile remained close to zero for approximately 30 seconds, then ramped up somewhat faster than the response trajectory specified in the 2015 standard (which requires a six-minute ramp rate limitation).

- Most systems (97%) that disconnected remained at close to zero generation for each least one minute or longer.
- 24% of systems do not appear to be observing the six-minute ramp rate limitation, ramping at a sustained average ramp rate exceeding 33.3% of rated power per minute<sup>26</sup>.

This is consistent with AEMO’s findings in previous disturbances, and suggests that some distributed PV inverters are not behaving consistently with the defined standards. AEMO is continuing collaboration with industry to assess possible causes of this behaviour.
