Trip of Collector Wind Farm 330 kV A Busbar on 26 August 2022

January 2023

Reviewable Operating Incident
Report under the National
Electricity Rules

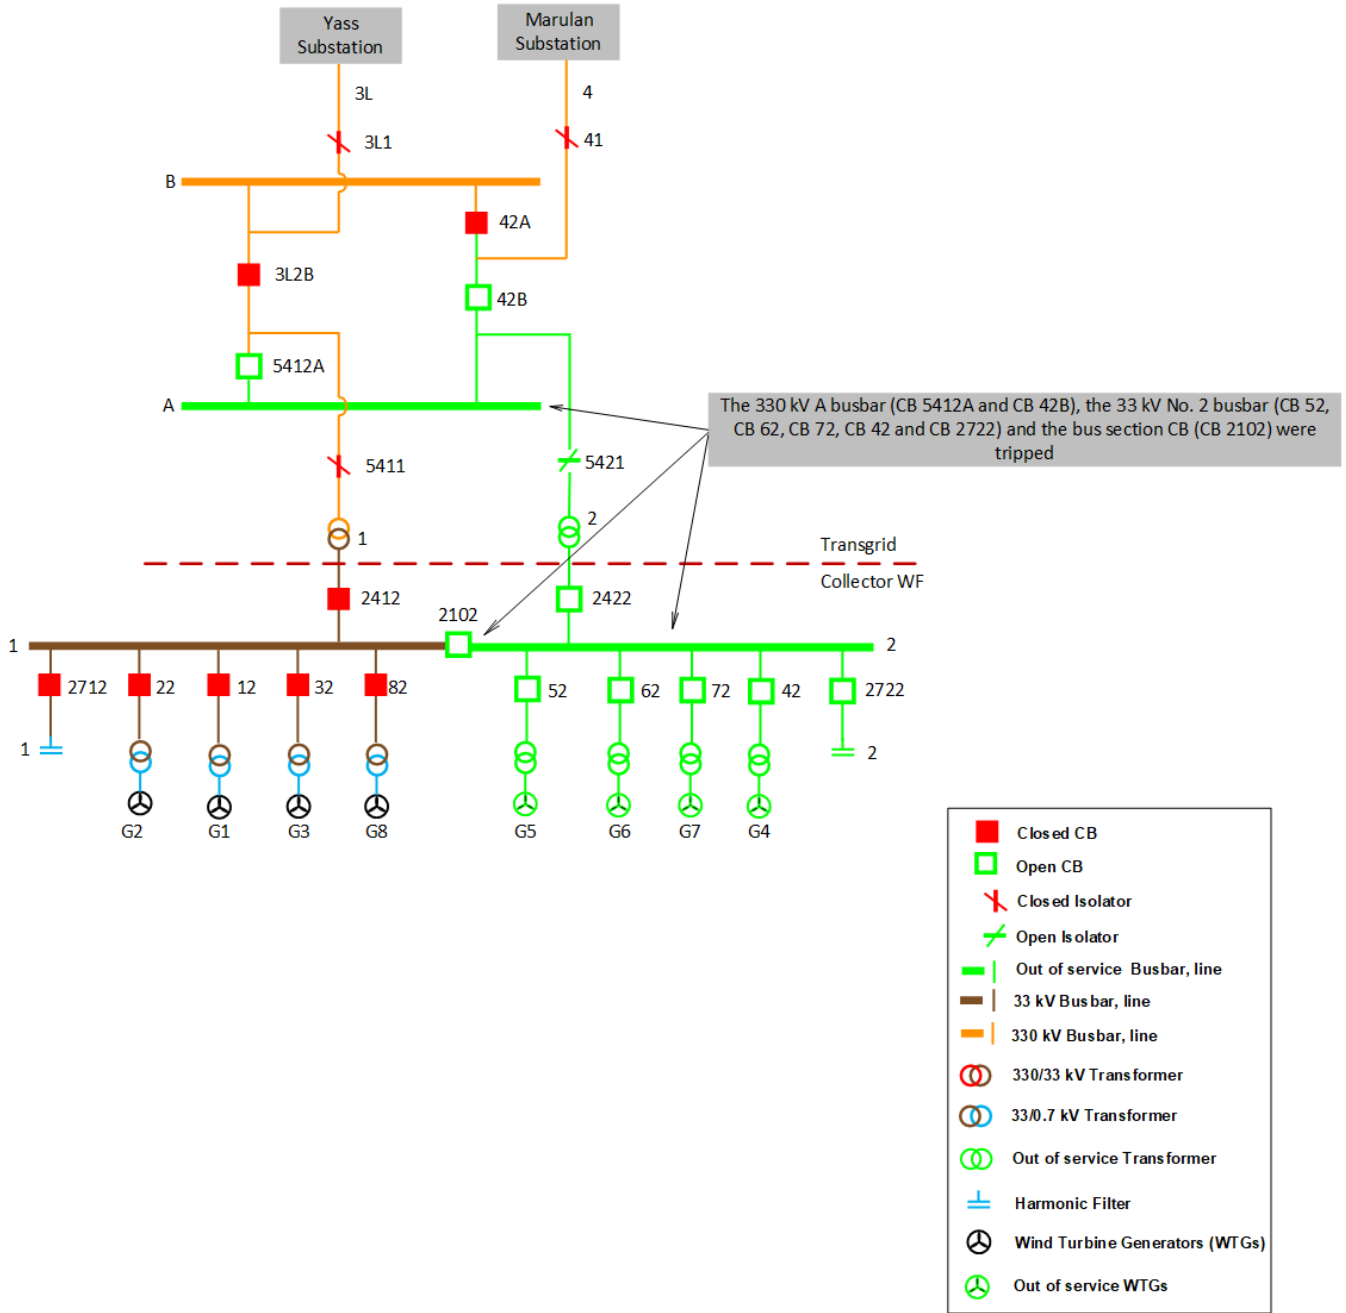
Figure 2 Post-incident diagram – Collector WF 330 kV substation

Details	
Reviewable operating incident type	Non-credible contingency event impacting critical transmission elements.
Incident details	This report relates to the reviewable operating incident ³ that occurred on 26 August 2022 in New South Wales. The incident involved the trip of the Collector WF 330 kV A busbar, the Collector WF 33 kV No. 2 busbar and their associated circuit breakers (CBs).
Incident classification	Other causes – human error.
Generation impact	There was a reduction of 4 megawatts (MW) output from the Collector WF immediately after the incident occurred.
Customer load impact	Nil.
Pre-incident conditions	Prior to the event, the Collector WF 330/33 kV No. 2 transformer was isolated and earthed for maintenance and high voltage testing. The transformer and its associated switching devices including isolator 5421 and CB 2422 were out of service as shown in Figure 1.
Incident key events	<p>On 26 August 2022:</p> <ol style="list-style-type: none"> At 0823 hrs, the Collector WF 330 kV A busbar (CB 5412A and CB 42B) and the 33 kV bus section CB (CB 2102) tripped. As a result, all the circuit breakers attached to the 33 kV No. 2 busbar including CB 52, CB 62, CB 72, CB 42 and CB 2722 were tripped as shown in Figure 2. AEMO and Transgrid observed a 4 MW reduction in the output from Collector WF post-incident. The output from Collector WF was approximately 10.69 MW pre-incident and immediately dropped to 6.68 MW post-incident. At 1214 hrs, the Collector WF 330 kV A busbar, the 330/33 kV No. 2 transformer and the Collector WF 33 kV No. 2 busbar were returned to service.

Conclusions	AEMO has concluded that: <ol style="list-style-type: none"> 1. On 26 August 2022, due to a human error, Transgrid technicians inadvertently injected current into the Collector WF No. 2 transformer REF CTs. This caused the REF protection to operate and trip the Collector WF 330 kV A busbar, the 33 kV bus section CB (CB 2102) and the 33 kV No. 2 busbar. 2. There was a reduction of 4 MW output from the Collector WF post-incident. 3. Transgrid identified the cause of this incident and returned the Collector WF 330 kV A busbar, the 330/33 kV No. 2 transformer and the Collector WF 33 kV No. 2 busbar to service. As the root cause had been identified, AEMO correctly identified there was no requirement to reclassify this incident as a credible contingency. 4. Transgrid has updated its procedure for CT isolation/restoration, amending the sequence for the restoration and demagnetisation of CTs to reduce the likelihood of human error. 5. The power system remained in a secure operating state throughout this incident and the FOS was met for this incident.

Recommendations	AEMO recommends that Transgrid shares details of this incident and the changes made to the CT restoration and demagnetisation sequence with the Power System Security Working Group (PSSWG).
