# Trip of Red Cliffs – Kiamal 220 kV line, Kiamal synchronous condenser, Buronga No. 2 and No. 3 synchronous condensers

September 2022

Reviewable Operating Incident  
Report under the National  
Electricity Rules

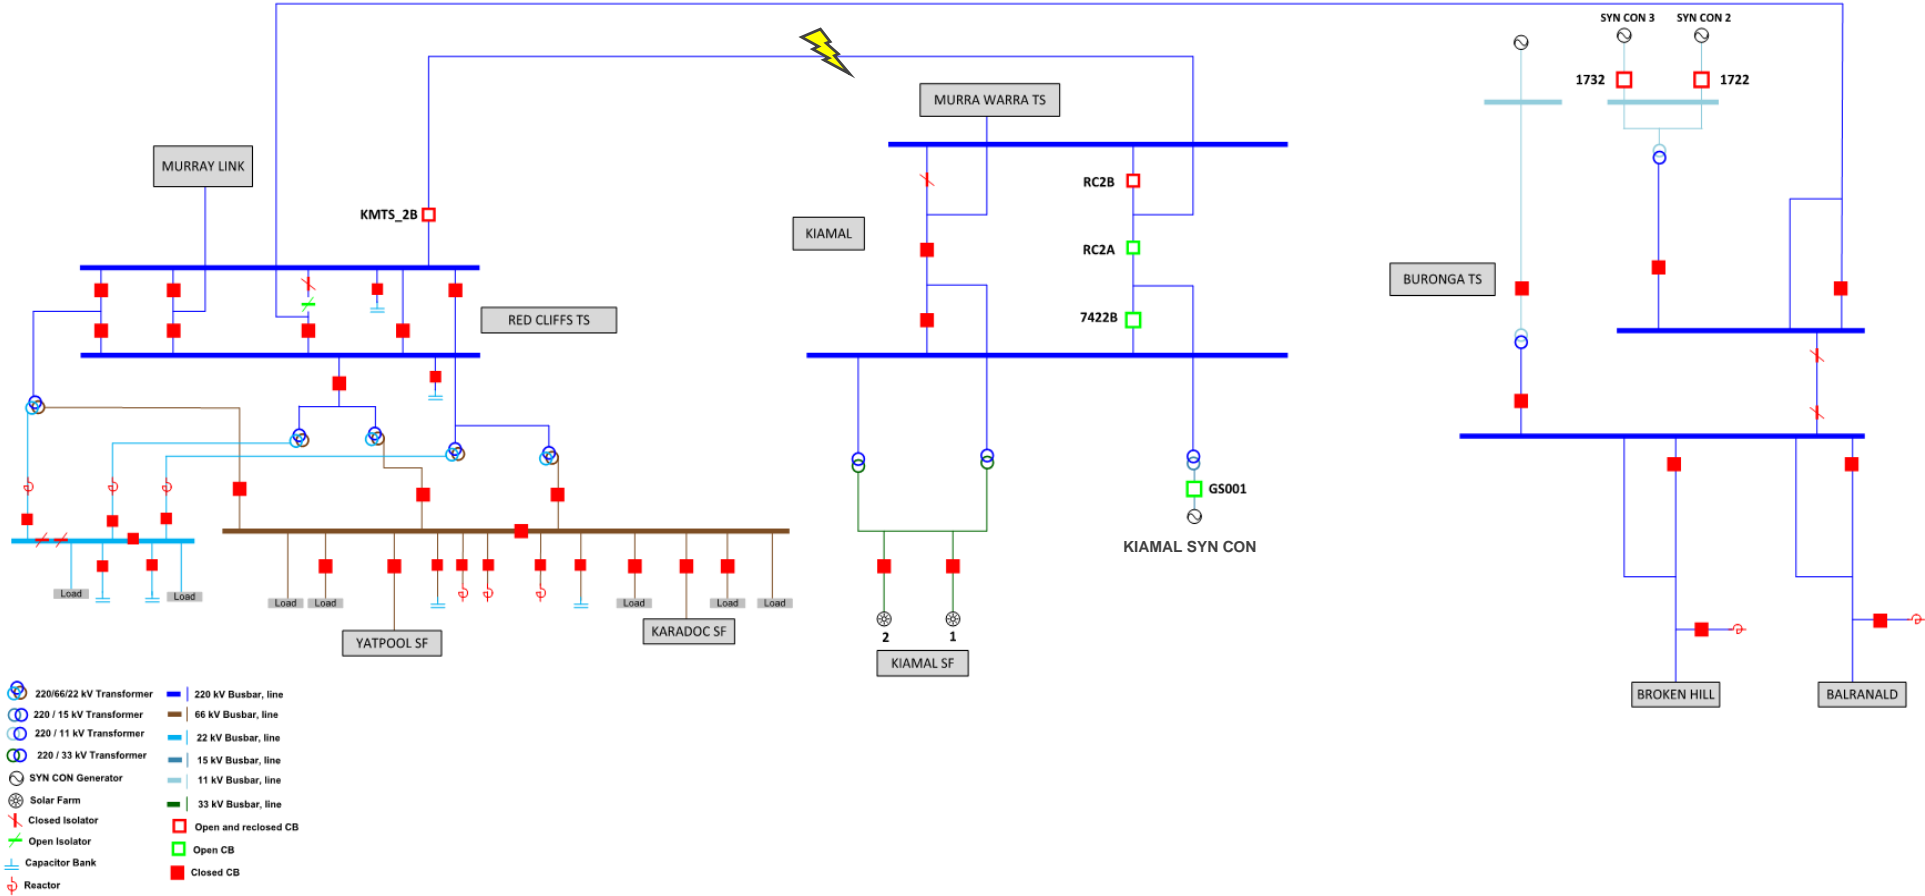
Figure 1 Simplified network configuration post fault clearance and the trip of Kiamal synchronous condenser, showing CBs that tripped and reclosed and CBs that remained open

Figure 1 in Appendix A1 shows which CBs tripped during the incident.

the breakers 7422B and RC2A at KMTS was due to the failure of the synchronous condenser internal CB (see Figure 1 in Appendix A1).
