Trip of Terang Terminal Station No. 2 220 kV Busbar on 10 May 2022

October 2022

Reviewable Operating Incident
Report under the National
Electricity Rules

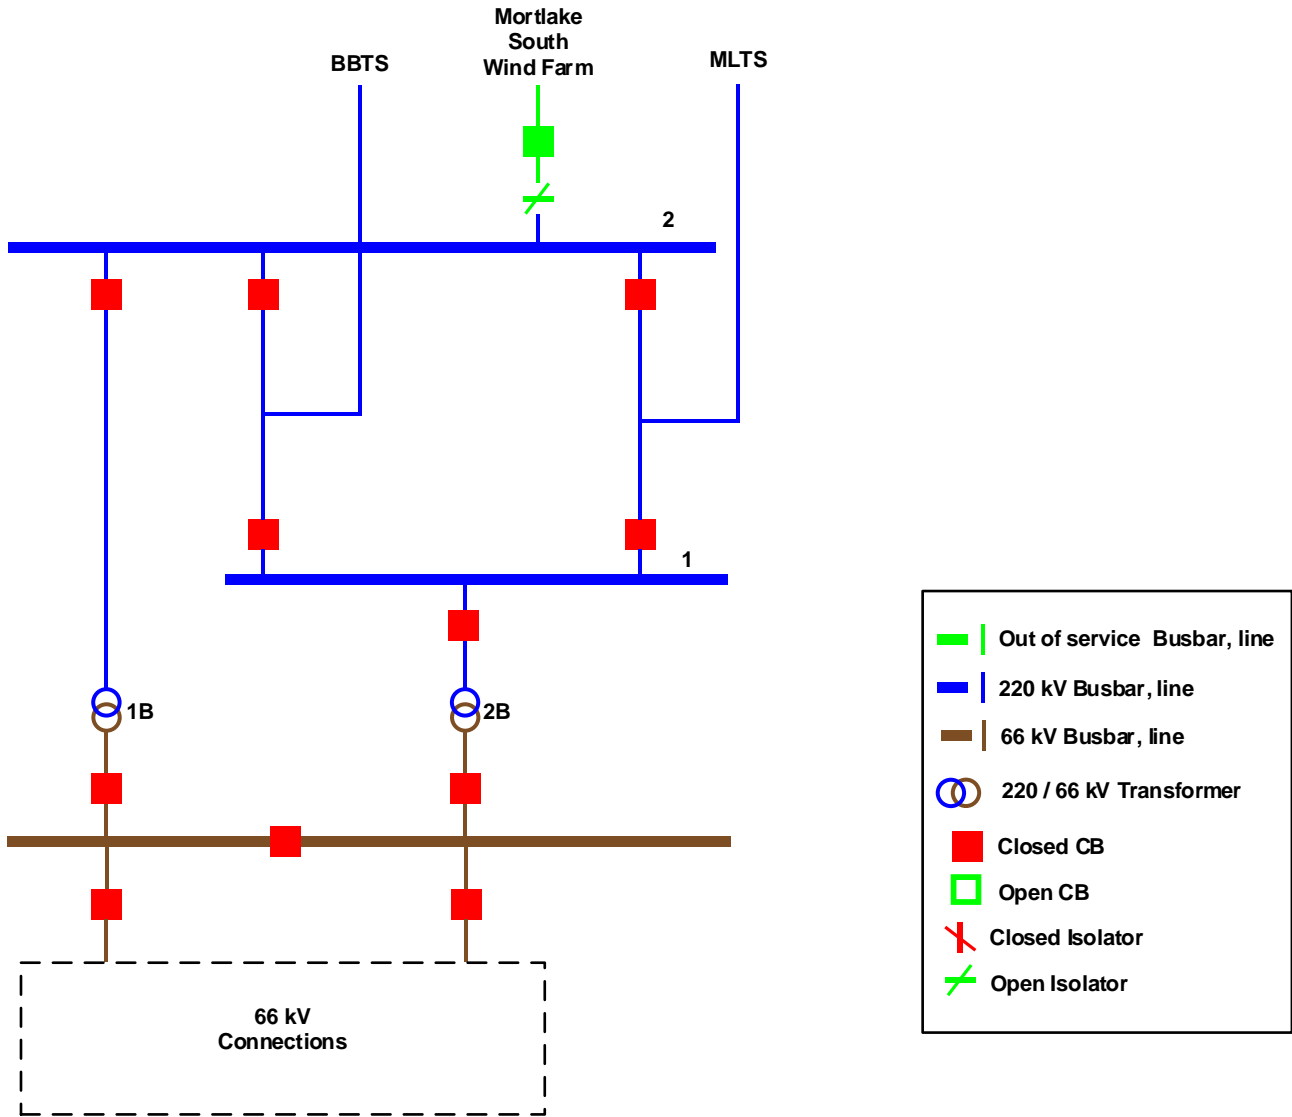
Figure 1 Pre-incident diagram – Terang Terminal Station

Details	
Reviewable operating incident type	Non-credible contingency event impacting critical transmission elements.
Incident details	This report relates to a reviewable operating incident ³ that occurred on 10 May 2022 in Victoria. This incident involved the trip of the Terang No. 2 220 kilovolts (kV) busbar.
Incident classification	Other causes – human error – insufficient isolations established for secondary testing work.
Generation impact	Nil
Customer load impact	Nil
Pre-incident conditions	An AusNet delivery partner was working on the Mortlake South Wind Farm (MSWF) circuit breaker management (CBM) relay at Terang Terminal Station (TGTS) on 10 May 2022. The work included testing newly added Supervisory Control and Data Acquisition (SCADA) points in the relay related to the Generator Fast Trip (GFT) A and B schemes ⁴ . Shortly before the incident, the testing staff had implemented secondary isolations on the MSWF CBM protection panel to allow testing of the new SCADA points. Figure 1 shows the configuration at TGTS immediately prior to the incident.

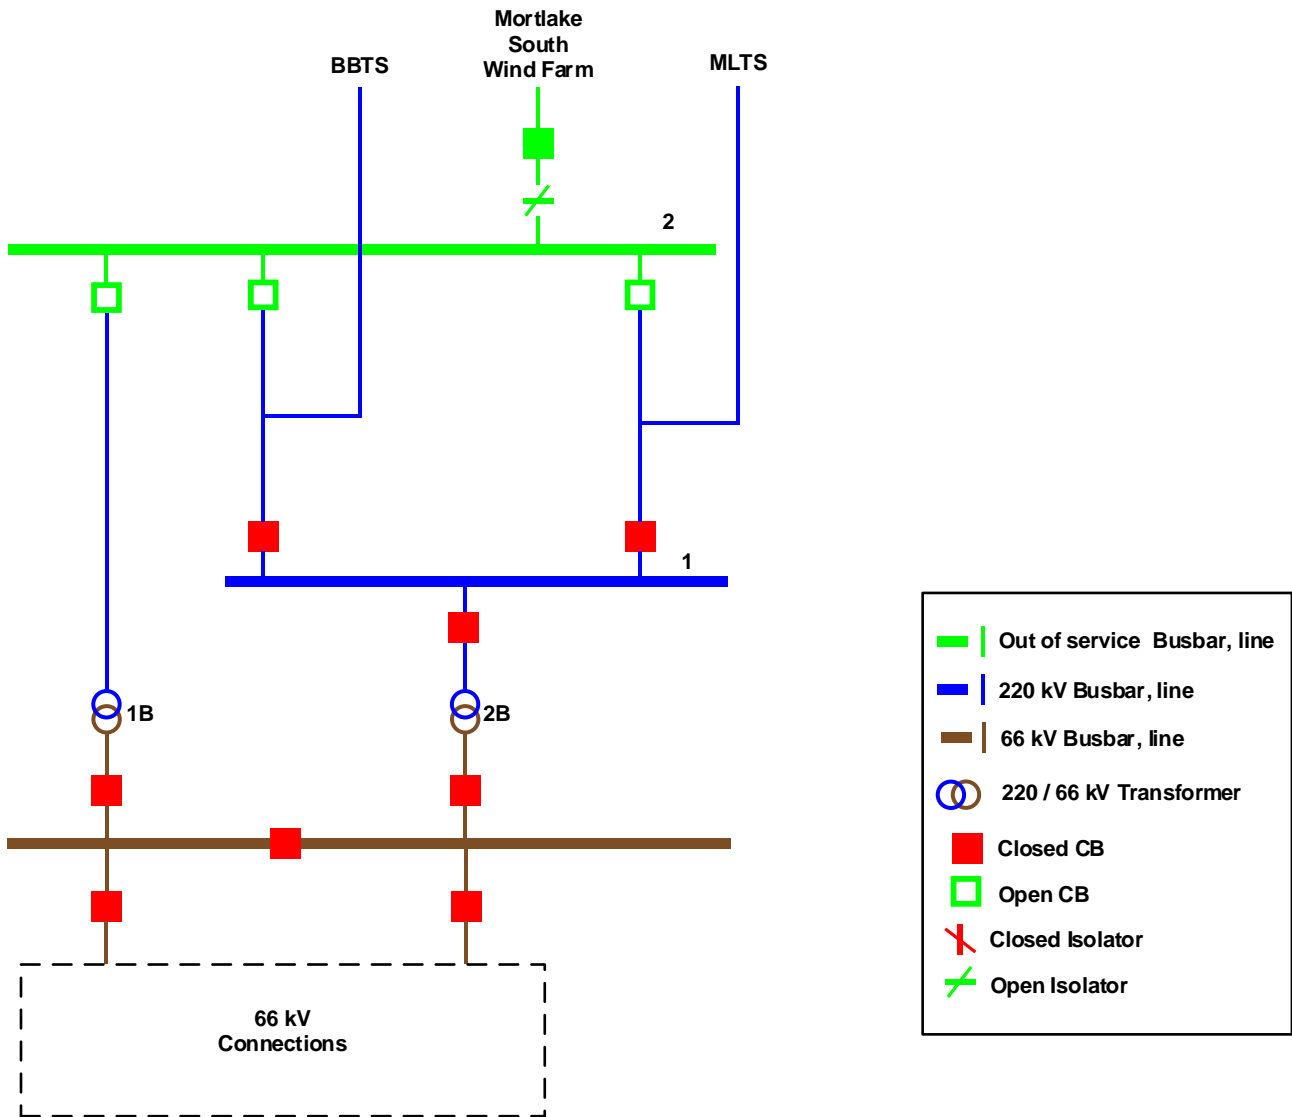
Figure 2 Post-incident diagram – Terang Terminal Station

Incident key events	<ol style="list-style-type: none"> At 1355 hrs on 10 May 2022, during testing of the MSWF GFT circuit breaker fail (CBF) protection, the TGTS No. 2 220 kV busbar unexpectedly tripped (see Figure 2). At 1418 hrs on 10 May 2022, the TGTS No. 2 220 kV busbar was returned to service.
Incident cause	<p>Post incident investigation by AusNet has confirmed:</p> <ul style="list-style-type: none"> The MSWF Line X protection relay is designed to issue a CBF trip signal (after a timed delay) to the TGTS No. 2 220 kV bus protection to trip the TGTS No. 2 220 kV busbar if it receives both “differential communications fail”, and “CB closed” status signals. Isolations implemented to allow the planned SCADA alarm testing were insufficient. Because of this, a simulated “CB closed” status was sent to the MSWF Line X protection relay during testing of the SCADA points. The MSWF Line X protection relay was in service at TGTS but the MSWF line itself had not been commissioned at the time of the incident. Therefore, the MSWF protection relay had a status of “differential communications fail”. This, in combination with the simulated “CB closed” status from the CBM relay, caused the MSWF Line X protection relay to issue a CBF trip signal to the TGTS No. 2 220 kV bus protection to trip the busbar. The root cause of the incident has been identified as human error – the testing team did not isolate the “CB closed” status output from the CBM relay to the protection relay to avoid sending a CBF trip signal to the TGTS No. 2 220 kV bus protection relay.

Conclusions	AEMO has concluded that: <ol style="list-style-type: none"> 1. During the testing of SCADA alarms, the MSWF Line X protection relay sent a CBF trip signal to the TGTS No. 2 220 kV bus protection to trip the busbar. 2. Based on information provided by AusNet at the time of the incident, AEMO was satisfied that the reason had been identified and a reoccurrence of this incident was unlikely, therefore the incident was correctly not reclassified as a credible contingency. 3. The power system remained in a secure operating state throughout this incident. 4. The root cause of the incident has been identified as human error – the testing team did not isolate the “CB closed” status output from the CBM relay to avoid it sending a simulated “CB closed” status signal to the line protection relay. 5. Following the event, AusNet isolated the MSWF CBF trip signal to the No. 2 220 kV bus protection to prevent further trips until the MSWF line is commissioned.

Details	
Rectification	The MSWF CBF trip signal to the No. 2 220 kV bus protection was isolated to prevent further inadvertent trips before the MSWF line is fully commissioned.
Power system security	The power system remained in a secure operating state throughout this incident and the Frequency Operating Standard ⁵ was met.
Reclassification	AEMO assessed whether to reclassify this incident as a credible contingency event ⁶ . The cause of this incident was identified and rectified by AusNet prior to returning the busbar to service and AEMO was satisfied that another occurrence of this event was unlikely under the current circumstances. Therefore, AEMO correctly identified that reclassification was not required.
Market information	AEMO issued Market Notice 96237 at 1440 hrs on 10 May 2022 (approximately 45 minutes after the incident) – advice of the non-credible contingency event (this market notice was issued in accordance with NER requirements).

Recommendations	<ol style="list-style-type: none"> 1. AEMO recommends that network service providers (NSPs) review working practices and procedures to ensure they include a cross check of all available sources to identify the sources of tripping (for example, site drawings, databases, and as built diagrams) prior to commencing work and performing necessary isolations. 2. AEMO plans to share the findings from this event (and other similar events involving human error) at the Power System Security Working Group by Q1 2023.
