# Trip of Uralla 330 kV B Bus and 330 kV CB 5012 on 4 September 2022

February 2023

Reviewable Operating Incident  
Report under the National  
Electricity Rules

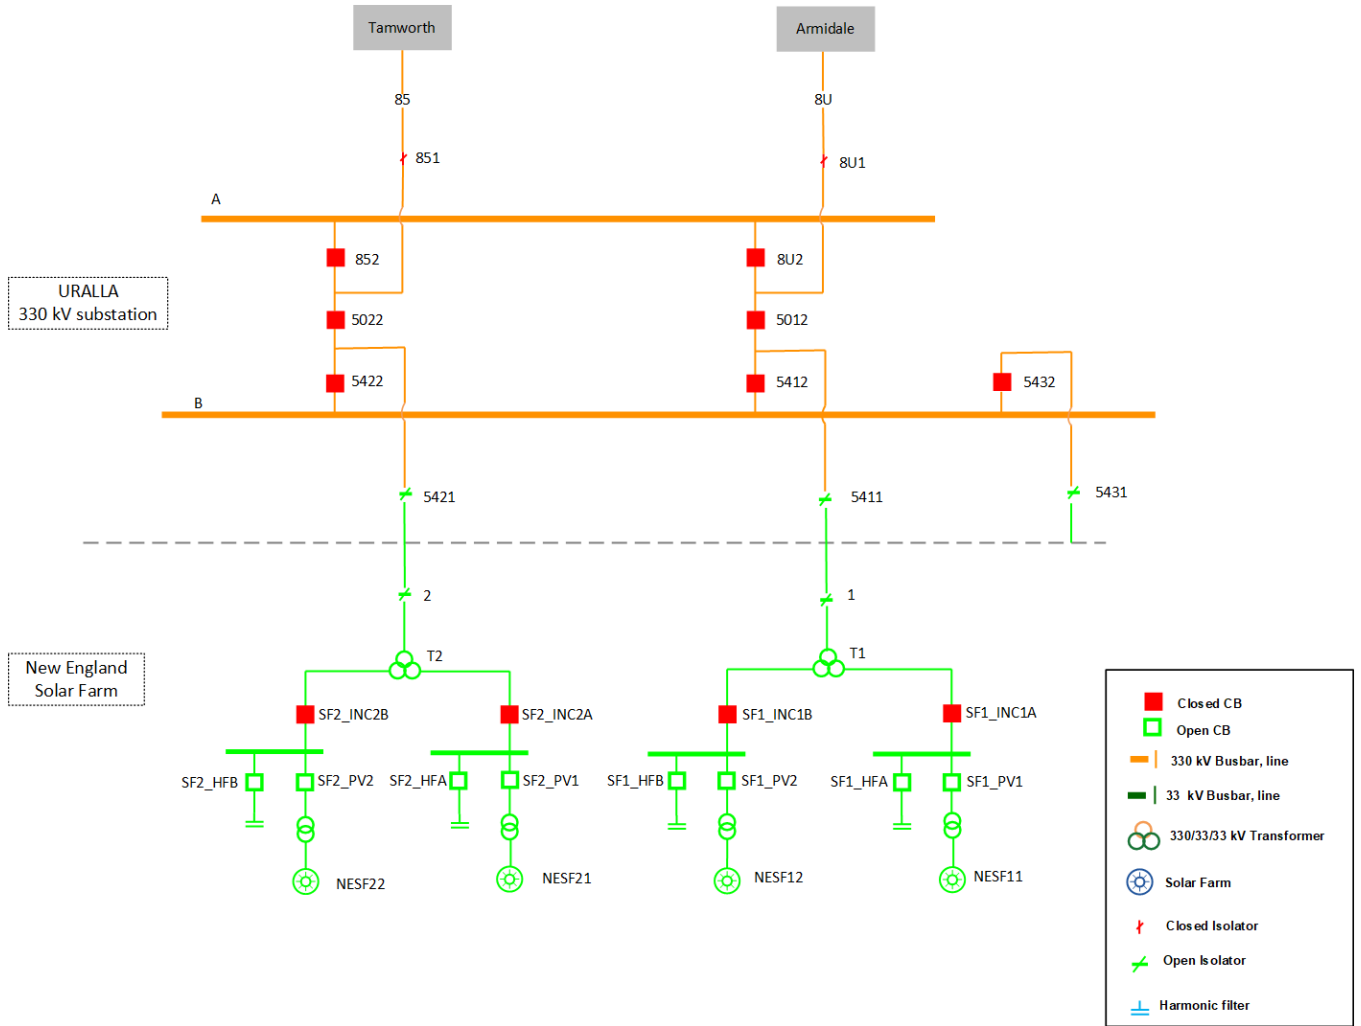
Figure 1 Pre-incident diagram

Details	
<b>Reviewable operating incident type</b>	Non-credible contingency event impacting critical transmission elements.
<b>Incident details</b>	This report relates to a reviewable operating incident <sup>3</sup> that occurred on 4 September 2022 in New South Wales. The incident involved the trip of the Uralla 330 kilovolts (kV) B busbar and Uralla 330 kV circuit breaker (CB) 5012.
<b>Incident classification</b>	Other causes – human error – insufficient isolations on the New England Solar farm (NESF) protection panel.
<b>Generation impact</b>	Nil
<b>Customer load impact</b>	Nil
<b>Pre-incident conditions</b>	Immediately prior to the event, NESF staff were working on the protection panel at the NESF switching station. The work included confirmation of intertrip protection system between Transgrid and NESF. Isolators 5421 and 5411 were open and NESF was out of service prior to the event, as shown in Figure 1 (NESF's rated capacity is 400 megawatts [MW]).

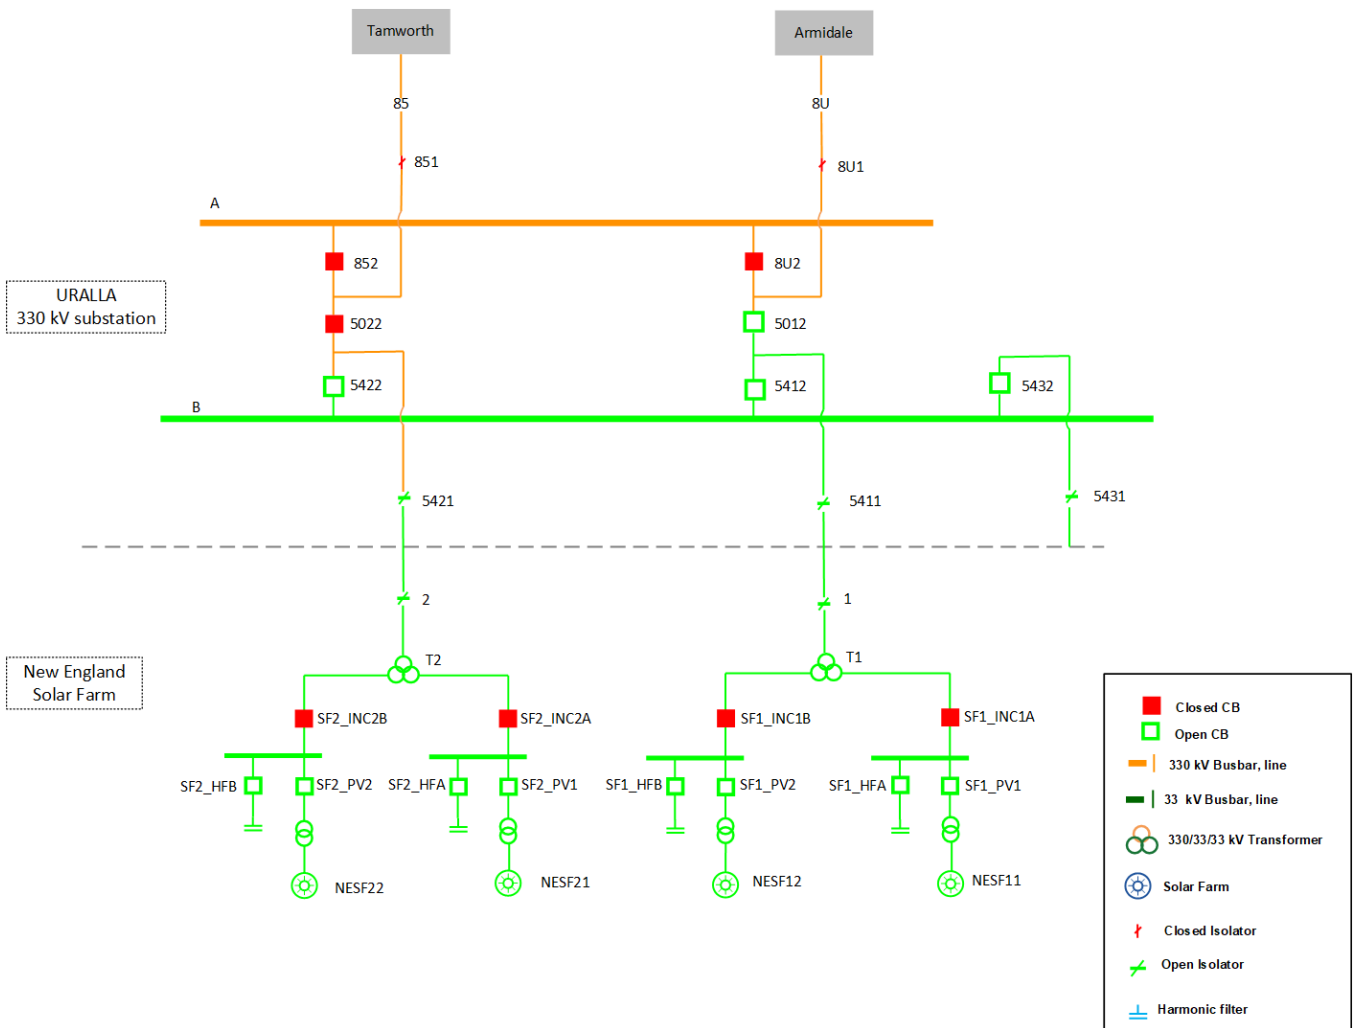
Figure 2 Post-incident diagram

<b>Incident key events</b>	<ol style="list-style-type: none"> <li>At 1454 hrs on 4 September 2022, the Uralla 330 kV B busbar and Uralla 330 kV CB 5012 tripped, as shown in Figure 2.</li> <li>At 1701 hrs on 4 September 2022, the Uralla 330 kV B busbar and CB 5012 were restored.</li> </ol>
<b>Incident cause</b>	<p>Post-incident investigation by Transgrid and NESF has confirmed:</p> <ul style="list-style-type: none"> <li>NESF technical staff were on site at NESF undertaking work on the solar farm's protection panel with the Uralla 330 kV Bus and Uralla 330 kV CB 5012 in service.</li> <li>While staff were working on the NESF protection system, a trip signal was inadvertently sent, tripping the Uralla 330 kV B busbar and 330 kV CB 5012.</li> <li>The root cause of the incident has been identified as human error. The NESF staff had not sufficiently isolated the NESF protection panel for their works and this allowed a trip signal from NESF to trip in-service equipment at Uralla 330 kV substation.</li> </ul>

<b>Power system response (facilities and services)</b>	There were no other material impacts on the broader power system, load, or generation.
<b>Rectification</b>	<p>Following the trip of the Uralla 330 kV B busbar and 330 kV CB, NESF has confirmed that:</p> <ul style="list-style-type: none"> <li>After the incident occurred, a standard isolation procedure was put into effect at the NESF substation, with Transgrid being informed of works on site throughout the process.</li> </ul> <p>Transgrid has confirmed that:</p> <ul style="list-style-type: none"> <li>The protection isolations implemented by Transgrid staff at the Uralla 330 kV substation were also insufficient.</li> <li>Transgrid has amended its procedures to ensure that there are additional isolations in place to reduce risk of inadvertent trips during future protection works.</li> </ul>
<b>Power system security</b>	The power system remained in a secure operating state throughout this incident and the Frequency Operating Standard was met for this incident.
