Trip of Belmont 275 kV No. 2 Busbar on 16 May 2023

September 2023

Reviewable Operating Incident
Report under the National
Electricity Rules

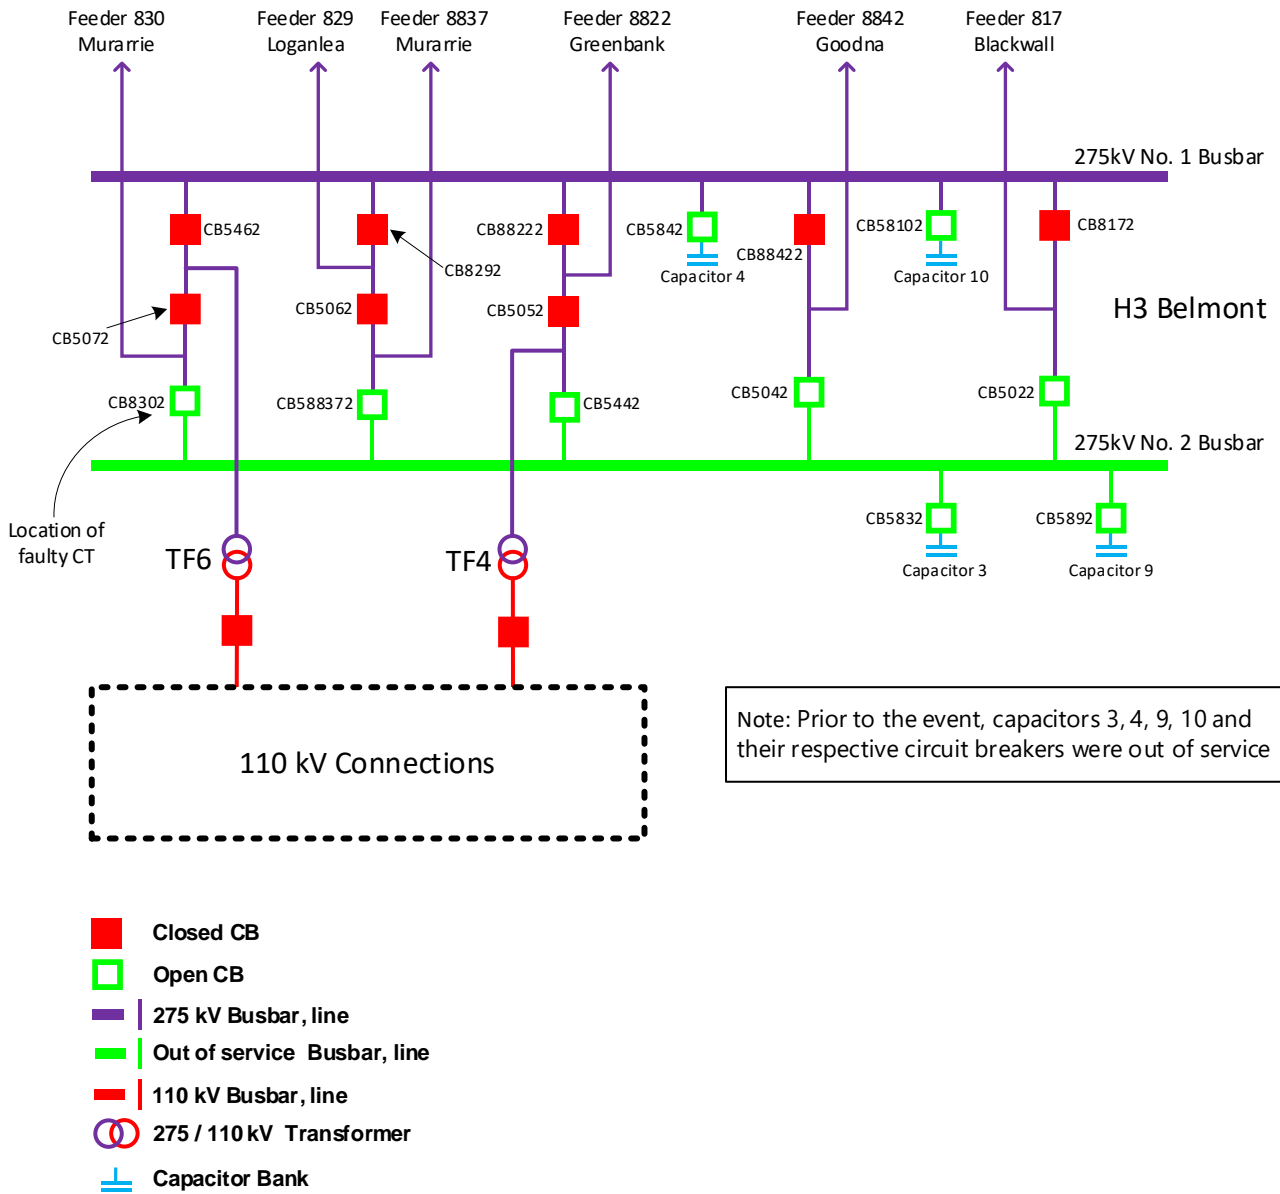
Incident cause	<p>Post incident investigation by Powerlink has confirmed that:</p> <ol style="list-style-type: none"> At 1852 hrs on 16 May 2023, the X busbar protection system of the Belmont 275 kV No. 2 busbar operated due to spill current (also known as differential current) supplied from the C phase CT associated with CB 8302. The C phase CT secondary core associated with CB 8302 had failed due to low insulation resistance. This resulted in spill current in the busbar unit protection of the Belmont 275 kV No. 2 busbar, causing the X busbar protection system to operate. The protection system operated in line with its settings and tripped the 275 kV CBs associated with the Belmont 275 kV No. 2 busbar.
Power system response (facilities and services)	There was no other material impact on the broader power system, load or generation.
Rectification	<p>On 16 May 2023, Powerlink identified the cause of Belmont busbar protection operation as a secondary system issue associated with CB 8302, after conducting a visual inspection of equipment at Belmont 275 kV substation and reviewing relevant relay records.</p> <p>On 26 May 2023, Powerlink informed AEMO that the faulty CT associated with CB 8302 had been replaced and returned CB 8302 to service.</p> <p>On 21 June 2023, Powerlink confirmed to AEMO that the trip of the Belmont 275 kV No. 2 busbar was due to low insulation resistance of the C phase CT secondary core associated with CB 8302.</p>

Figure 1 Incident diagram – Belmont substation equipment status immediately following the incident

Conclusions	AEMO has concluded that: <ol style="list-style-type: none"> 1. On 16 May 2023, the Belmont 275 kV No. 2 busbar tripped due to the operation of its X busbar protection system. The busbar protection operated due to low insulation resistance on a C phase CT secondary core associated with CB 8302. This resulted in spill current in the unit protection of the Belmont 275 kV No. 2 busbar. This caused the busbar zone protection (unit protection) to operate, tripping the Belmont 275 kV No. 2 busbar. 2. The cause of this incident was identified by Powerlink and AEMO was satisfied that the event was unlikely to reoccur under the current circumstances. Therefore, AEMO correctly identified that reclassification was not required. 3. The power system remained in a secure operating state and the Frequency Operating Standard was met throughout this incident. 4. The root cause of the incident has been identified as a transmission equipment failure. 5. Powerlink replaced the CT associated with CB 8302 and restored the CB into service on 26 May 2023.
