# Trip of Mount Beauty Terminal Station 220 kV No. 2 busbar on 3 November 2023

April 2024

Reviewable Operating Incident  
Report under the National  
Electricity Rules

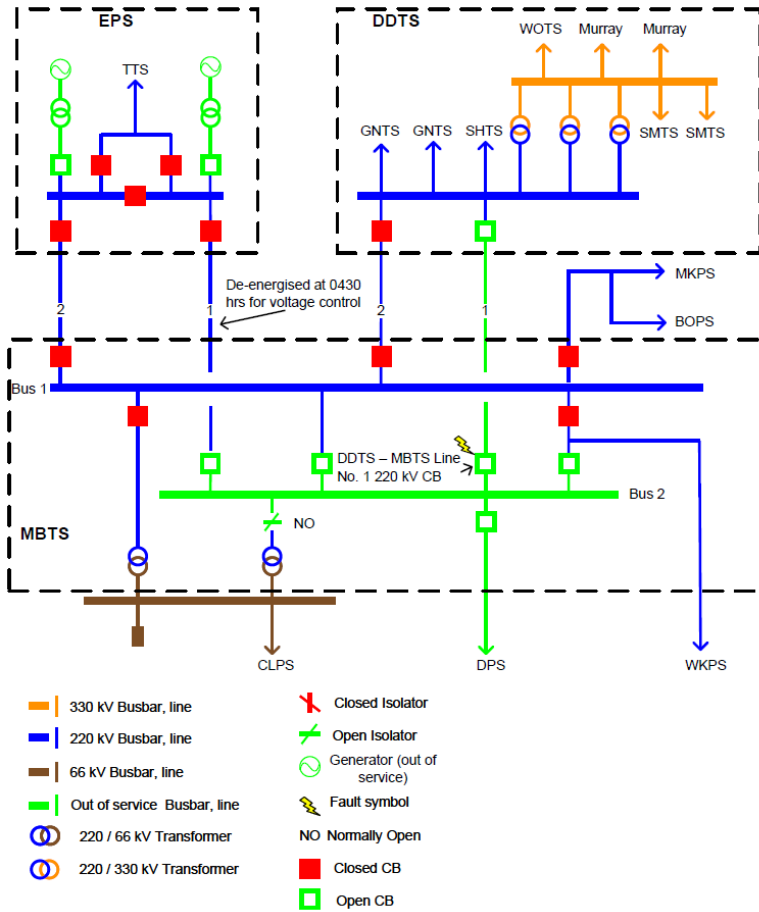
**Figure 1 Post-incident diagram**

<b>Incident key events</b>	<ol style="list-style-type: none"> <li>At 0412.40 hrs on 3 November 2023, the DDTS – MBTS 220 kV No. 1 line tripped.</li> <li>Two seconds later at 0412.42 hrs on 3 November 2023, the DDTS – MBTS 220 kV No. 1 line auto-reclosed.</li> <li>A further seven seconds later at 0412.49 hrs on 3 November 2023: <ul style="list-style-type: none"> <li>The DDTS – MBTS 220 kV No. 1 line tripped and did not auto reclose.</li> <li>The MBTS 220 kV No. 2 busbar tripped (see Figure 1). This offloaded the Eildon Power Station (EPS) – MBTS 220 kV No. 1 line at the MBTS end.</li> </ul> </li> <li>At 0427 hrs on 3 November 2023, AEMO requested AusNet Services de-energise the EPS – MBTS 220 kV No. 1 line (which was already open at the MBTS end) for voltage control.</li> <li>At 0430 hrs on 3 November 2023, AusNet Services deenergised the EPS – MBTS 220 kV No. 1 line by opening the line at the EPS end.</li> <li>At 0840 hrs on 3 November 2023, the MBTS 220 kV No. 2 busbar and the EPS – MBTS 220 kV No. 1 line returned to service.</li> <li>At 1622 hrs on 13 November 2023, the DDTS – MBTS 220 kV No. 1 line and DDTS – MBTS Line No. 1 220 kV CB returned to service.</li> </ol>

<b>Incident cause</b>	<p>AusNet Services’ post-incident investigation confirmed that:</p> <ul style="list-style-type: none"> <li>The initial trip at approximately 0412.40 hrs was caused by a white phase-earth fault located on the DDTS – MBTS 220 kV No. 1 line, approximately 11.5 kilometres (km) from DDTS. Later that day, AusNet Services conducted a post-incident line patrol and was not able to identify a root cause for this initial fault.</li> <li>The DDTS – MBTS 220 kV No. 1 line completed an auto-reclosure at 0412.42 hrs. A second trip occurred at approximately 0412.49 hrs and was also caused by a white phase-earth fault, caused by an internal flashover within the MBTS DDTS No. 1 line 220 kV CB. All CBs connected to the MBTS 220 kV No. 2 busbar and the DDTS – MBTS 220 kV No. 1 line tripped. As the reclaim timer of 25 seconds (s) from the initial trip had not expired, there was no subsequent auto-reclosure attempt of the DDTS – MBTS 220 kV No. 1 line. As per AusNet’s busbar protection design philosophy, the MBTS 220 kV No. 2 busbar protection also did not attempt to auto-reclose.</li> <li>All protection referred to in this section operated as expected.</li> </ul>

Details	
<b>Power system response (facilities and services)</b>	There was no other material impact on the broader power system, load, or generation.
<b>Rectification</b>	The MBTS DDTs No. 1 line 220 kV CB was isolated until AusNet Services replaced the CB on 13 November 2023. AusNet Services is continuing to investigate the root cause of the CB's failure and plans to share any key findings with AEMO and where relevant the Power System Security Working Group (PSSWG).
<b>Power system security</b>	<p>Following the contingency at 0412.49 hrs on 3 November 2023, AEMO's energy management system (EMS) showed alarms that a trip of the EPS – Thomastown Terminal Station (TTS) 220 kV line would cause a subsequent overvoltage of 1.12 per unit, which is above the limit at MBTS. To maintain the power system security, at 0428 hrs, AEMO requested AusNet Services de-energise the EPS – MBTS No. 1 220 kV line to manage the post-contingent voltage at MBTS. AusNet de-energised the EPS – MBTS No. 1 220 kV line at 0430 hrs.</p> <p>During this incident AEMO invoked the following constraint sets:</p> <ul style="list-style-type: none"> <li>• V-EPMB and V-MB_BUS2 between 0425 hrs and 0905 hrs on 3 November 2023 to manage the MBTS 220 kV No. 2 busbar outage.</li> <li>• V-DDMB between 0425 hrs on 3 November 2023 and 1630 hrs on 13 November 2023 to manage the outage of DDTs – MBTS 220 kV No. 1 line.</li> </ul> <p>AEMO and AusNet appropriately responded to address the power system security issue and returned the power system to a secure operating state within 30 minutes<sup>4</sup>. The power system was in a satisfactory operating state from the commencement of the event at 0412 hrs until 0430 hrs, when the power system was returned to a secure operating state. The Frequency Operating Standard (FOS) was met for this incident<sup>5</sup>.</p>
