# Trip of South East No. 1 and No. 2 SVC on 23 March 2023

August 2023

Reviewable Operating Incident  
Report under the National  
Electricity Rules

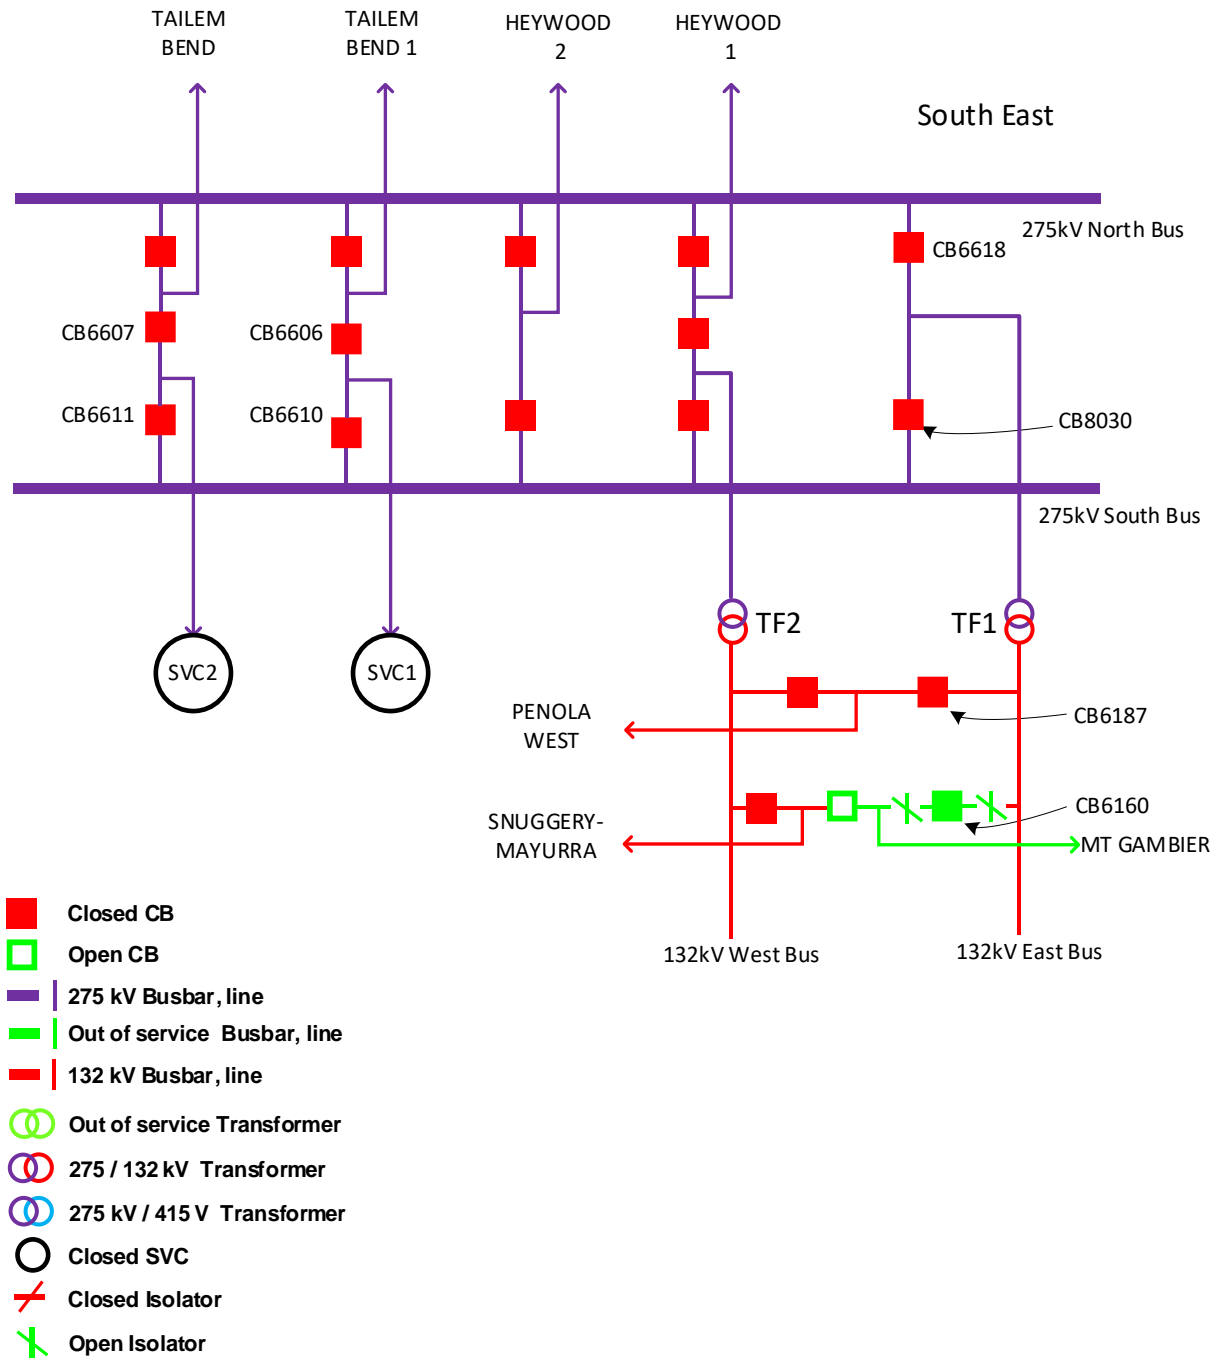
Figure 1 Incident diagram – Network representation immediately prior to the incident

<b>Pre-incident conditions</b>	<ul style="list-style-type: none"> <li>Prior to this event, ElectraNet's maintenance service provider (MSP) staff were onsite at South East substation carrying out planned switching to isolate South East TF1. Circuit breaker (CB) 6187 and CB 8030 had already been opened as part of this switching process, leaving TF1 connected to the power system via CB 6618.</li> <li>ElectraNet believed that the South East 275 kV SVC No. 1 and No. 2 supply 1 was supplied from auxiliary supply of TF4 and SVC No. 1 and No. 2 supply 2 was supplied from the main AC changeover board fed from auxiliary supply of TF1/TF2 (see blue arrow in Figure 3). However, at this time, South East 275 kV SVC No. 1 and No. 2 supply 1 and supply 2 were being sourced from the auxiliary supply of TF1. Unexpectedly, the TF4 415 V source was not supplying SVC No. 1 and No. 2 supply 1.</li> <li>Additionally, the South East – Mt Gambier 132 kV transmission line was out of service (see Figure 1).</li> </ul>

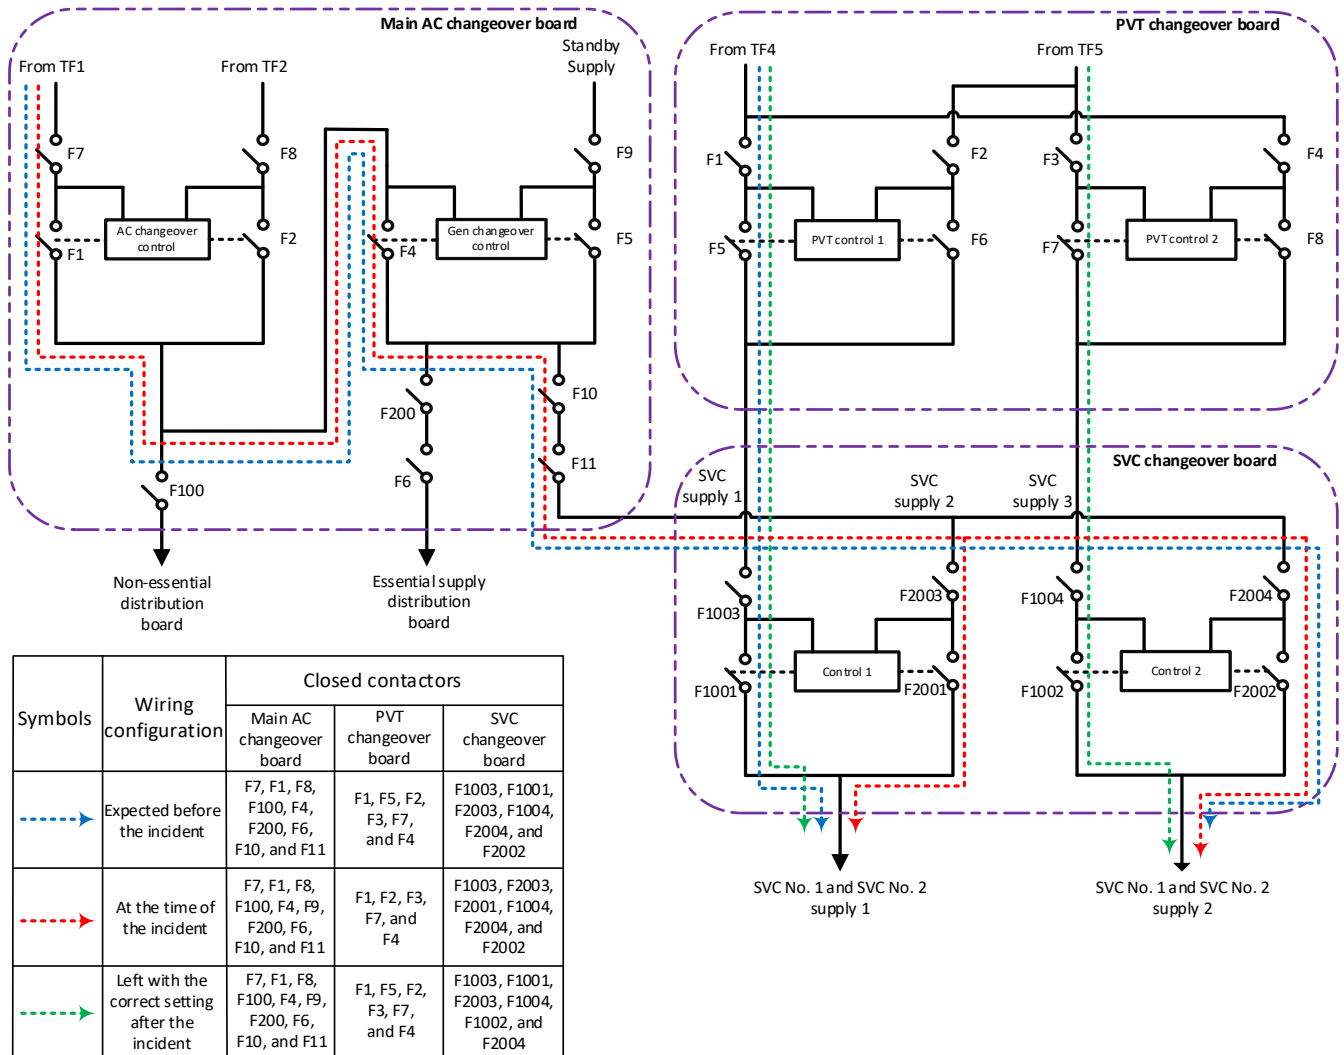
Figure 3 South East AC changeover system

<b>Conclusions</b>	<p>AEMO has concluded that:</p> <ul style="list-style-type: none"> <li>• South East 275 kV SVC No. 1 and No. 2 tripped as a result of AC changeover boards being left in an incorrect configuration (see red arrow in Figure 3), resulting in supplies to the cooling system of South East 275 kV SVC No. 1 and No. 2 being derived from TF1. Auto changeover contactor F5 on PVT changeover board was not able to close as it was set to manual mode instead of auto mode. The cooling system trip protection operated in line with its settings and tripped the 275 kV CBs associated with the South East 275 kV SVC No 1 and No. 2.</li> <li>• ElectraNet has confirmed that the auto changeover contactors in changeover boards have been reconfigured (see green arrow in Figure 3) and has advised its control room of this arrangement. All auto changeover contactors in changeover boards have been checked and set to auto mode. The auto changeover contactors in changeover boards have been left in a configuration that will not be affected by TF1 or TF2 outages.</li> <li>• AEMO correctly identified the need to reclassify this incident as a credible contingency, as at the time of the incident the cause was unknown. Subsequently ElectraNet identified the incident cause and determined the incident was unlikely to reoccur. AEMO correctly cancelled the reclassification.</li> <li>• The power system remained in a secure operating state and the Frequency Operating Standard was met during the incident.</li> </ul>

<b>Recommendations</b>	<ul style="list-style-type: none"> <li>• ElectraNet to complete full testing of the SVC LV supplies system including a review of scheme alarms and ensure that scheme system instructions are available to site operators.</li> <li>• ElectraNet to implement clear field signage for operators to correctly configure the changeover boards including checking of the AC changeover board configuration when isolating South East transformers.</li> <li>• ElectraNet to update the standard switching instructions for transformers at South East to ensure the status of the SVC LV supplies is checked prior to any high voltage (HV) switching steps.</li> <li>• AEMO and ElectraNet to share findings of this event with the Power System Security Working Group (PSSWG) by Q4 2023.</li> </ul>
