PRELIMINARY REPORT – BLACK SYSTEM EVENT IN SOUTH AUSTRALIA ON 28 SEPTEMBER 2016

A PRELIMINARY OPERATING INCIDENT REPORT FOR THE
NATIONAL ELECTRICITY MARKET – INFORMATION AS AT
9.00 AM, MONDAY 3 OCTOBER 2016

Published: 5 October 2016

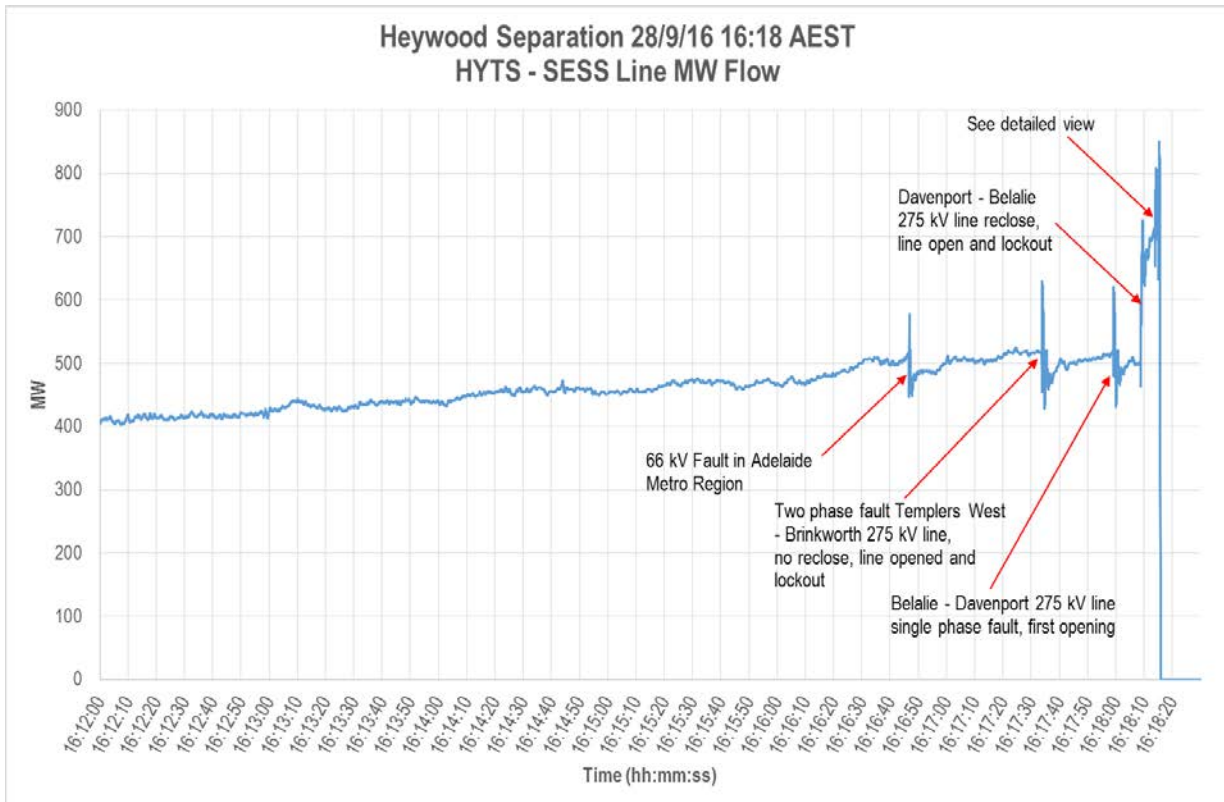
Figure 2 Heywood separation pre-event and event

The reduction in generation during the event, combined with oscillations caused by faults on the transmission network, caused the flow on the Heywood interconnector⁵ to increase to approximately 850 – 900 MW by 16:18:15. Flows between 850 – 900 MW are in excess of the design limits of the interconnector.

Protection settings are in place to avoid damage to network and generation infrastructure in the event of system faults. These settings mean that equipment will open automatically to avoid system damage. At 16:18:15.8, in response to the high power flows on the Heywood interconnector, the protection at South East substation operated to open the Heywood interconnector.

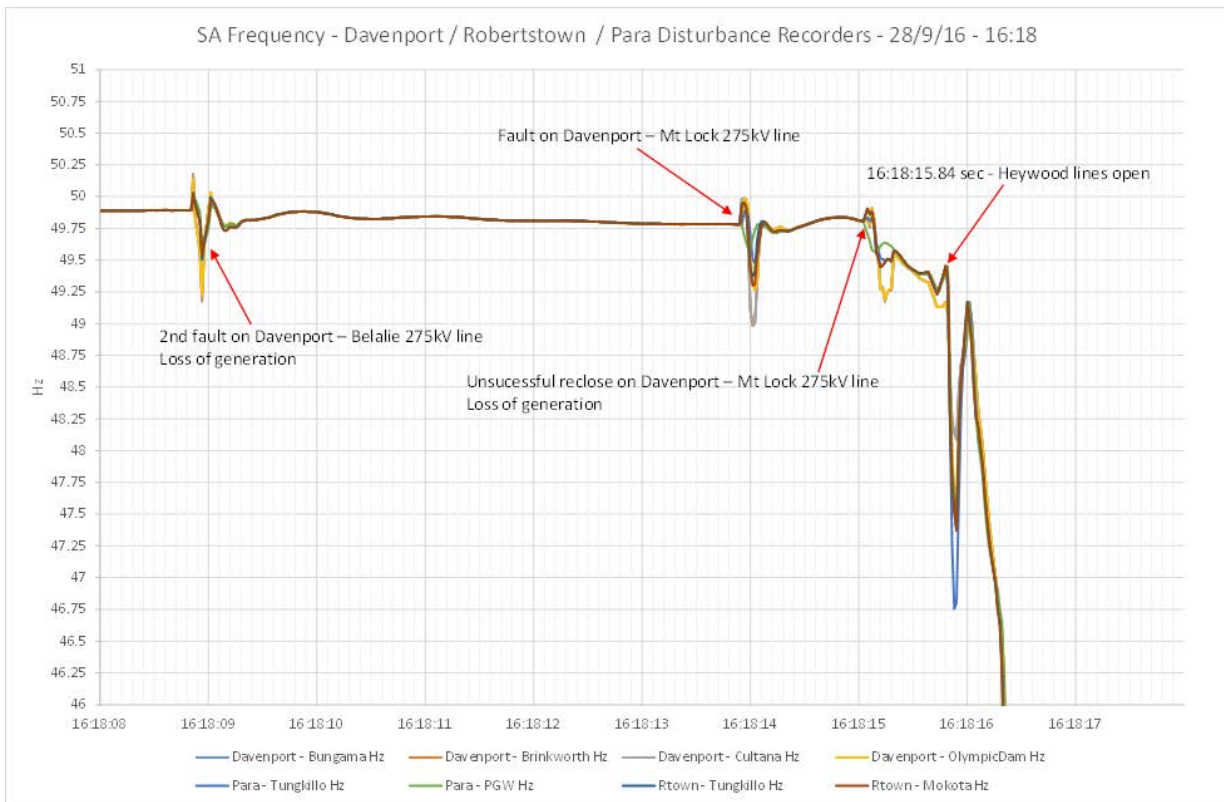
Figure 4 SA frequency during the event

In this event, the 850–900 MW disturbance resulted in a RoCoF that was greater than all design limits of equipment on the system and above the design limits of the UFLS scheme.

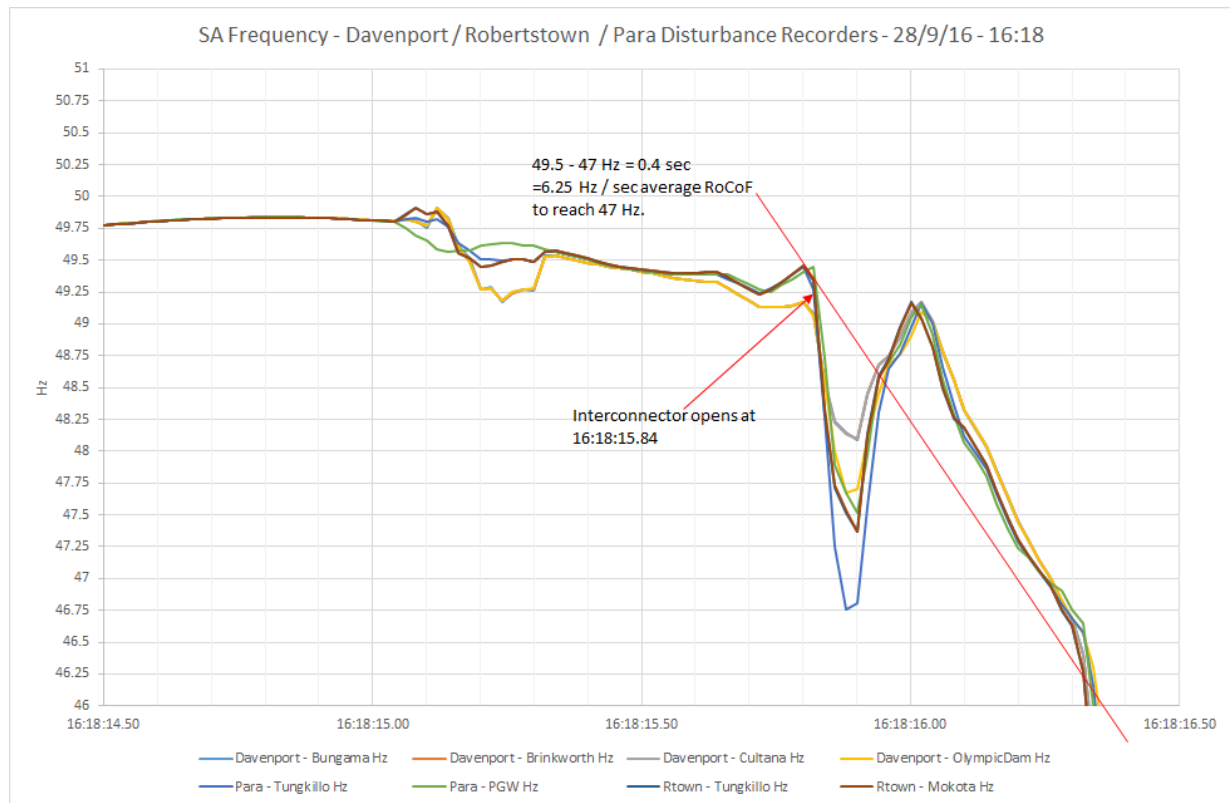
Figure 5 Frequency response and RoCoF during pre-event and event

Generator performance standards after 2007 require generating units to remain on line for a Rate of Change of Frequency (RoCoF) of 1 Hz/second for 1 second as a minimum, and up to 4 Hz/second for 0.25 seconds. RoCoF must be maintained within this limit to prevent damage to generating units and effective operation of protection relays and emergency control schemes such as the automatic Under Frequency Load Shedding (UFLS) scheme.

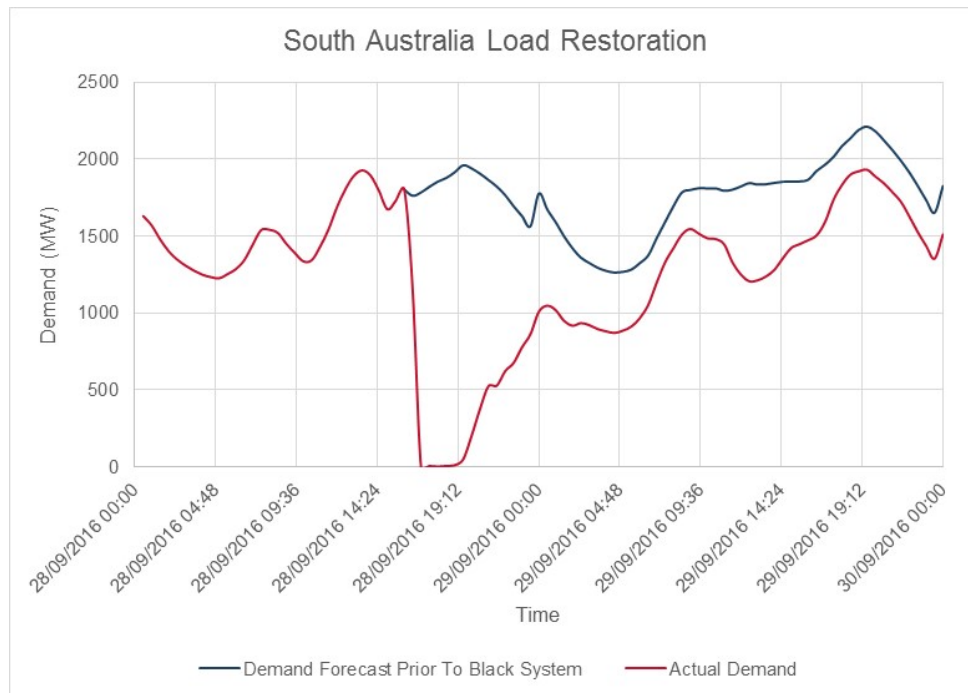
Figure 6 Comparison of forecast and actual load

The figure below illustrates the restoration of consumer load following the SA region Black System as a comparison between the forecast load for SA and the load actually supplied.
