# MULTIPLE CONTINGENCY EVENT FOLLOWING AN EARTHQUAKE IN VICTORIA ON 19 JUNE 2012

PREPARED BY: Systems Capability

DATE: 3 December 2012

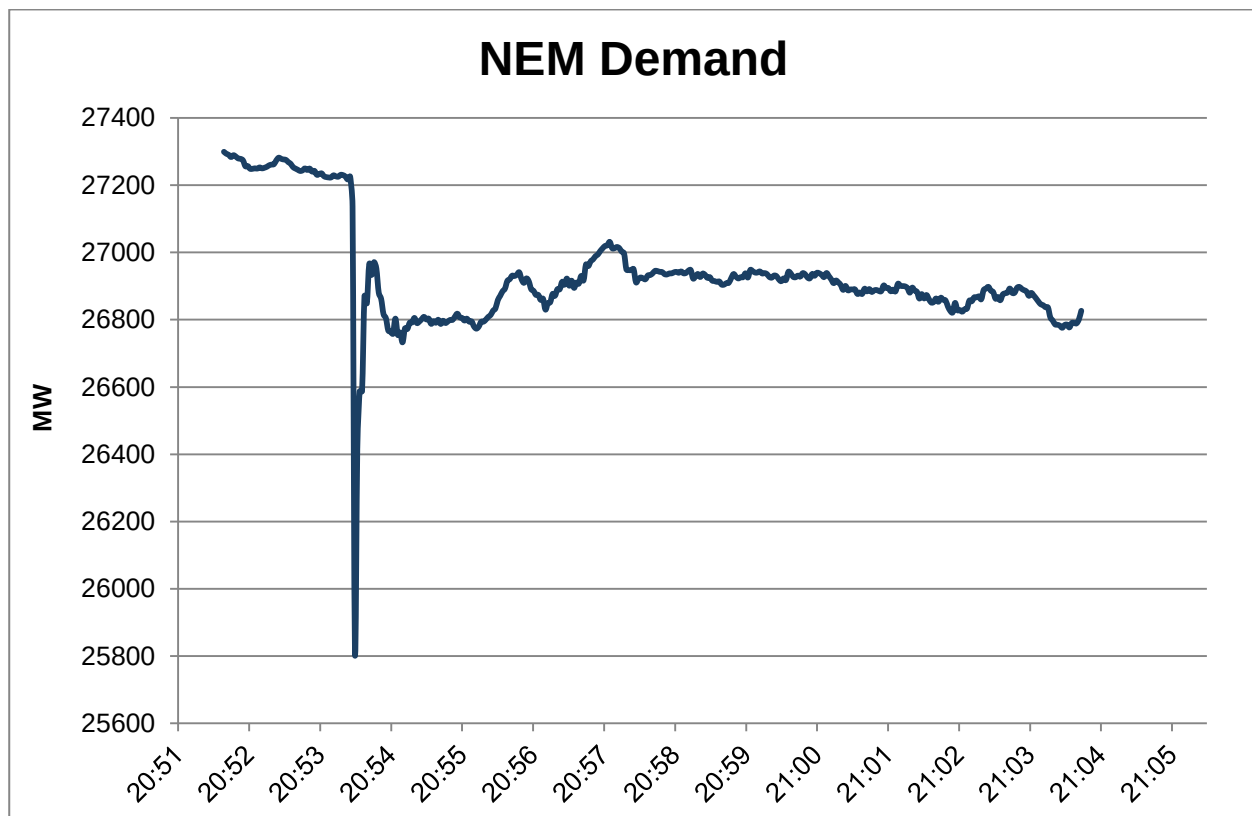
Figure 2 NEM demand profile during the incident

Figure 2 below shows the NEM demand before and after the earthquake occurred.
