MULTIPLE CONTINGENCY EVENT FOLLOWING AN EARTHQUAKE IN VICTORIA ON 19 JUNE 2012

PREPARED BY: Systems Capability

DATE: 15 January 2013

FINAL (Version 3)

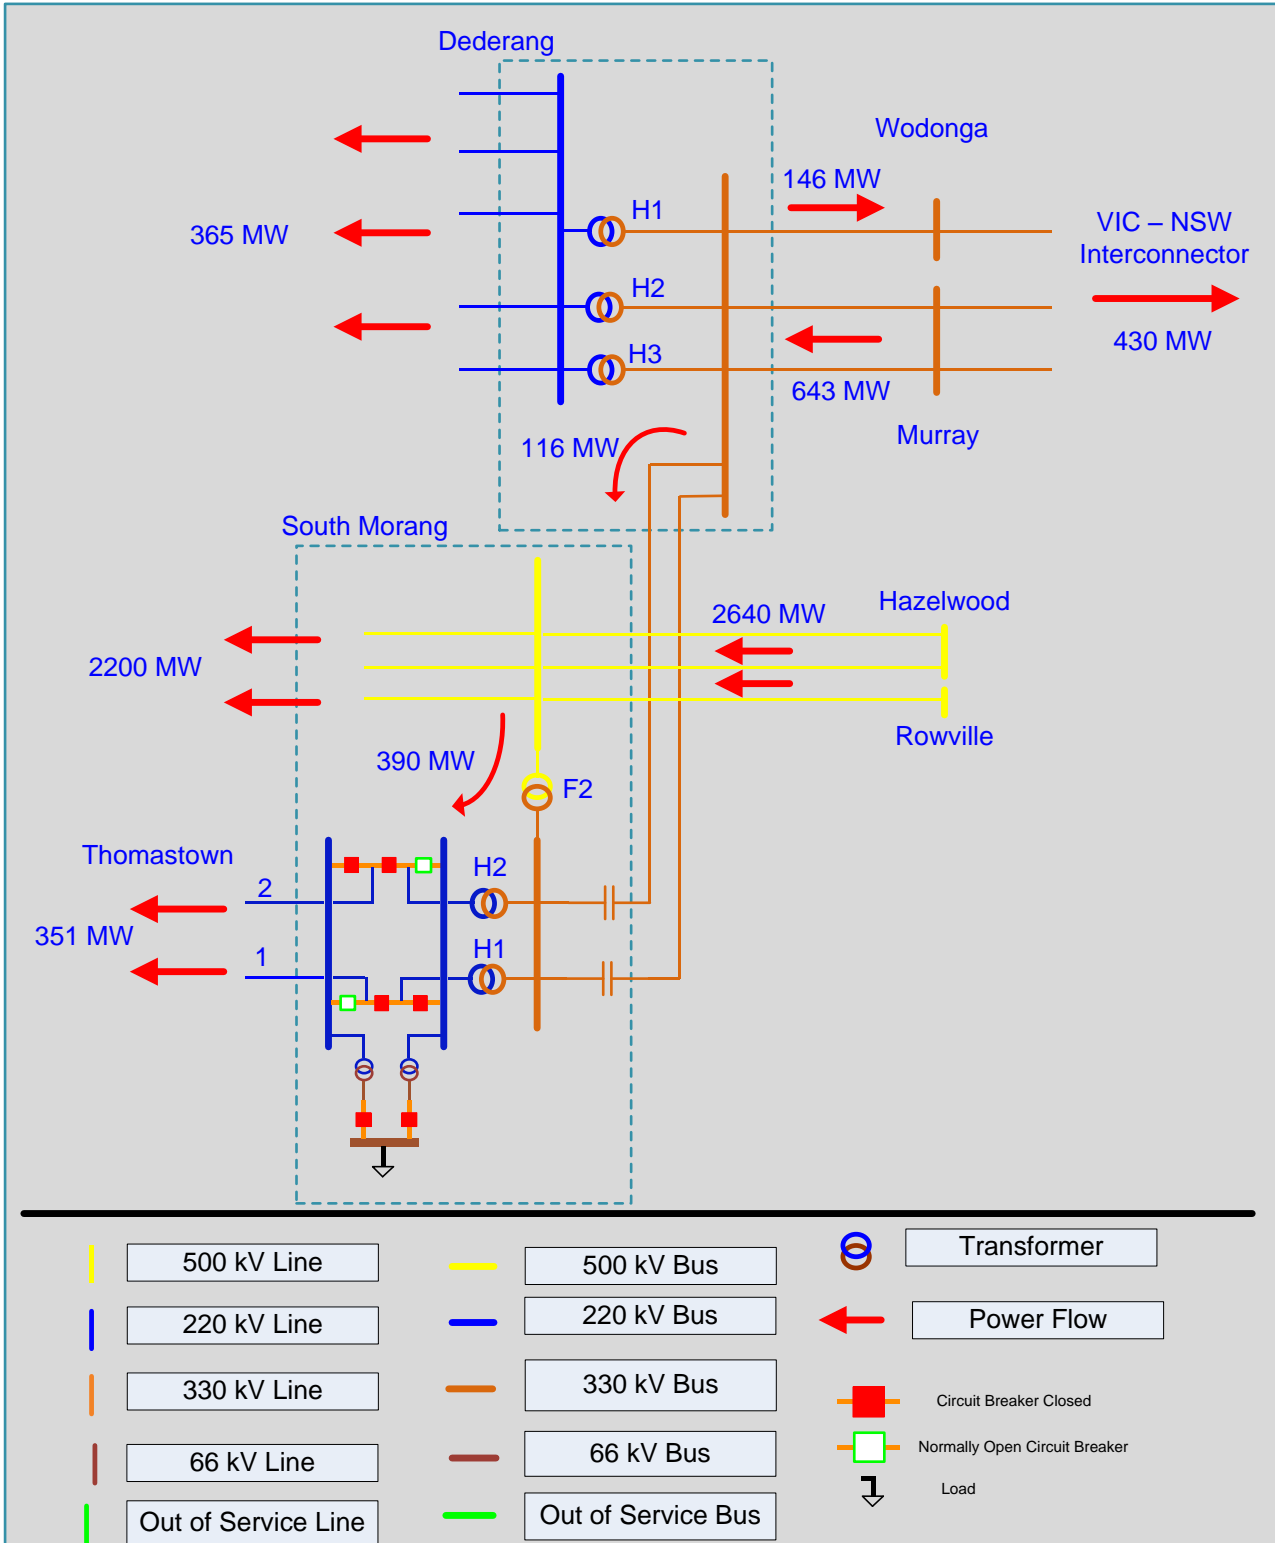
Figure 3 Pre event system conditions

The status of the power system prior to the incident is shown in Figure 3. For clarity, only equipment relevant to this incident has been included in the diagram.

The South Morang H1 and H2 transformers tripped at 2054 hrs on Buchholz relay operation. Due to the switching arrangement at the South Morang station, the No.1 South Morang – Thomastown 220 kV transmission line also de-loaded with the H1 transformer. Figure 4 shows the state of the network following the event.

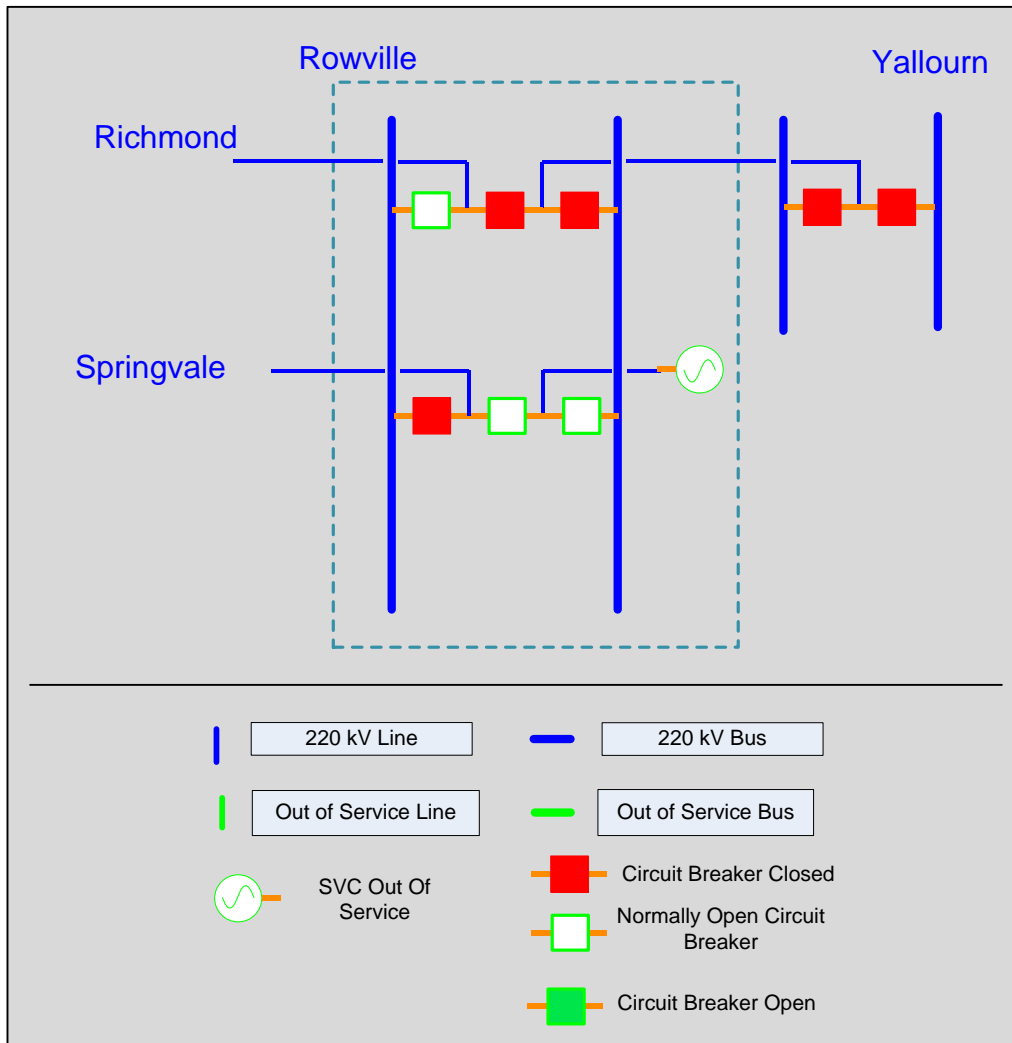
Figure 5 Pre-event system conditions

The status of the power system at Rowville station prior to the incident is show in Figure 5. For clarity, only equipment relevant to this incident has been included in the diagram.

At 2118 hrs, approximately 25 minutes after the earthquake, the No.5 Rowville – Yallourn 220 kV transmission line tripped on X and Y protection at both ends of the transmission line. The line auto reclosed at the Rowville end as a result of the Single End Auto Reclose (SEAR) function at Rowville. Due to the switching configuration at Rowville terminal station, the No.4 Rowville - Richmond 220 kV transmission line was also unloaded. The state of the power system following the incident is shown in Figure 6.
