Trip of the Wodonga Terminal Station No. 1 and No. 2 330 kV transformers on 3 May 2021

Reviewable Operating Incident Report under the
National Electricity Rules

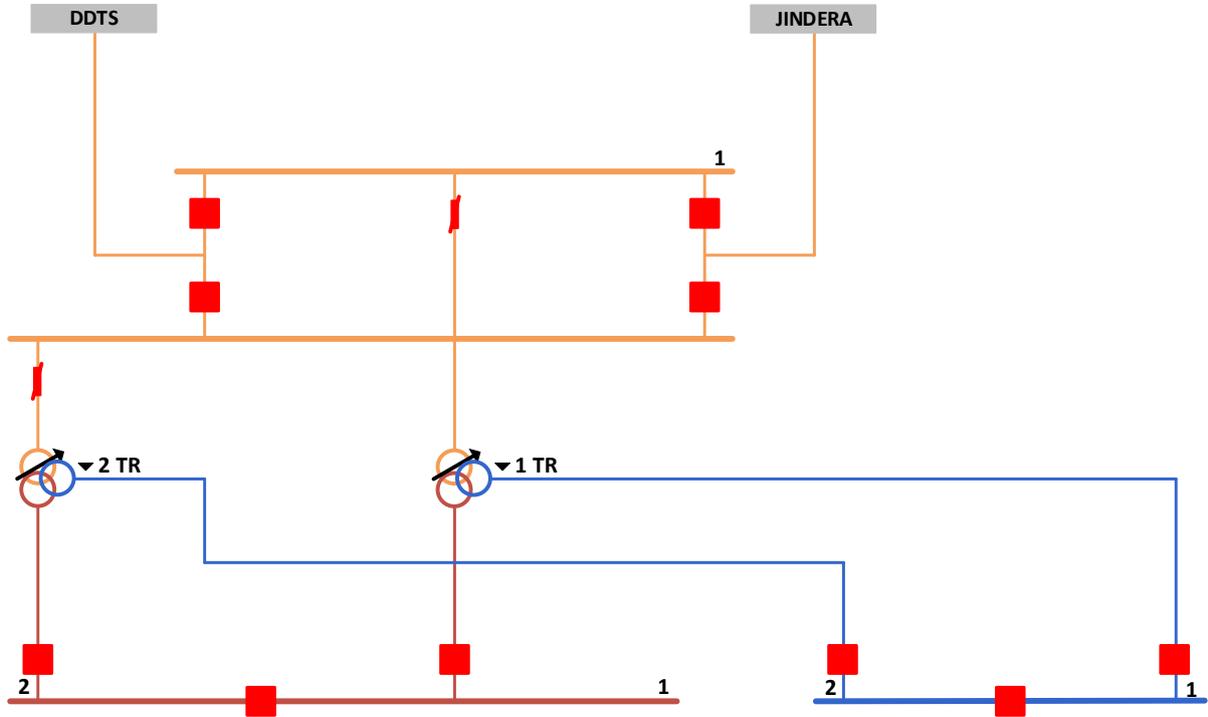
Figure 1 Substation topology at WOTS

Incident key events	<ol style="list-style-type: none"> At 0439 hrs: <ul style="list-style-type: none"> A lightning strike caused a fault on the WOTS 22 kV system. WOTS No. 1 and No. 2 330/66/22 kV transformer protection operated unexpectedly resulting in de-energisation of the WOTS No. 1 and No. 2 330 kV busbars. This also disconnected the DDTS – WOTS 330 kV line and the WOTS – Jindera 330 kV line. At 0450 hrs, WOTS No. 1 busbar, the DDTS – WOTS No.1 330 kV line and the No. 1 330/66/22 kV transformer were returned to service. At 0451 hrs, the WOTS – Jindera No.1 330 kV line was returned to service. At 0452 hrs, WOTS No. 2 busbar, the DDTS – WOTS No. 2 330 kV line, the WOTS – Jindera No. 2 330 kV line and No. 2 330/66/22 kV transformer were returned to service. At 0458 hrs, all disconnected load was restored. The No. 1 and No. 2 330/66/22 kV transformer Y protection Rapid Earth Fault Current Limiter (REFCL) remote trips were isolated on the same day.

Details
Power system response (facilities and services)	<p>Coincident with the 22 kV fault caused by a lightning strike, the WOTS No. 1 and No. 2 transformer Y protection operated unexpectedly, tripping both transformers and de-energising the WOTS No. 1 and No. 2 330 kV busbars. This also caused the disconnection of the DDTs – WOTS 330 kV line and the WOTS – Jindera 330 kV line, as there are no circuit breakers between the transformer HV windings and 330 kV busbars at Wodonga.</p> <p>The Y protection relays of No. 1 and No. 2 transformers at WOTS was triggered by REFCL remote trip signal immediately after the lightning strike on the WOTS 22 kV system at 0439 hrs.</p> <p>AusNet advised that the Wodonga Terminal Zone Substation REFCL was not in-service at the time of the incident and the REFCL did not record any trip initiate signals to the Y protection of both transformers. The protection mal-operation was likely due to the long distance low voltage secondary cables between the REFCL in the 22 kV yard and the transformer relays control building. It is likely that due to the low voltage secondary cable's length, the lightning strike induced sufficient current in these low voltage cables to trigger the Y protection. The WOTS Y protection relays interpreted this induced current as a trip signal from the REFCL and tripped.</p>
