# TRIP OF TRANSMISSION LINES IN TASMANIA FOLLOWED BY THE LOSS OF BASSLINK ON 10 AND 16 DEC 2014, AND 23 FEB 2015

AN AEMO POWER SYSTEM OPERATING INCIDENT REPORT  
FOR THE NATIONAL ELECTRICITY MARKET

Published: **MAY 2015**

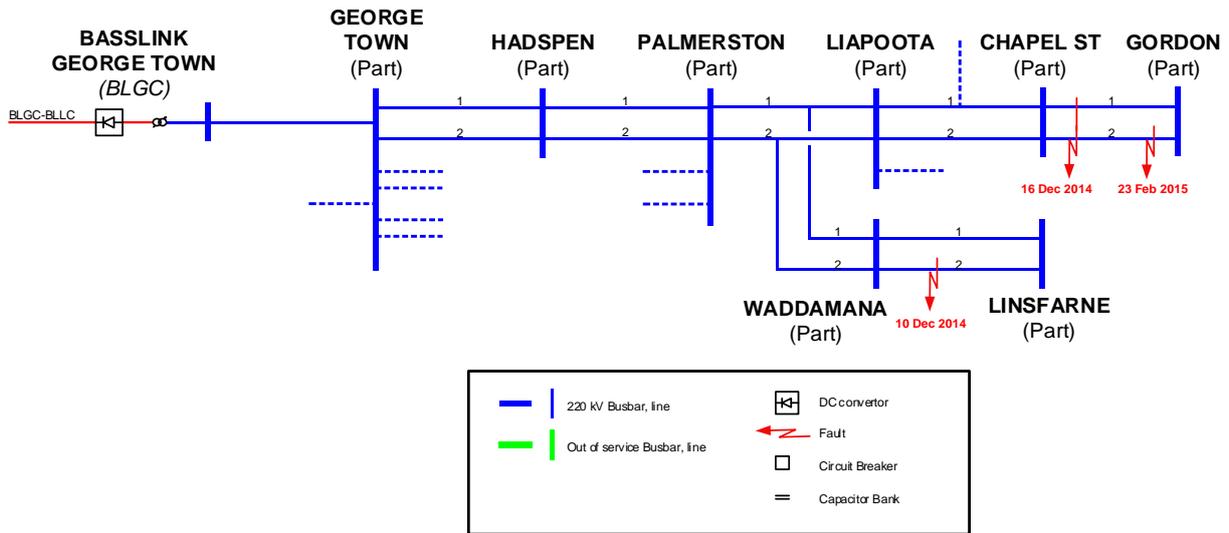
# APPENDIX A. POWER SYSTEM DIAGRAM

Power system diagram showing part of the Tasmanian 220 kV transmission system and the location on the system of the three faults.

See Appendix A for a power system diagram illustrating the incidents.
