Trip of New England Solar Farm Transformers 1 and 2 on 5 October 2022

March 2023

Reviewable Operating Incident
Report under the National
Electricity Rules

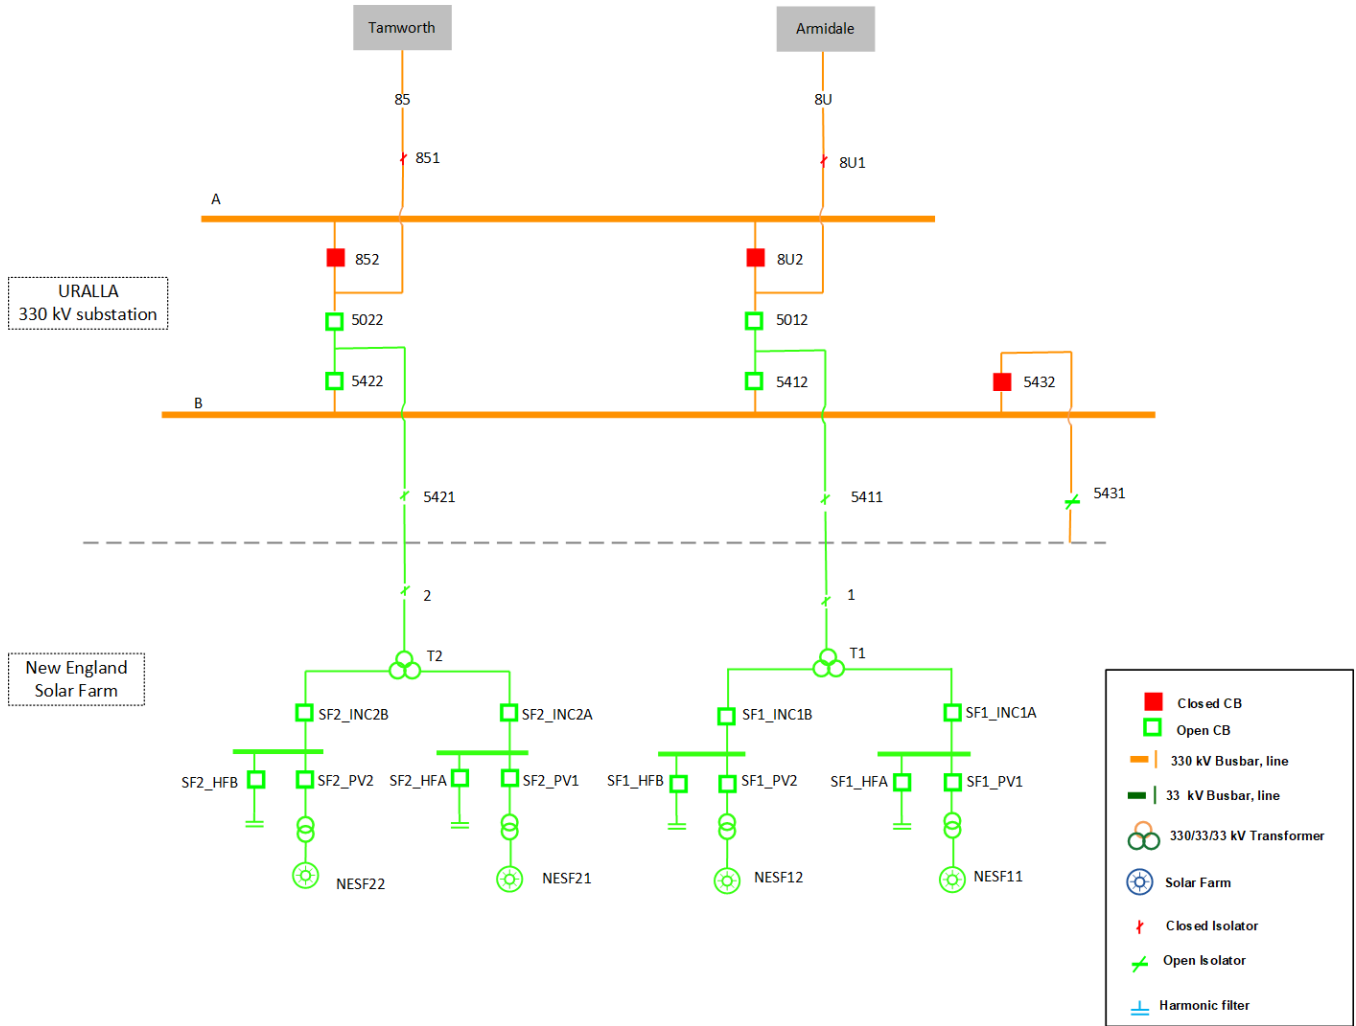
Figure 1 Post-incident diagram

Pre-incident conditions	Prior to the event, NESF was out of service and isolated via 33 kV circuit breakers SF_INC1A, SF_INC1B, SF_INC2A and SF_INC2B.
Incident key events	<ol style="list-style-type: none"> At 1548 hrs on 05 October 2022, the Armidale to Walcha South 66 kV line tripped. Simultaneously, Uralla 330 kV circuit breakers 5012, 5022, 5412 and 5422 opened. This tripped both NESF 330/33 kV transformers 1 and 2 and disconnected the 330 kV B busbar at Uralla. Figure 1 shows the configuration following the event. At 1410 hrs on 18 October 2022, the NESF 330/33 kV transformers 1 and 2 were returned to service.
Incident cause	<p>Post-incident investigations by Transgrid and Essential Energy have confirmed:</p> <ul style="list-style-type: none"> A scissor lift being operated by a third party made contact with the Armidale to Walcha South 66 kV line, causing this line to trip⁷. The investigation into the root cause of the scissor lift contacting the 66 kV line is ongoing and outside the scope of this incident report. Simultaneously, NESF 330/33 kV transformers 1 and 2 unexpectedly tripped. It was later identified that the REF protection relays operated incorrectly for an out-of-zone fault, causing the NESF transformers to trip. <p>Further investigations by NESF concluded that:</p> <ul style="list-style-type: none"> During the fault, the NESF 330/33 kV transformers 1 and 2 HV neutral CTs measured 25 A primary current, which caused the set X HV REF protection to operate and trip NESF 330/33 kV transformer 1 and 2. The cause of the trip was identified as human error. The X-set REF CT polarities were inverted on both transformers during the installation and commissioning process of the NESF 330/33 kV

Details	
	<p>transformers 1 and 2. This led to a network disturbance, causing NESF transformers to trip when they were expected to remain connected.</p> <p>During the investigation, it was also identified that NESF 330/33 kV transformer 1 and 2 330 kV neutral CT secondary terminals were incorrectly wired to 800/1 CT turns ratio rather than 500/1.</p>
Power system response (facilities and services)	There were no other material impacts on the broader power system, load, or generation.
Rectification	Following the incident on 5 October 2022, NESF has confirmed that the NESF 330/33 kV transformers 1 and 2 polarity of the X-set HV REF CT polarity has been rectified. In addition, NESF 330/33 kV transformer 1 and 2 330 kV neutral CT ratios have been corrected to 500/1. The secondary connection changes have been verified as correct through on-site testing.
Power system security	The power system remained in a secure operating state throughout this incident and the Frequency Operating Standard ⁵ was met for this incident.

Conclusions	<p>AEMO has concluded that:</p> <ol style="list-style-type: none"> 1. On 5 October 2022, the Armidale to Walcha South 66 kV line tripped after a scissor lift contacted the circuit. At the same time, the NESF 330/33 kV transformers 1 and 2 tripped, which disconnected Uralla 330 kV busbar B, due to the unexpected operation of the NESF transformer REF protection. 2. AEMO correctly identified the need to reclassify this incident as a credible contingency until the cause of the incident had been identified and rectified. Subsequently, NESF confirmed that the NESF X-set REF CT polarity inversions had been corrected. As the root cause of the incident had been identified and rectified, AEMO considered this incident was unlikely to re-occur and removed the reclassification of this incident as a credible contingency at 1600 hrs on 21 March 2023. 3. The power system remained in a secure operating state throughout this incident. 4. The root cause of the incident has been identified as human error – during the installation and commissioning process, NESF 330/33 kV transformers 1 and 2 X-set REF CT polarities were inverted. Subsequently, the NESF transformers tripped in this event for a network disturbance where they were expected to remain connected. 5. NESF has confirmed that, for future projects and wherever REF protection is affected by an equipment replacement/installation, a specific inspection test checklist (ITC) will be used. This ITC will incorporate primary injection testing to verify CT ratios, polarities, and protection stability.
